# ASSESSMENT OF CONDITIONS

State University of New York College of Technology at  
Canton, Client

The intent of the document is to provide guidelines for future campus improvements and developments that support SUNY Canton's academic mission and strategic plan. It will also identify, prioritize, and structure future project requests for capital funding. This report, Phase 2 of the FMP, presents the Assessment of Conditions.

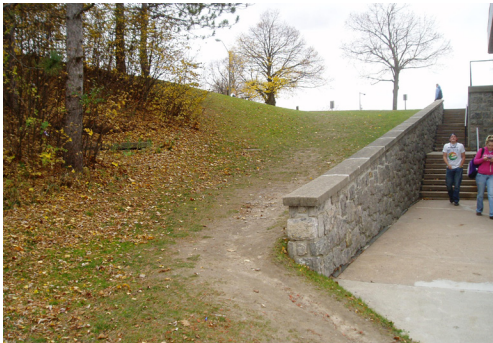
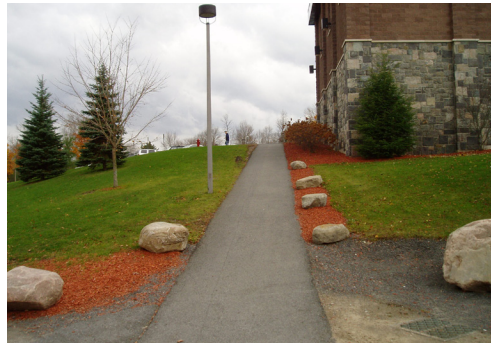
"Cowpath" and Rock Lined Walks

Similar to other college campuses, students tend to find shortcuts when walking from one destination to the next. These shortcuts cause lawn areas to deteriorate into dirt paths or "cowpaths". The photo below shows an example of the "cowpath". This also occurs at numerous walk intersections when pedestrians cut the corners of the intersections. Recently the College has been adding decorative landscape stones to some of the walks and intersections to improve the condition of pathways.

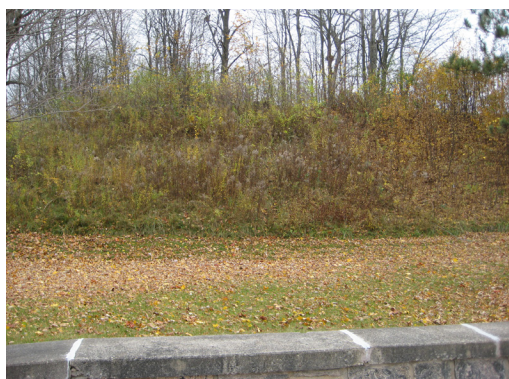
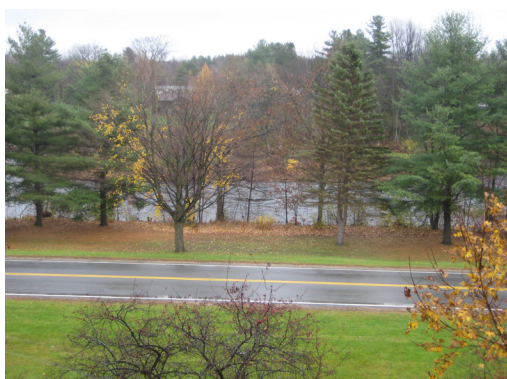
Natural Woodlands

Natural woodlands are found around the perimeter of the campus, including the river's edge as well as a few internal areas of the campus. The woodlands outside of the campus provide a solid buffer between adjacent properties while offering recreational opportunities such as nature trails. The woodland areas within the campus core add natural buffers which can define spaces and lessen winds. Although the woodlands are a naturalistic appearance, the understory brush and dead materials appear untidy and at times hinder views.

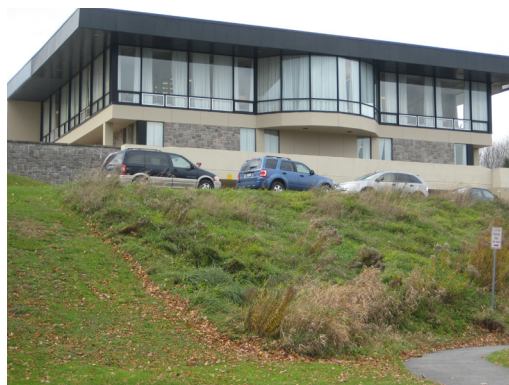
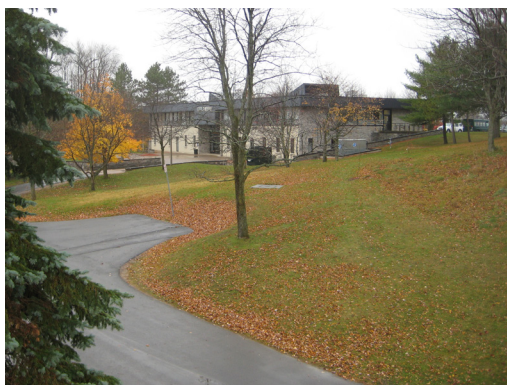
Lawn Areas

Vast areas of well maintained lawn exist throughout the campus. Although, the manicured lawns look pristine, they require enormous maintenance efforts. The campus spends countless hours mowing, as well as resources and money. In a few locations extremely steep sloped lawn areas have also proven to be challenging to maintain.

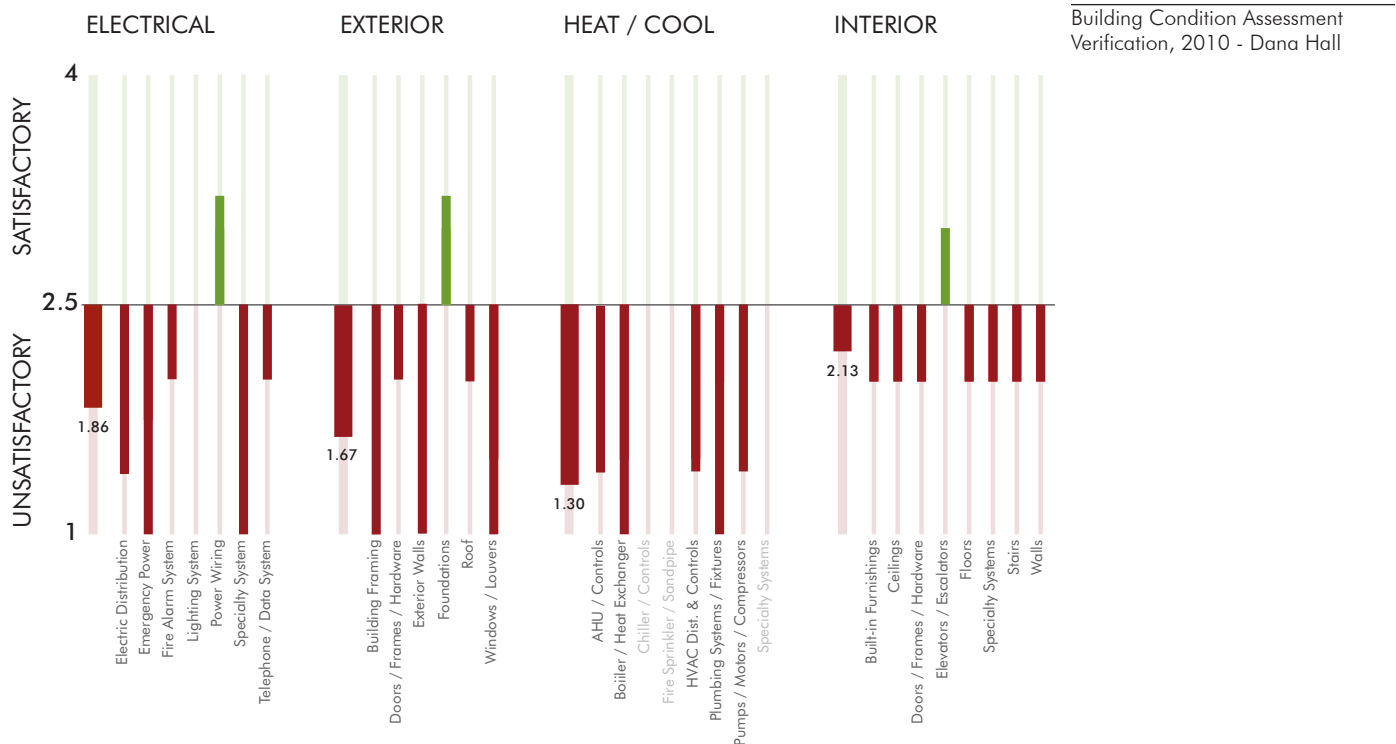
Since the BCAS assessment, Dana Hall has been vacated and is currently under construction to repair the structural wood beams of the building. As a result of the construction project, walls, ceilings, doors and frames are not in as good condition as noted in the BCAS. Additionally, the exterior doors, frames and hardware were judged to not be in as good of quality as the BCAS indicated. The gymnasium, in comparison to the remainder of the building, is in good condition. Protective measures to preserve the wood basketball court and bleachers during the rehabilitation project are in place.

- Complete roof replacement
- Window replacement - single pane windows throughout building
- Exterior shake shingles in poor condition - replacement recommended
- Replace aged doors (interior and exterior), frames and hardware
- Building not fully accessible (i.e. toilet rooms, elevators including visible signals, car dimensions, control buttons, etc., door widths, clearances, door hardware, etc.)
- Mechanical, electrical and plumbing equipment is original and requires replacement
- No fire protection system

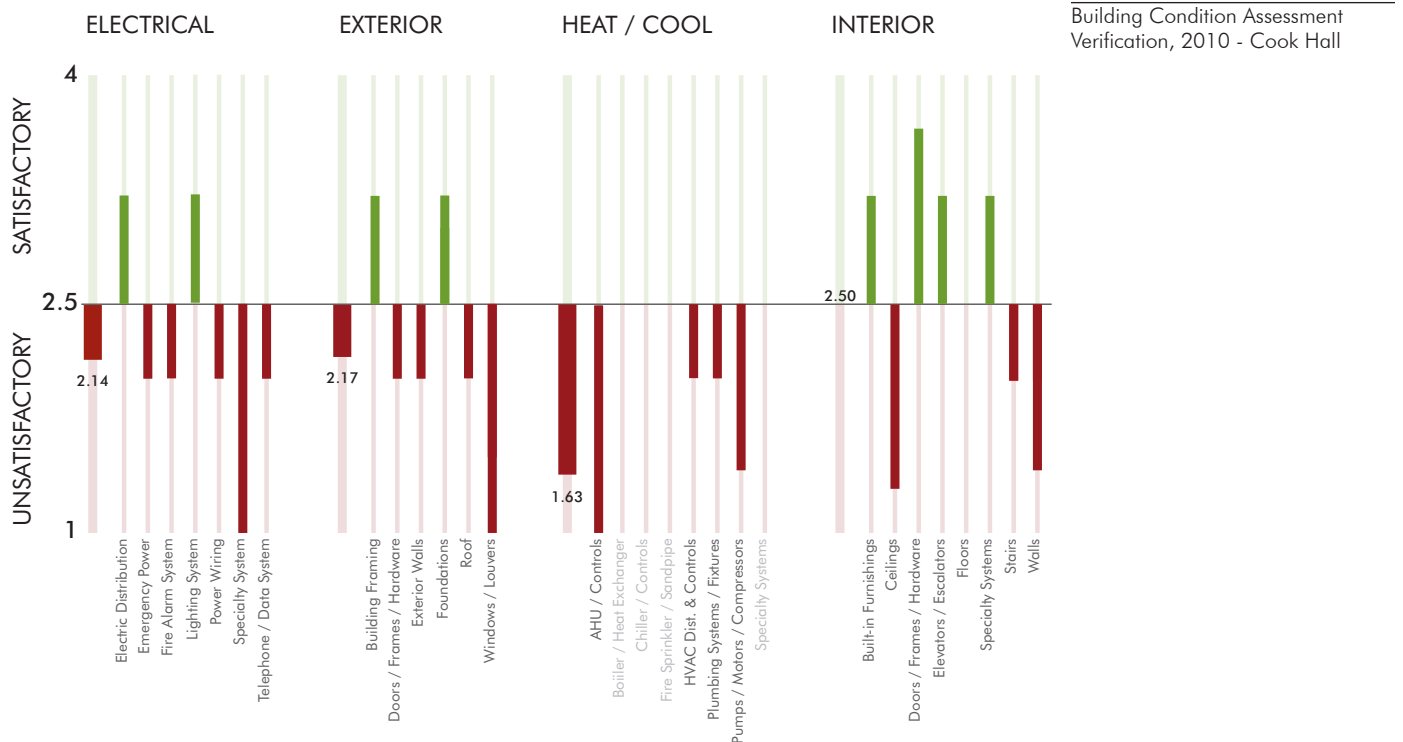
Cook Hall

- Complete roof replacement
- Window replacement - single pane windows throughout building
- Exterior stucco panel system is cracking and requires repair
- Enhance integrated building signage on front facade
- Building not fully accessible (i.e. toilet rooms, elevators including visible signals, car dimensions, control buttons, etc., door widths, clearances, door hardware, etc.)
- Ceilings at second floor have deteriorated
- Main distribution panel and branch circuit panels are full and original to the building
- No fire protection system

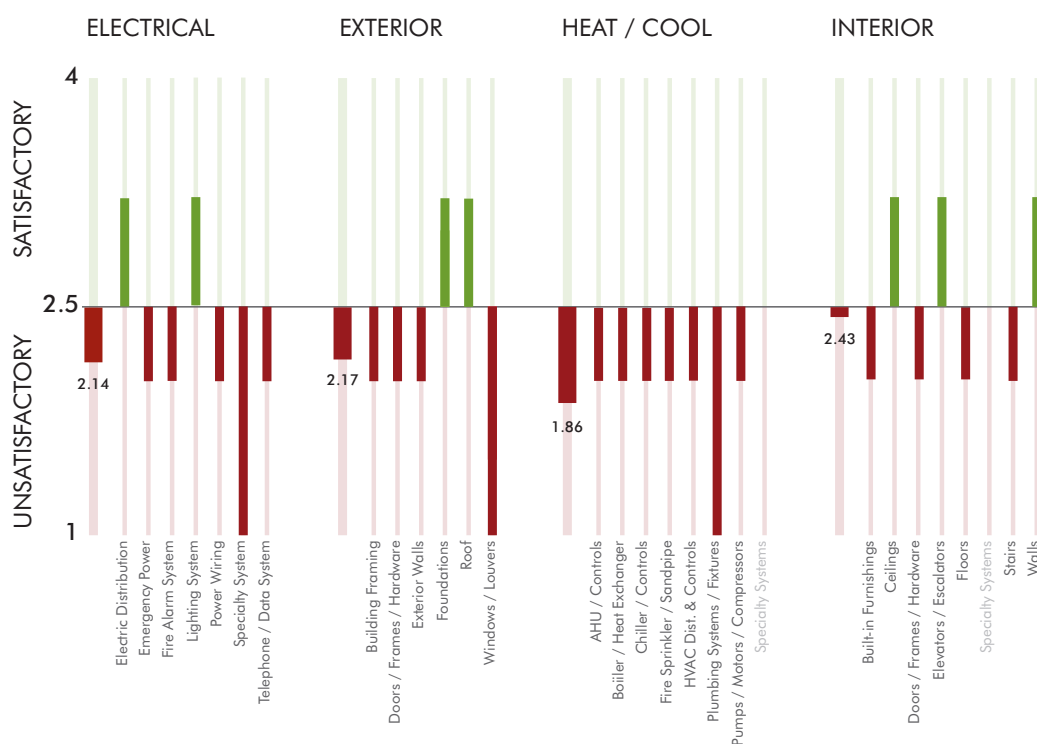
Chaney Dining Center

- Complete roof replacement
- Windows need replacement - single pane windows throughout building
- Enhance integrated building signage on front facade
- Building not fully accessible (i.e. toilet rooms, elevators including visible signals, car dimensions, control buttons, etc., door widths, clearances, door hardware, etc.)
- Replace steam boiler with new hot water boiler
- Replace all kitchen equipment with gas fired and electric based equipment
- Replace lighting in dining area
- Provide fire protection system throughout building

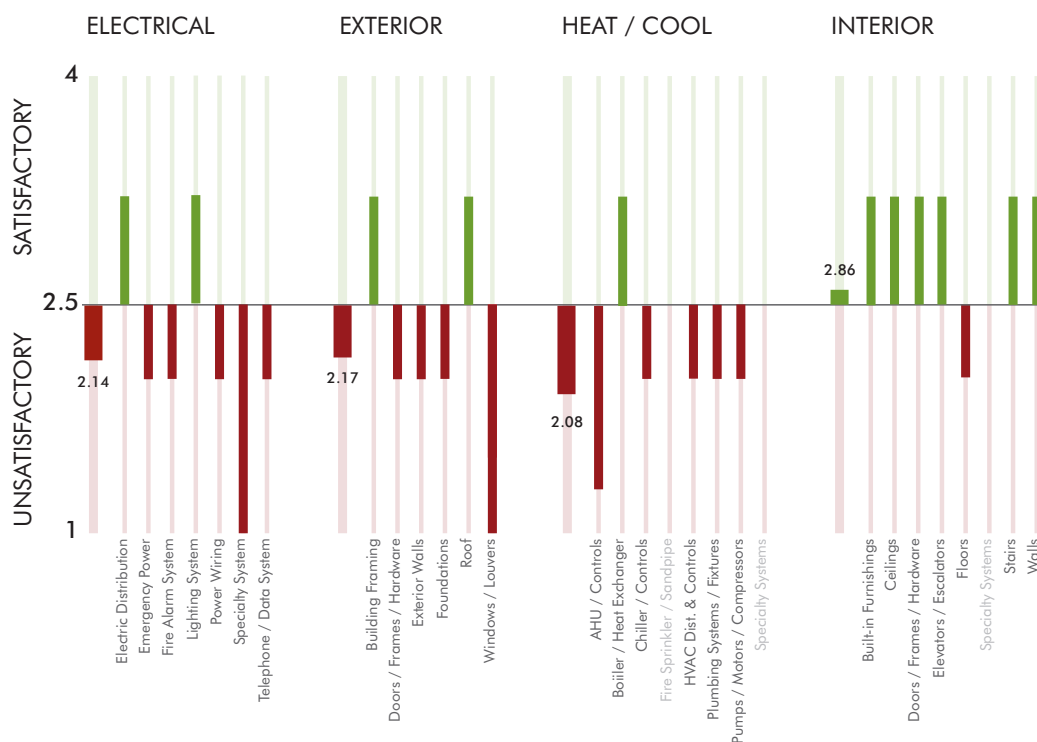
French Hall

- Complete roof replacement
- Windows need replacement - single pane windows throughout building
- Building not fully accessible (i.e. toilet rooms, elevators including visible signals, car dimensions, control buttons, etc., door widths, clearances, door hardware, etc.)
- Replace existing steam boiler with hot water boiler
- Replace all ductwork
- Main distribution panel and branch circuit panels are full and original to the building
- Provide fire protection system throughout building
