SUNY Canton

**Study of French Hall Sidewalks, Stairs, and Plazas,
and Campus Trees Along Cornell Drive**

SUCF Project Number: 231029001

Spring 2019

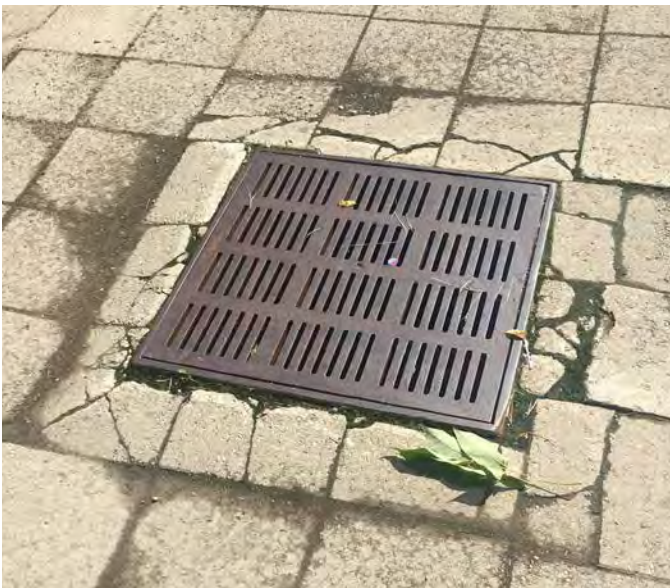
The walks within Roselle Plaza primarily consist of pavers. The pavers are in relatively good condition given that they are over 20 years old. However, some areas need repair due to cracking, oxidation marks from use of steel snow plows, differential settlement from freeze thaw, and from maintenance vehicles. In many locations where pavers abut the concrete, the pavers have settled causing a tripping hazard. The joints between the pavers are generally tight although a fair amount of weeds are growing between them.

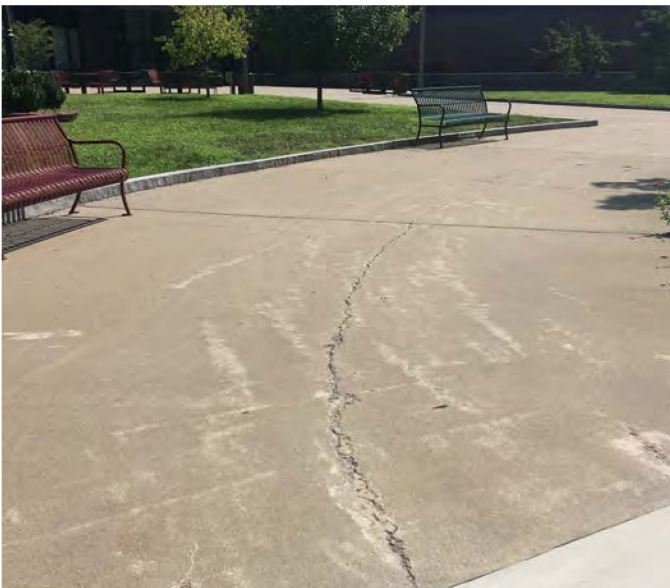
- Plaza area east of French Hall: concrete is in poor condition with numerous cracks.
- The oval area around the Knowledge Rock: in poor condition with areas cracking, spalling, and numerous rust / oxidation marks from plowing.
- The walkways leading to Miller Campus Center are in fair condition with some minor cracking. Areas have been repaired over the years and therefore the color of the concrete is different and patchy.

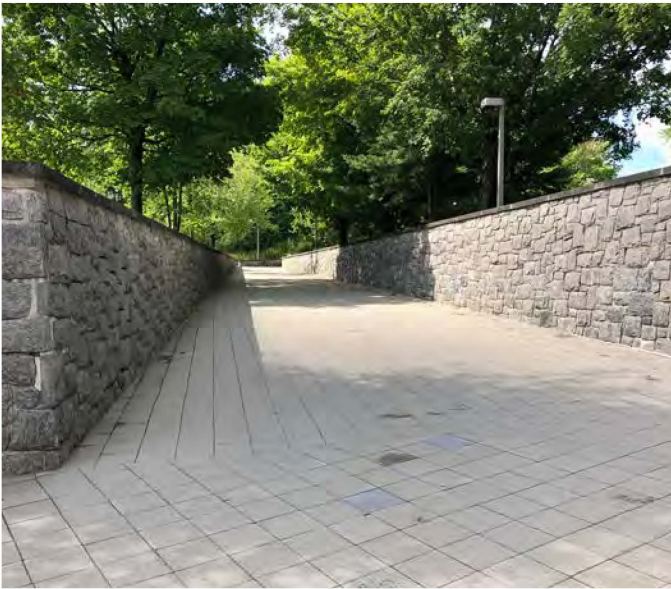
- The curbs adjacent to the plant beds are in good condition but contain some minor oxidation marks and chips in the curbing from plowing.
- The curbs along walks leading to the Miller Campus Center and the surrounding grass areas are in good to fair condition. There are heavy oxidation markings along the sides of the curbs and minor to moderate chipping from being struck by snow plowing blades. The corners of the curbs are deteriorating and in poor condition.

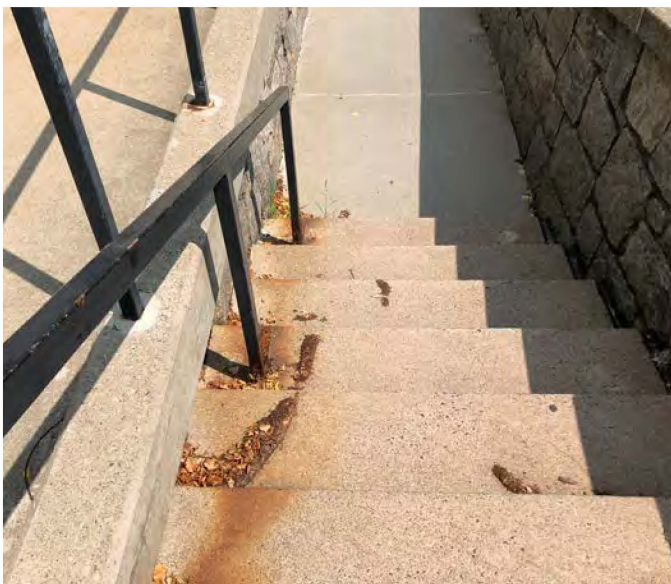
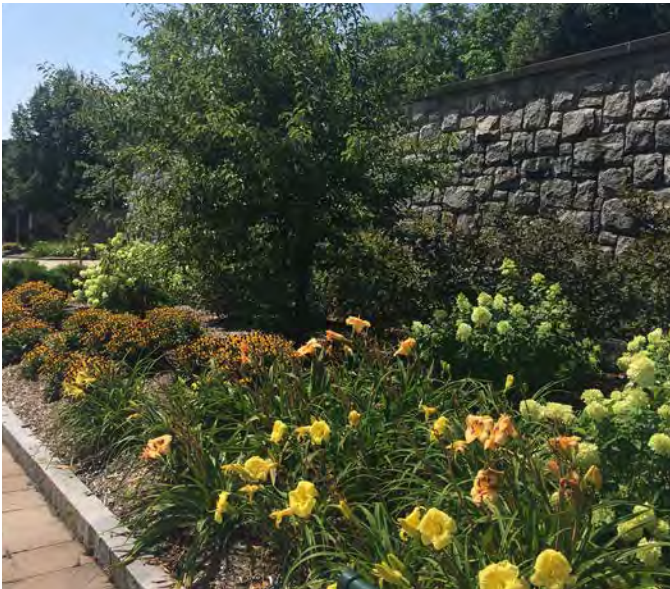
Existing retaining walls east of French Hall are in poor condition. The areas in poor condition showed clear signs of deterioration including loose or dislodged stones, large cracks and bowing. The walls block views from French Hall to the Miller Campus Center but are currently needed due to the steep grade change.

Stairs along both the north and south ends of French Hall are in poor condition. The stairs along the north end could be removed as they are not utilized as frequently as the south stairs. Stairs on the south end are severely damaged and a safety concern. This is primarily due to years of over salting as well as the corroding handrails. Rust is causing the concrete beneath the handrails to deteriorate. The barrier rails at the south end door above the stairs do not provide fall protection as required by the current building codes. The granite stairs and existing handrails from French Hall down to the library are in good condition. Only a few pavers where the railings are attached, are in poor condition and popping out of the ground due to freeze and thaw.

The deteriorating stairs to the south side of French Hall should be replaced. This stair case is one of the primary pedestrian access points into the campus. Therefore, it is recommended that the new stairs be wider to better accommodate the pedestrian flows. At the top of the stairs, additional site amenities will call attention to this gateway into the campus. The improvements are to include a campus directory sign, a bench, trash receptacle and landscaping. The landscape not only provides an aesthetic quality, but it will also serve as a barrier to help prevent students from walking down the hillside. An accessible route from the south side of French Hall down to the lower level behind French Hall was considered, but unfortunately, the grade change was too significant and deemed impracticable.

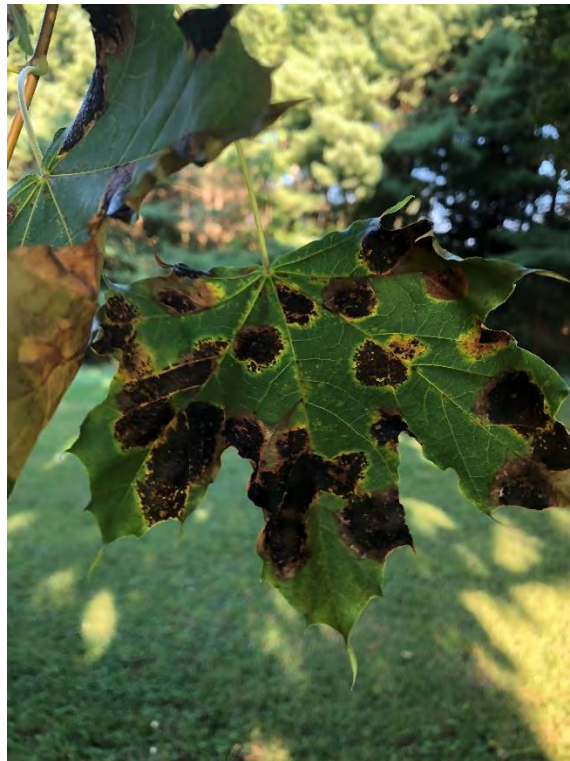
Tree #142 with tar spot present.

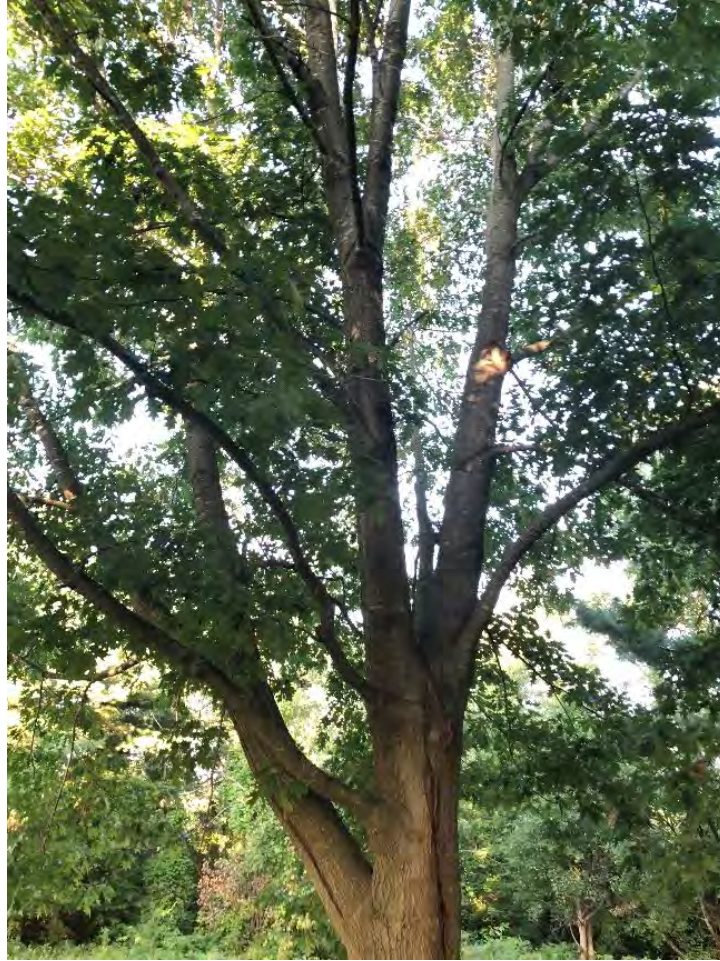
Tree #128 recommended for cabling due to co-dominant leaders.

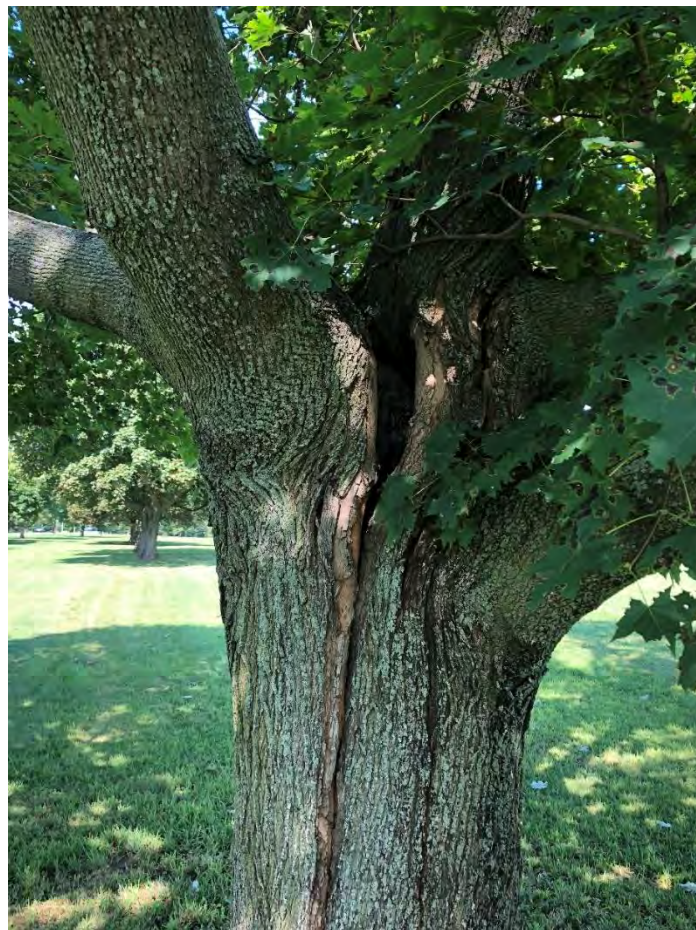
Tree #66 recommended for removal because it is in poor condition and has a crack.

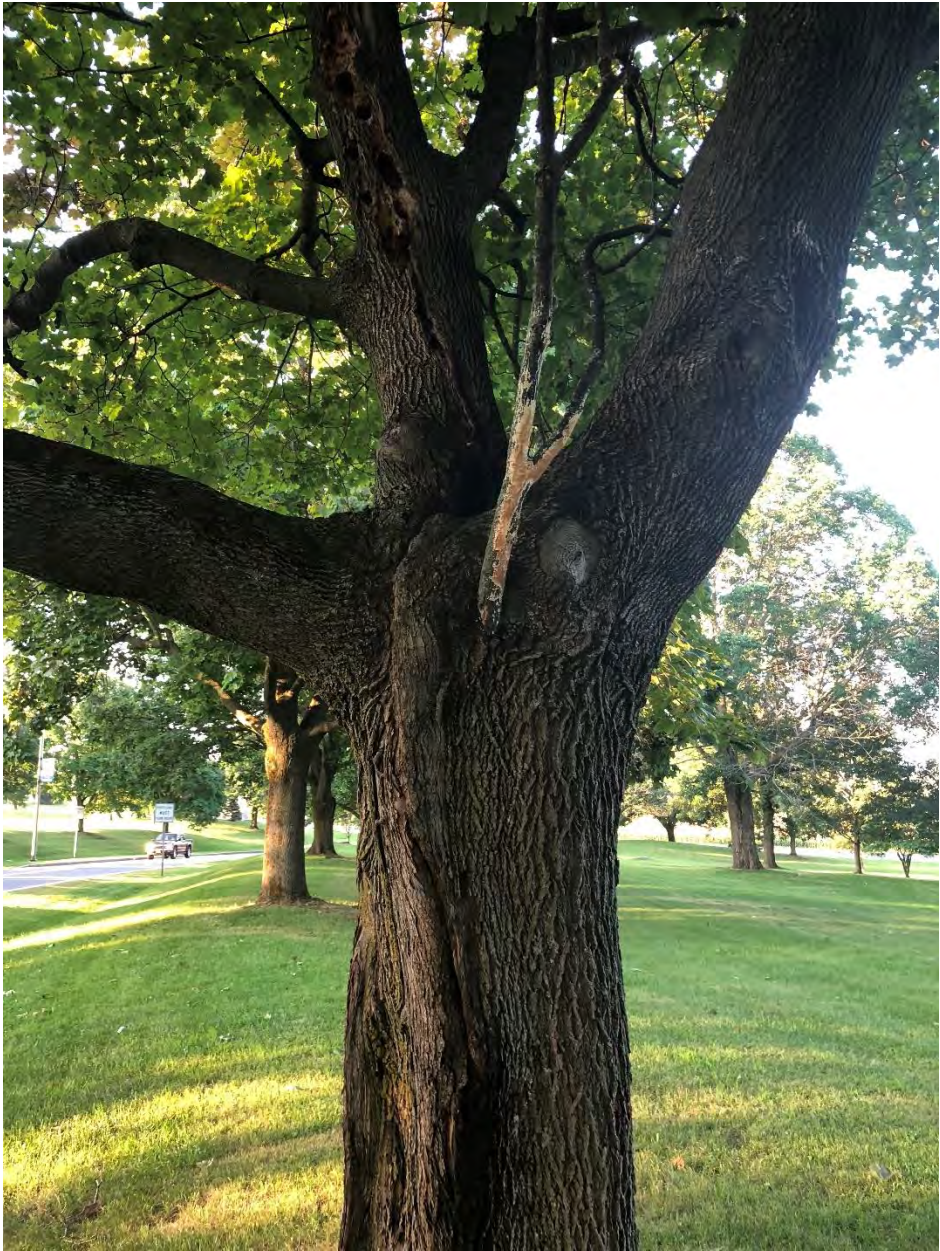
Tree #118 exhibiting a seam.
