State University of New York at Canton Campus Wide Site Utility Study SUCF Project No. 23206 Phase III- Implementation Plan

Village of Canton St. Lawrence County, New York

SUNY CANTON CAMPUS WIDE SITE UTILITY ASSESSMENT PHASE III - IMPLEMENTATION PLAN

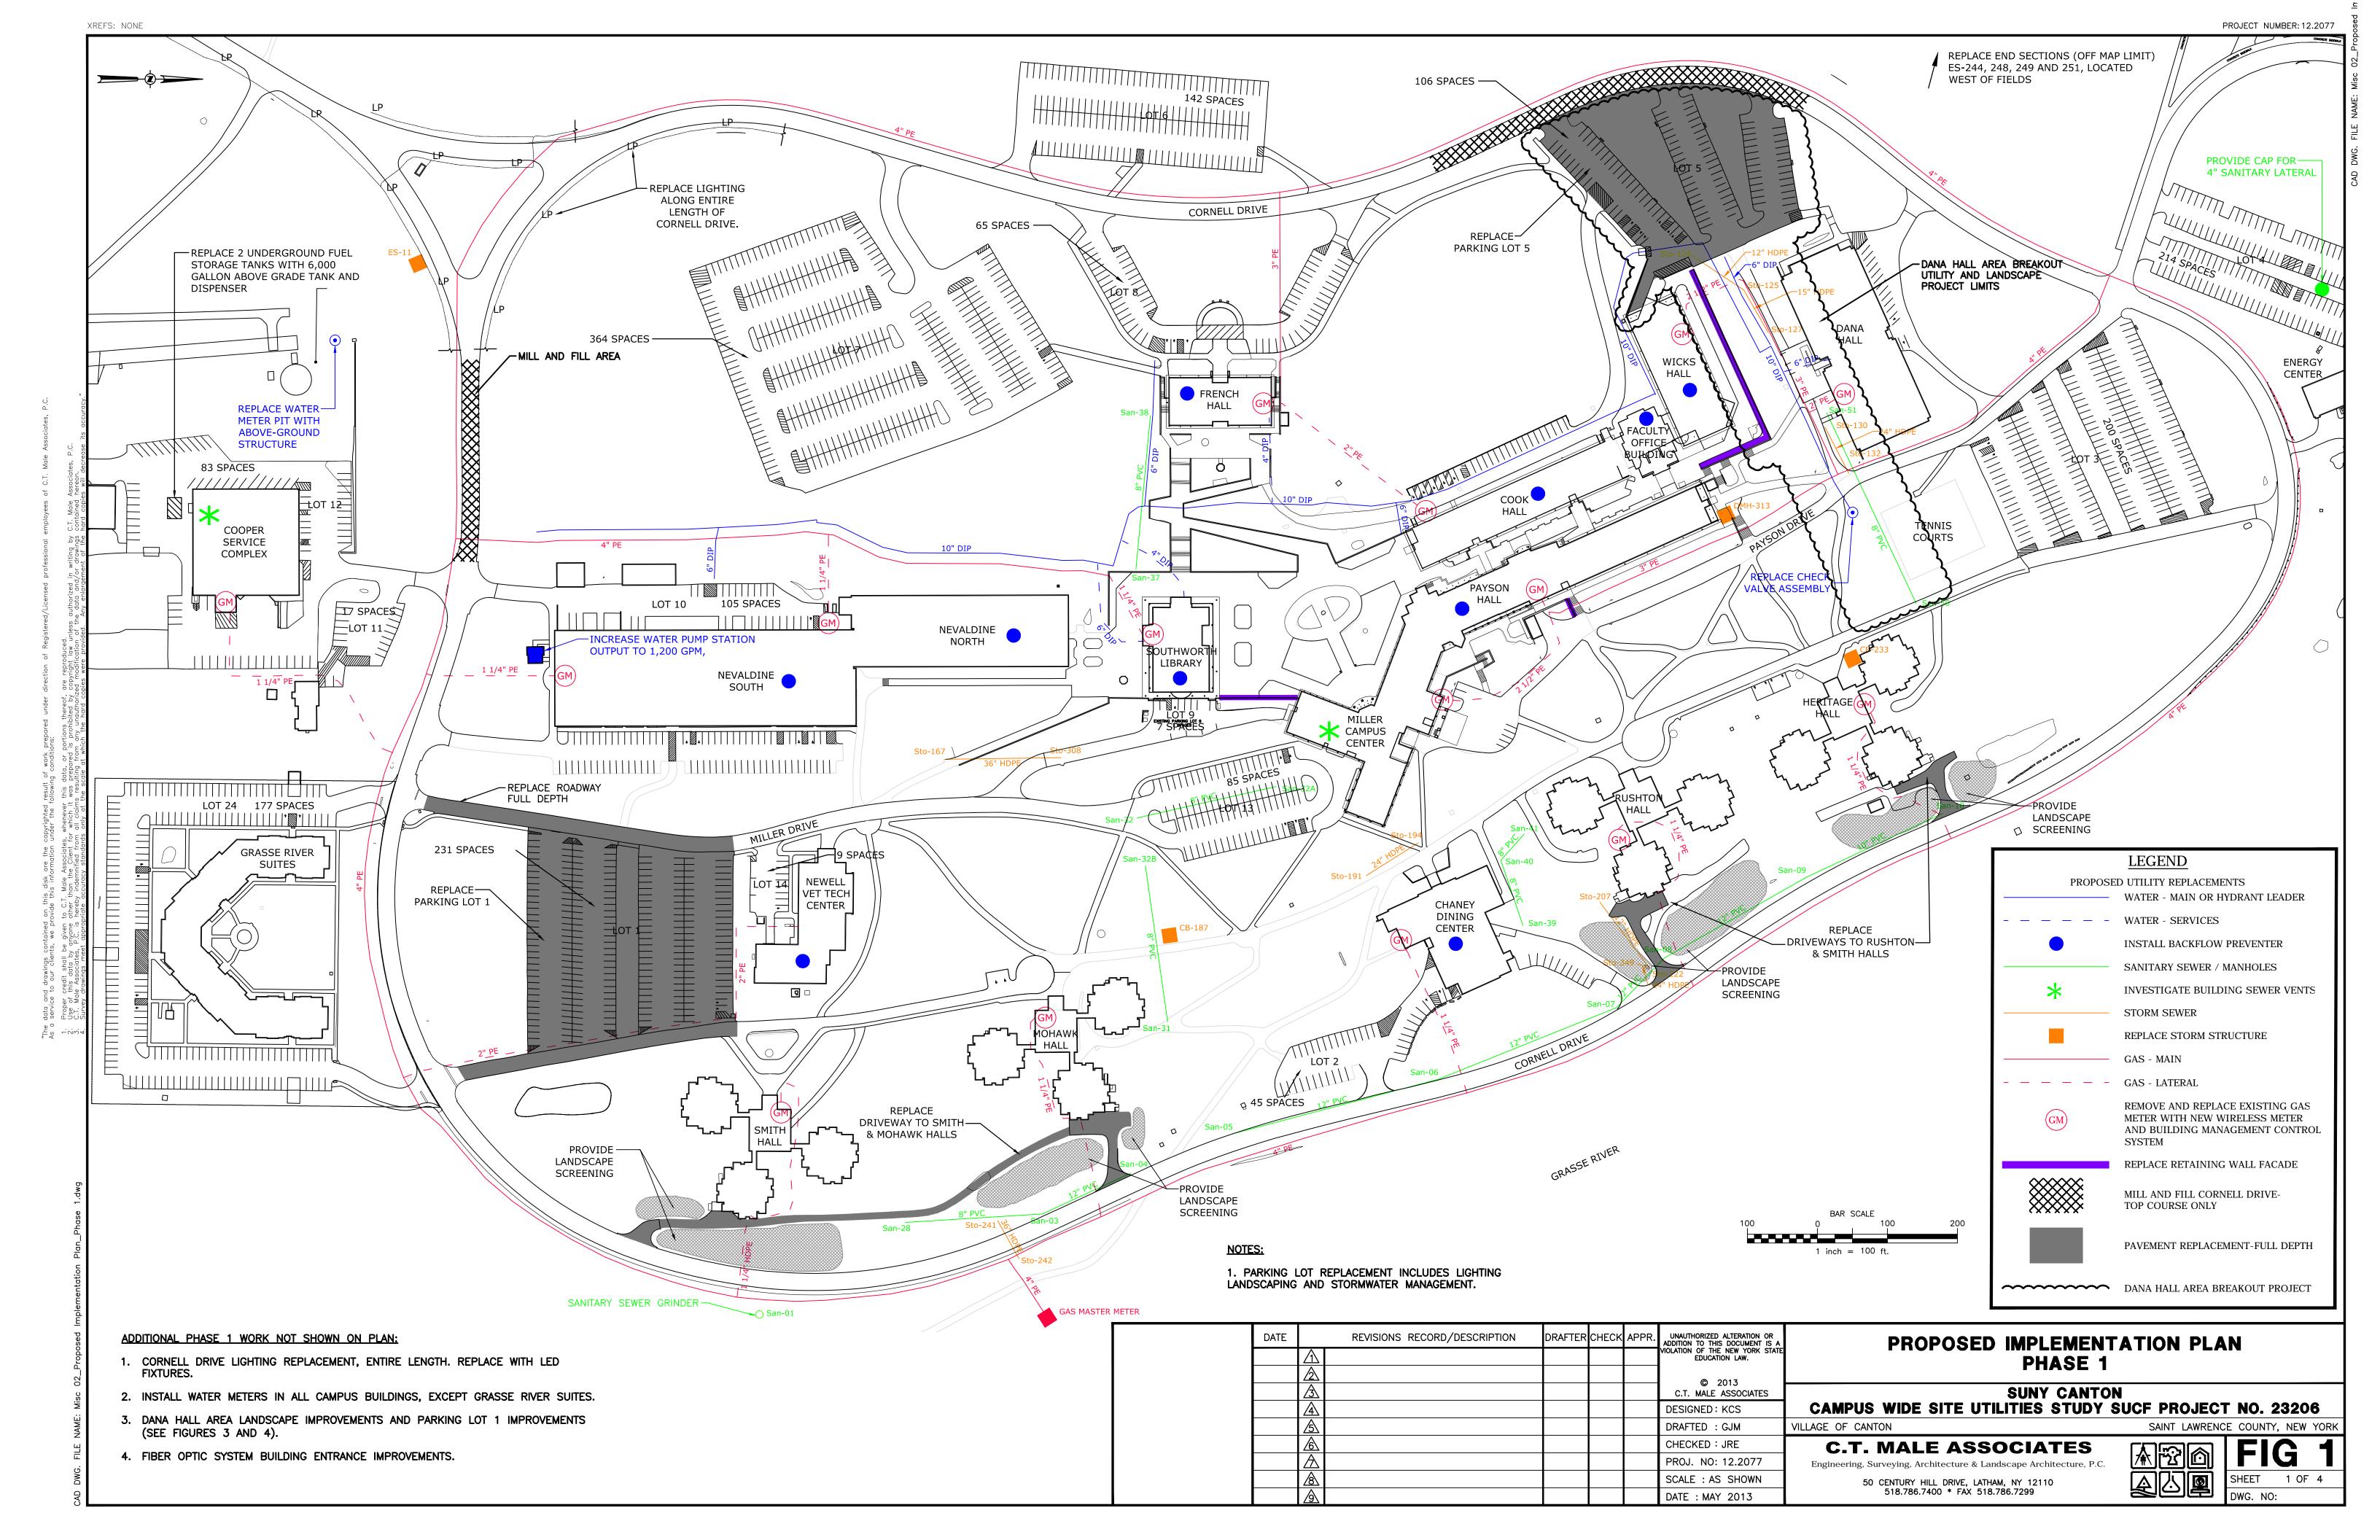
Phase 1 Improvement Map

Phase 1 improvements include repairs or replacements to the site utilities and amenities that are designated as priority, or are necessary to accommodate development outlined in the FMP. Phase 1 work would be performed within the next five years from 2013 to 2017. Figure 1, "Phase 1 Improvement Map", shows the location of the proposed improvements. Refer to Appendix B, which contains the preliminary cost estimate, for a more detailed breakdown of the quantities associated with the projects described below.

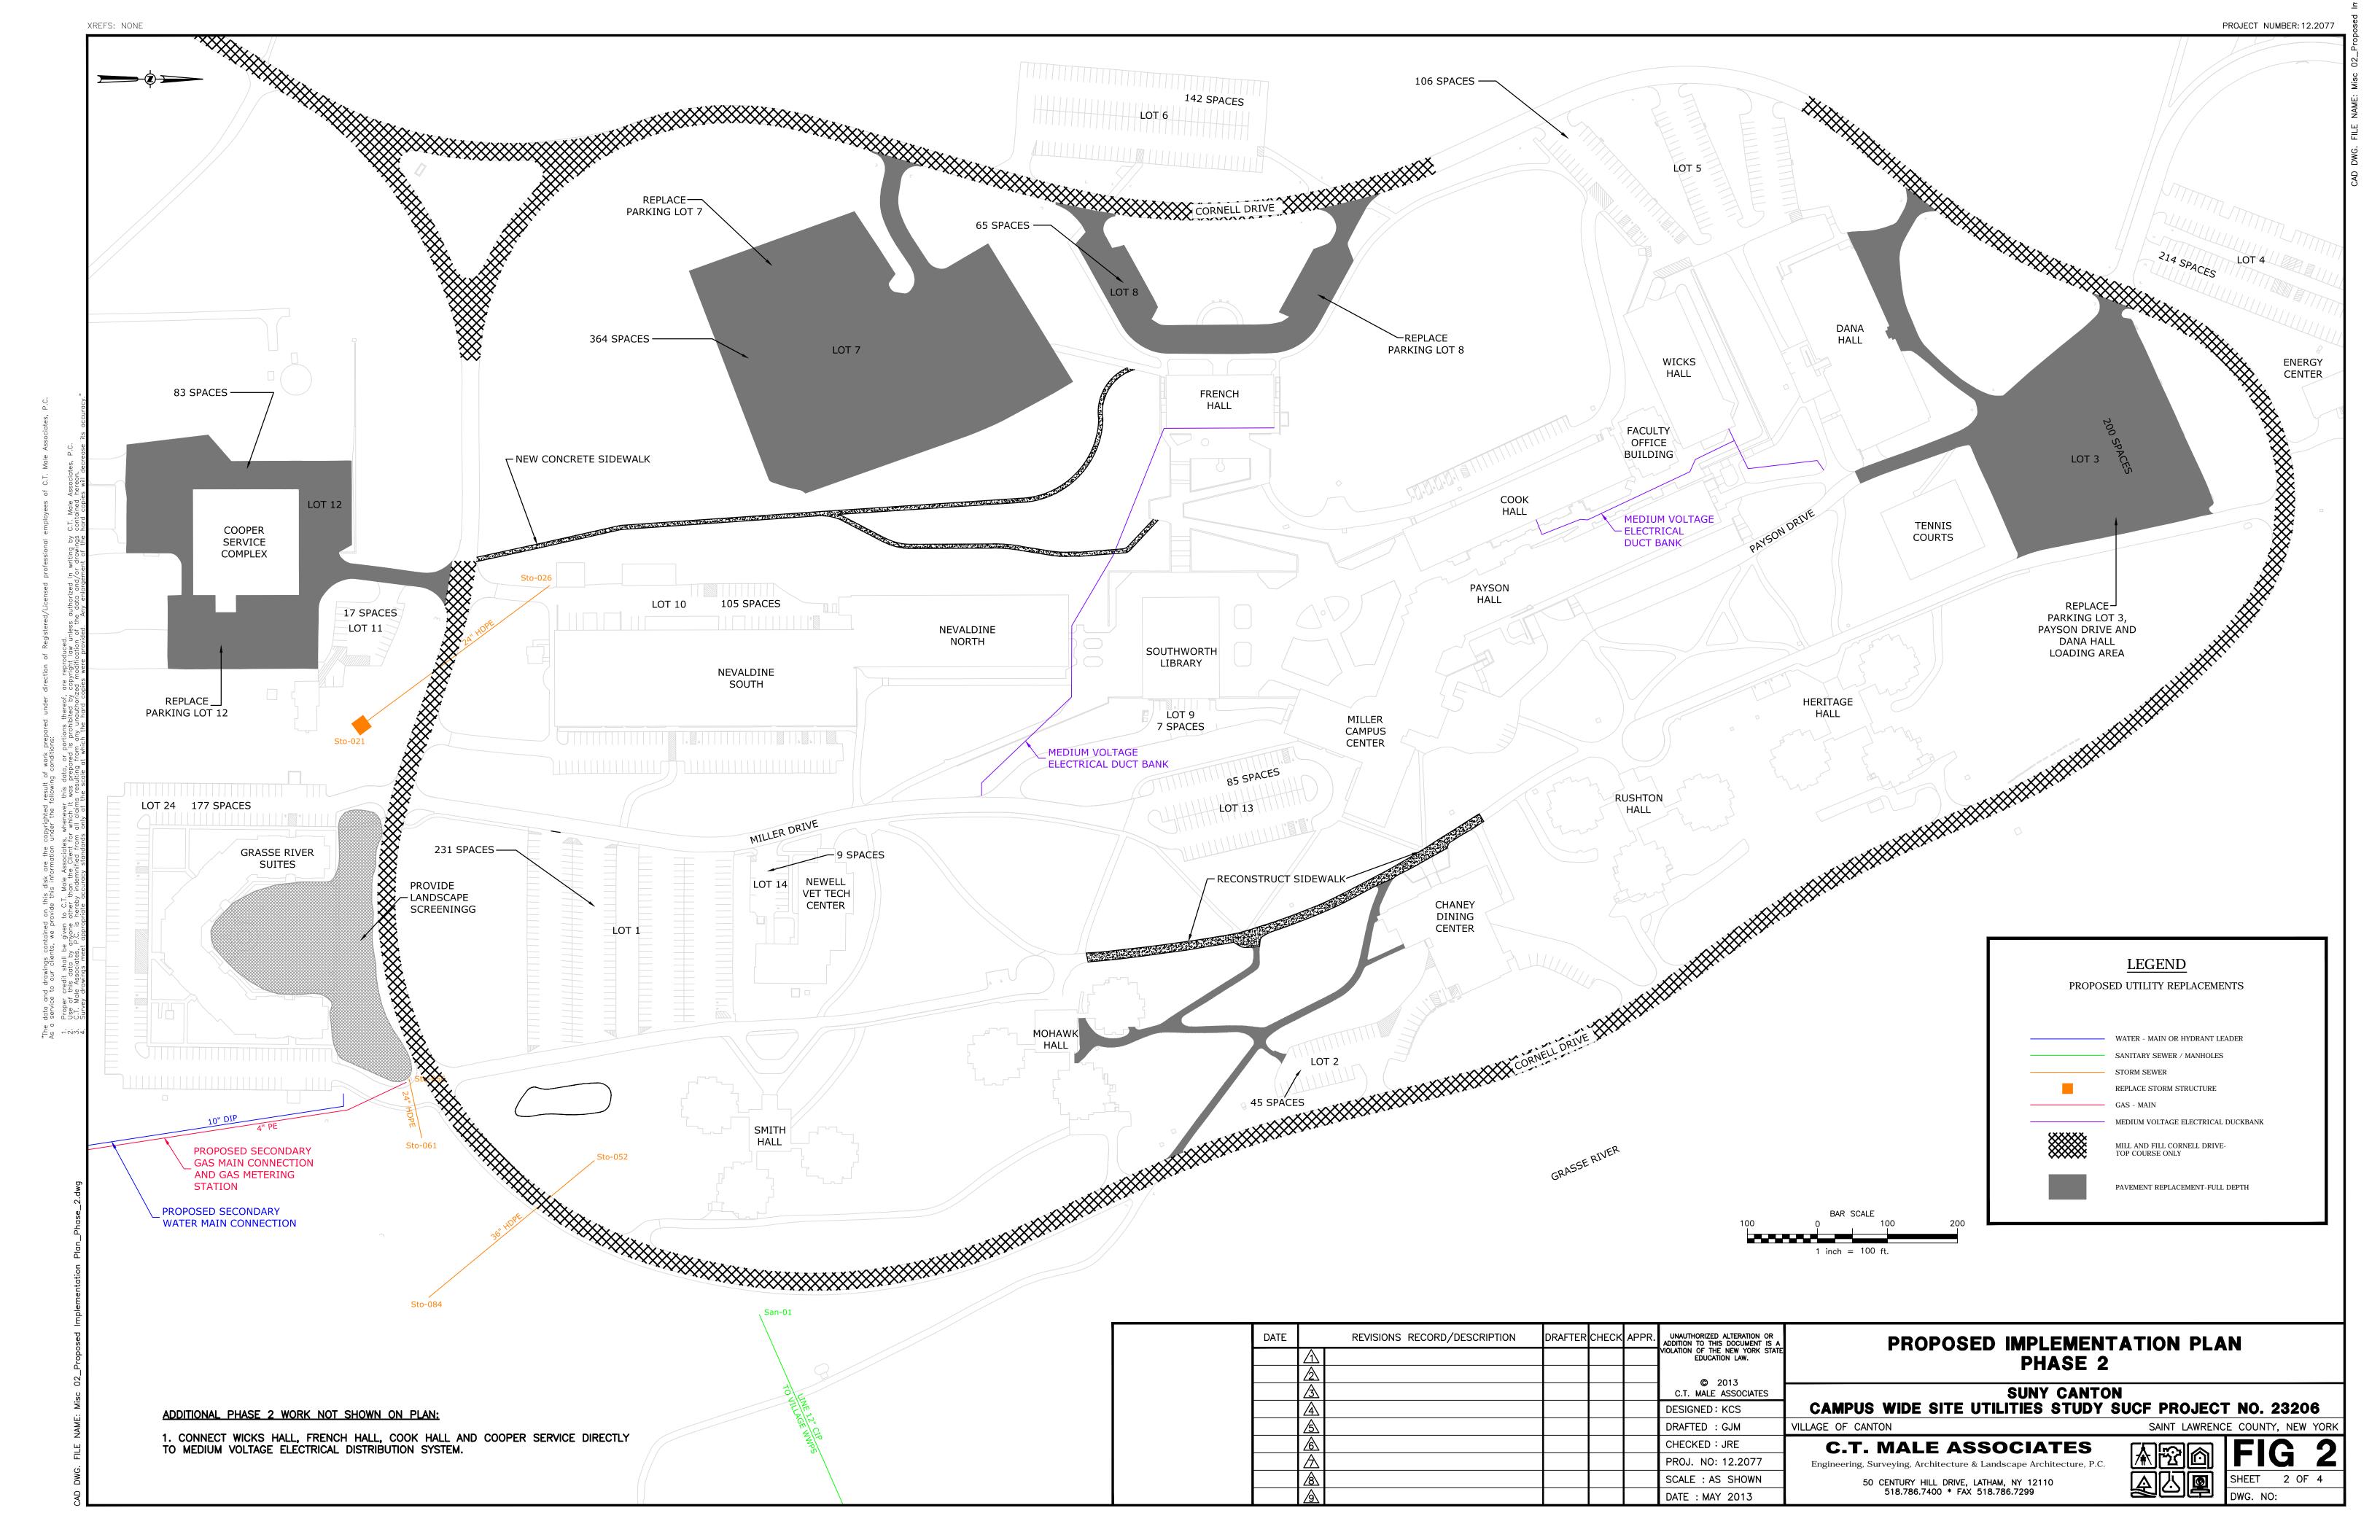
Phase 2 Improvement Map

Phase 2 improvements include repairs or replacements to the site utilities and amenities that are designated as necessary, but not of highest priority. Phase 2 work would be performed between 2018 and 2022. Figure 2, "Phase 2 Improvement Map", shows the location of the proposed improvements.

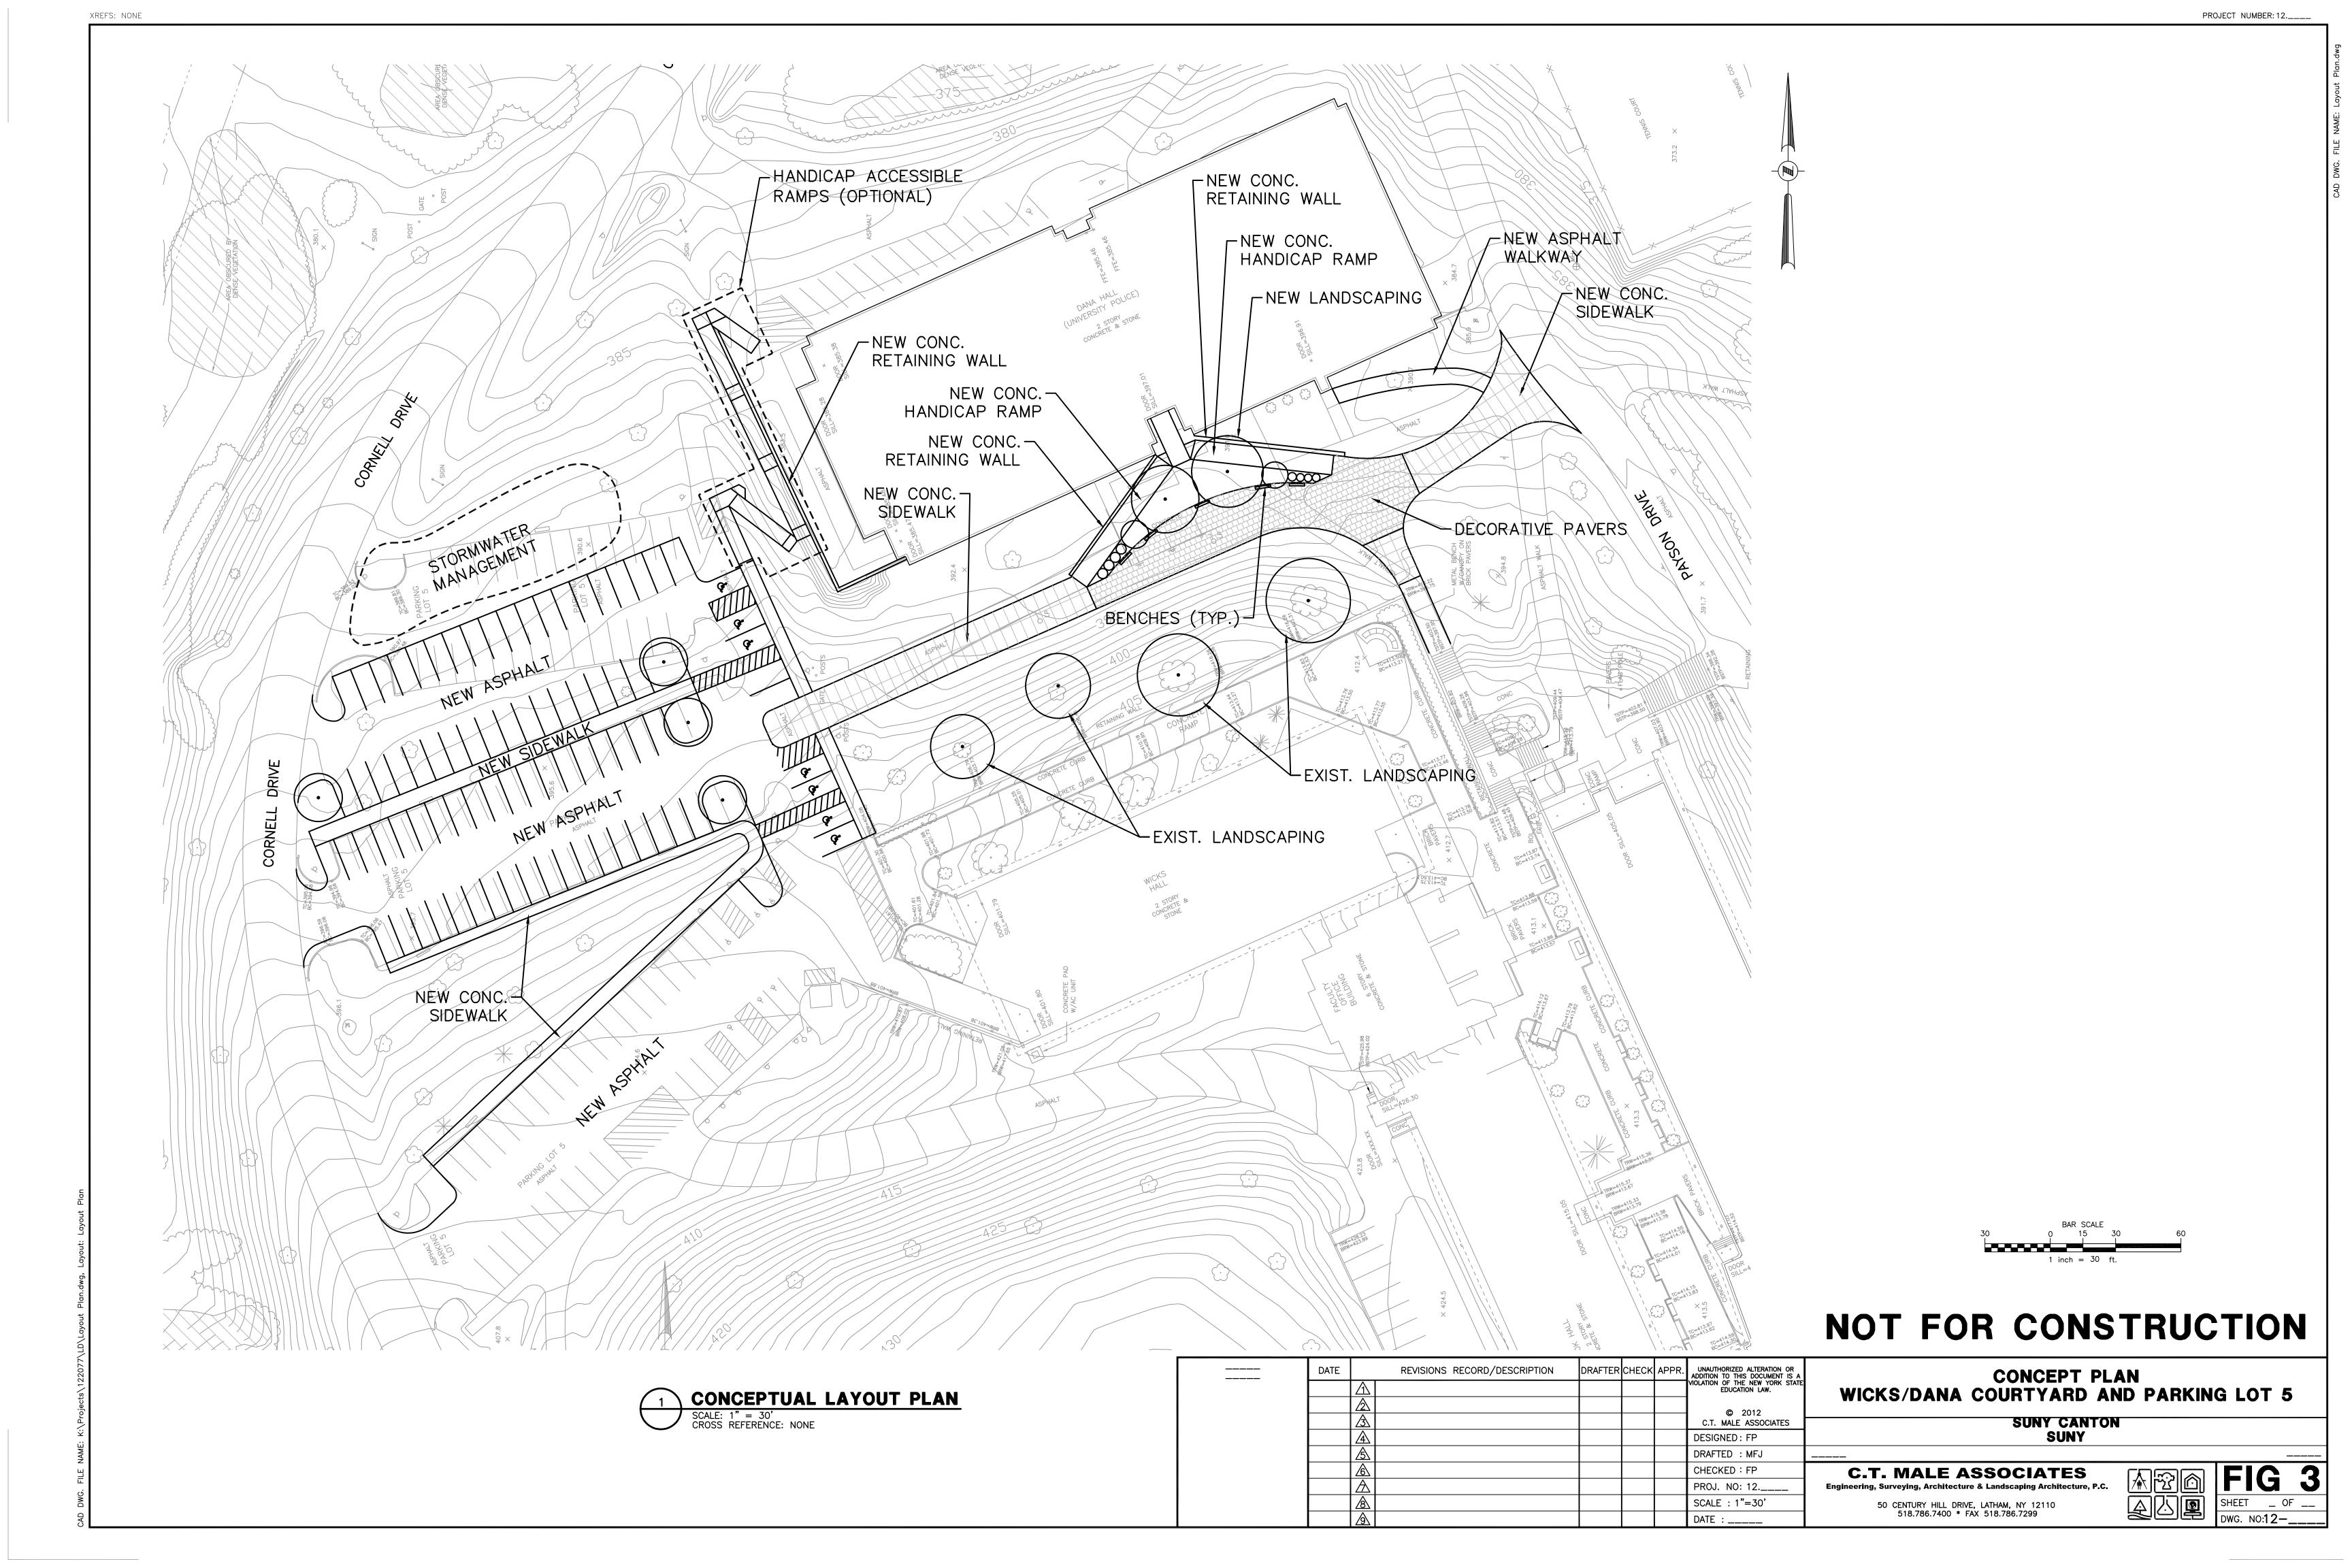
Conceptual Layout Plan - Wicks/Dana Hall Exterior Improvements

A breakout project consisting of the utility work south of Dana Hall and Parking Lot 5 has been identified. The corridor from Parking Lot 5 east to sanitary manhole 50 near the tennis courts contains numerous utility replacements that require nearly the entire corridor between Wick and Dana Halls to be disturbed. A landscaping and hardscaping improvement plan has been developed for this project area. Figure 3, "Conceptual Layout Plan- Wicks/Dana Hall Exterior Improvements", shows the location of the proposed improvements.

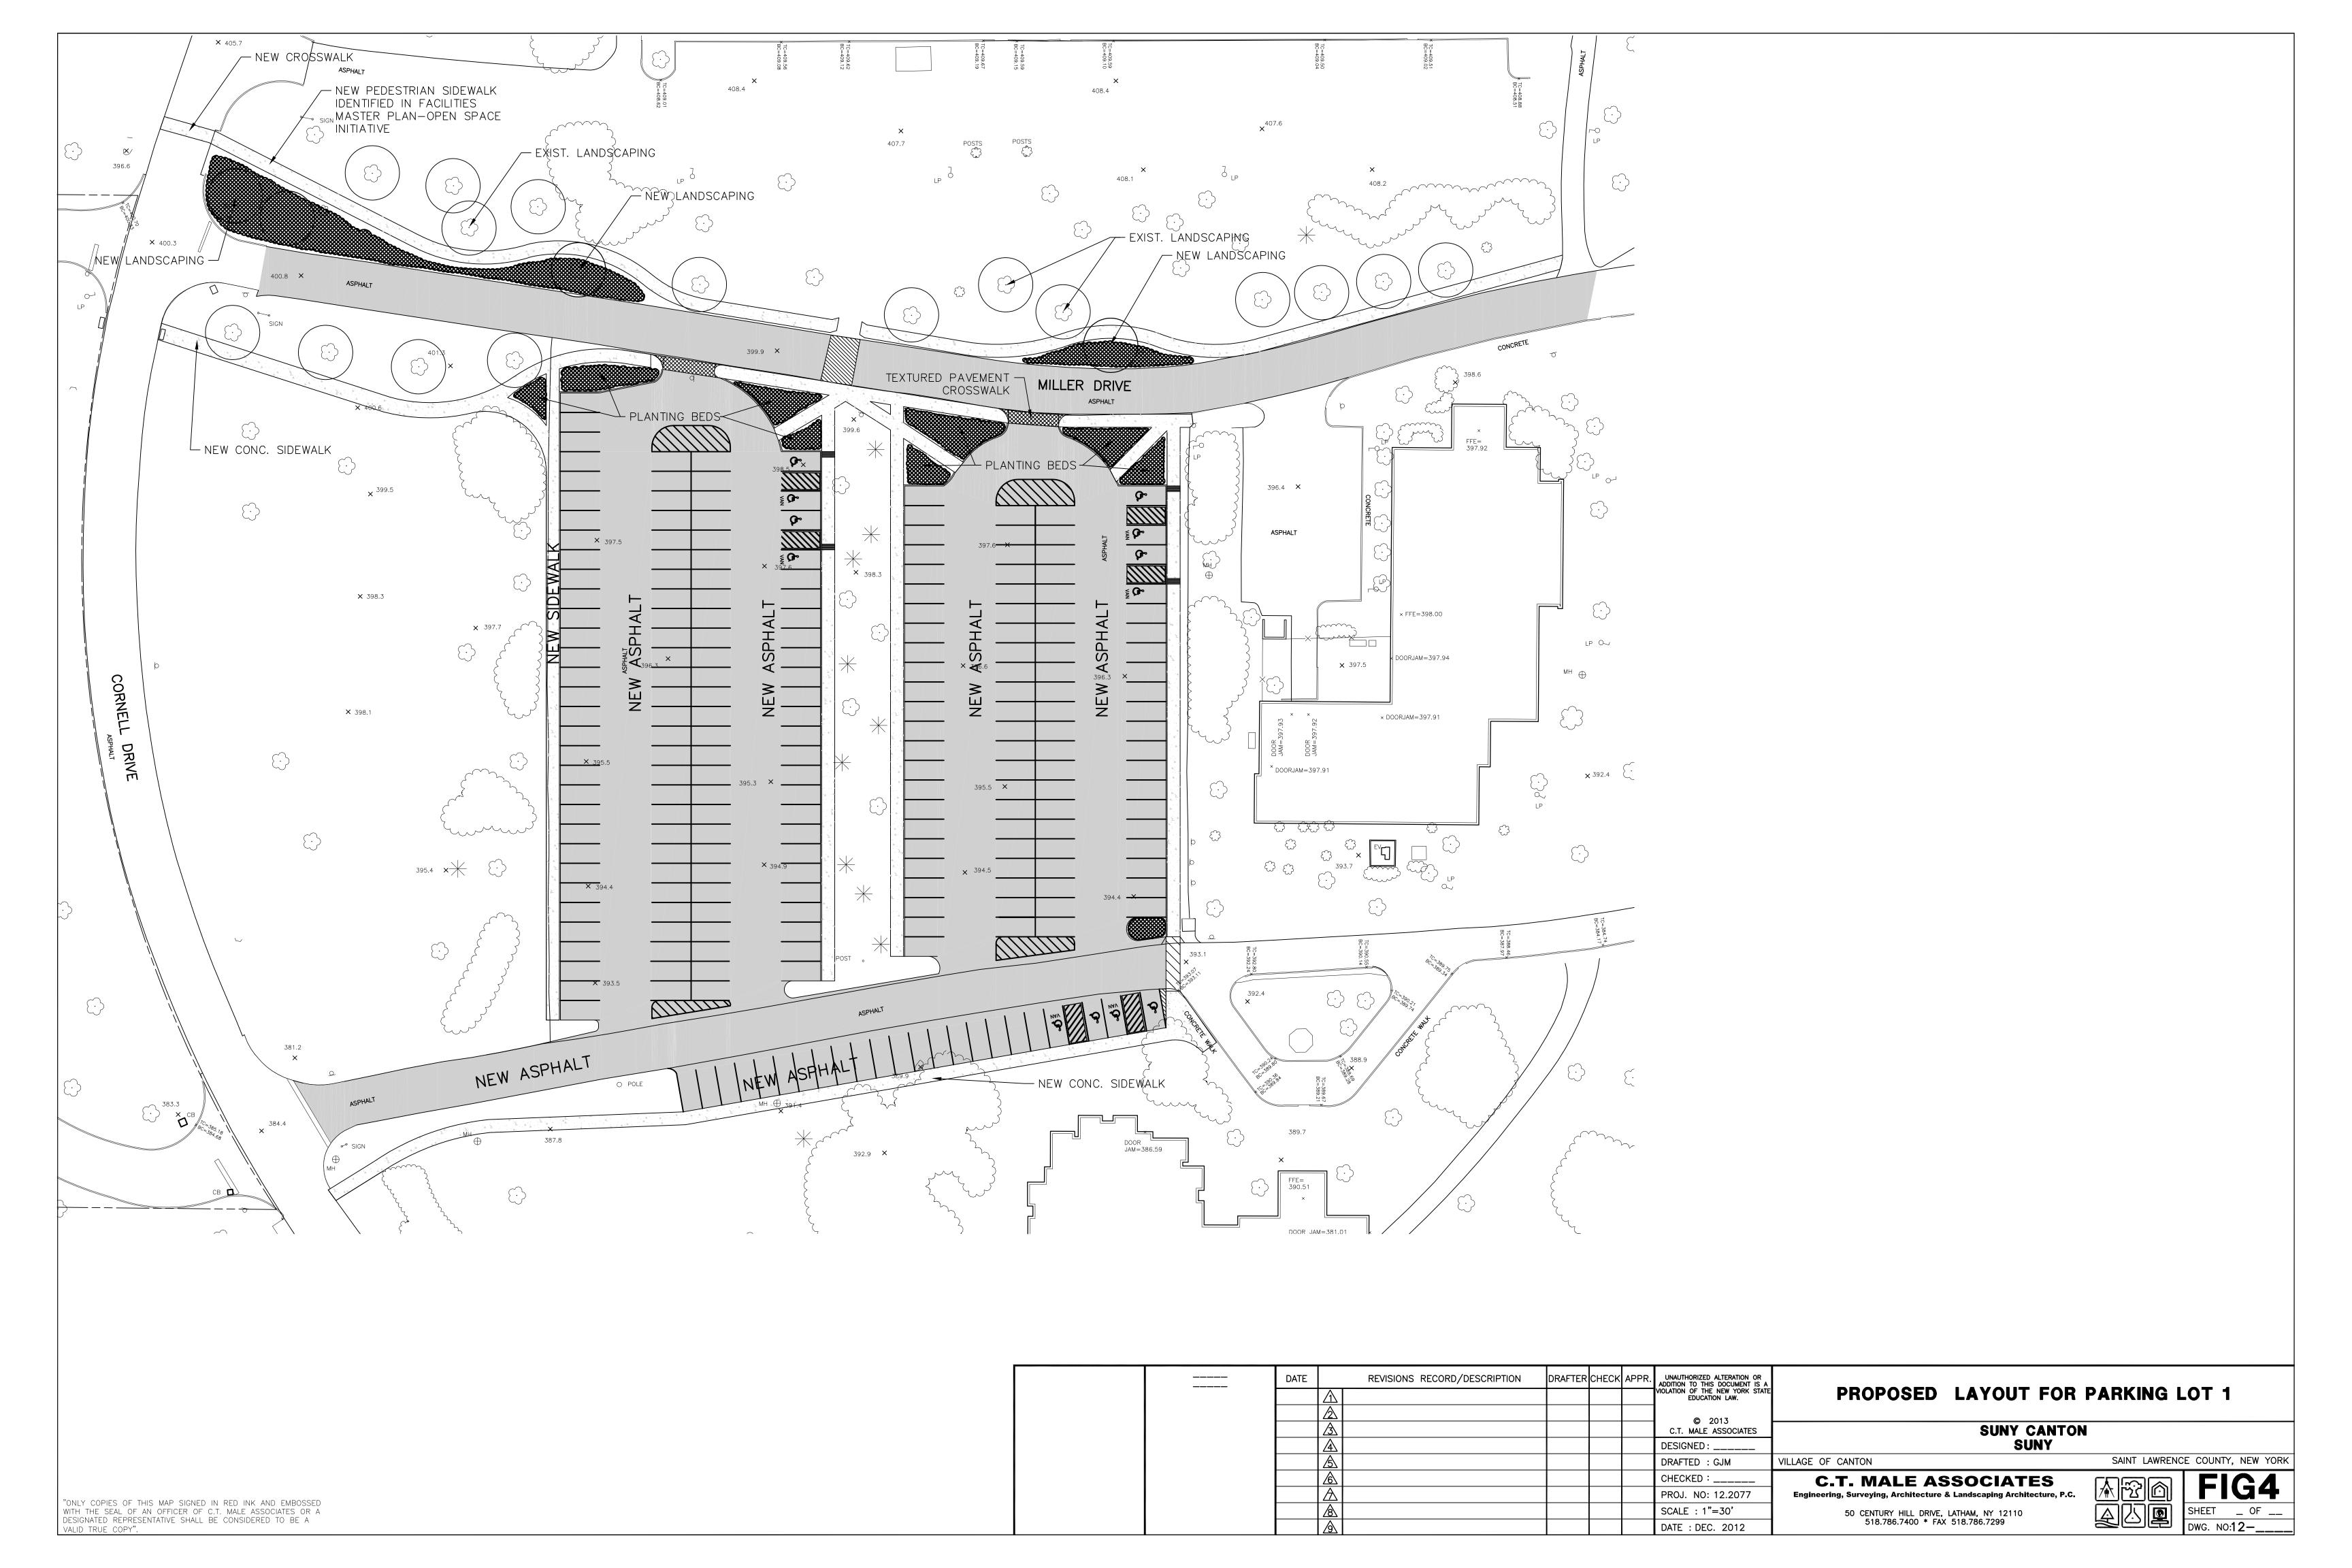
Proposed Layout - Parking Lot 1

All parking area restoration projects shall address Facilities Master Plan goal of increasing overall parking on campus. ADA Handicap accessibility standards shall be included during pavement replacement plans. Figures 3 and 4 of the implementation plan address the provision of an equal number of parking spaces while including appropriate handicap parking spaces which meet both the number and design standards.
