Chernobyl – Lasting Environmental Issues from the Worst Nuclear Disaster

Frederick Becker - CONS 387 Water & Wastewater Treatment, Dr. Adrienne Rygel - Spring 2023

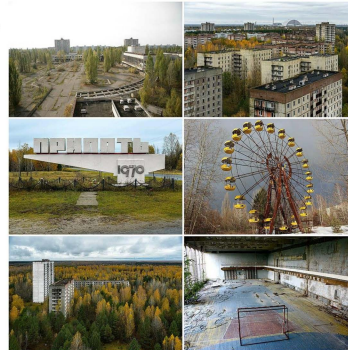
Above Right - Figure 4: A compilation of photographs of the now-abandoned Pripjat, with 50,000 residents evacuated from the city and another 60,000 from the surrounding regions of Ukraine and Belarus⁶

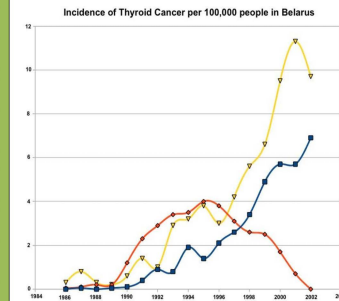
Above Left – Figure 8: A graph of the incidence of Thyroid Cancer rates in Belarus. Yellow depicts the adult population, with adolescents in blue, and children under 14 in red⁴

- Over 300,000 people involved in the cleanup and region have tested between 30-120 millisieverts (mSv) of radiation, with a yearly safe dose being under 20 mSv²
- By 2005 over 6000 cases of thyroid cancer were reported in children from the region, the majority from those who consumed high levels of dairy products²
- By 1990, forest workers were reported to have radiation doses 3 times higher than local residents not in contaminated forests³

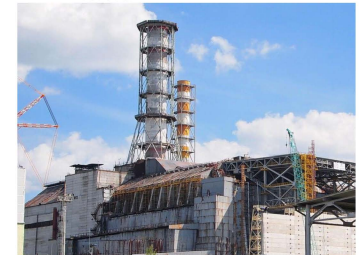
Above Right – Figure 9: The famous sarcophagus constructed over reactor unit 4 to help contain the spread of radioactive material

- Around 200,000 people known as ‘Liquidators’ were brought in from all over the Soviet Union for recovery and cleanup of the incident⁸
- Firefighters were first on the scene to control the radioactive graphite fire, these workers caught the brunt of radiation exposure
- Over the course of the next week, over 5000t of sand, lead, clay, boron and other materials were dropped onto the burning core while evacuations were underway⁸
- By October 1986, a large concrete shelter was built around the exposed reactor to further contain radioactive emissions⁸
- The condition of this shelter degraded over time, and a new sarcophagus was built around the old one, only completing construction in 2017⁸

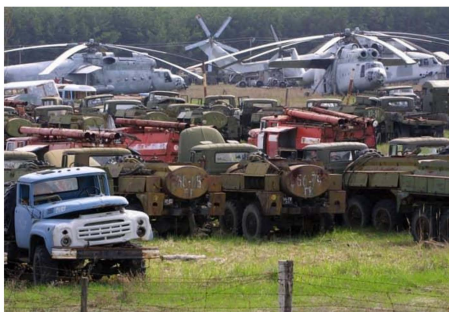
Above Left – Figure 6: A vehicle graveyard containing contaminated vehicles left abandoned after being used for cleanup

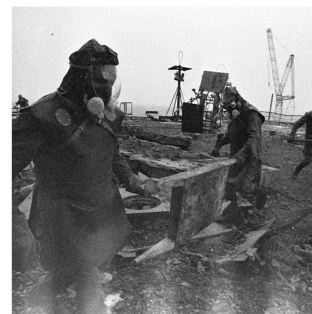
Above Right – Figure 7: Chernobyl Liquidators removing contaminated debris from the roof of the reactor unit building
