Gold King Mine, Colorado

Ronald Wood-Terrance, CONS 387 Water & Wastewater Treatment, Dr. Adrienne Rygel, Spring 2023

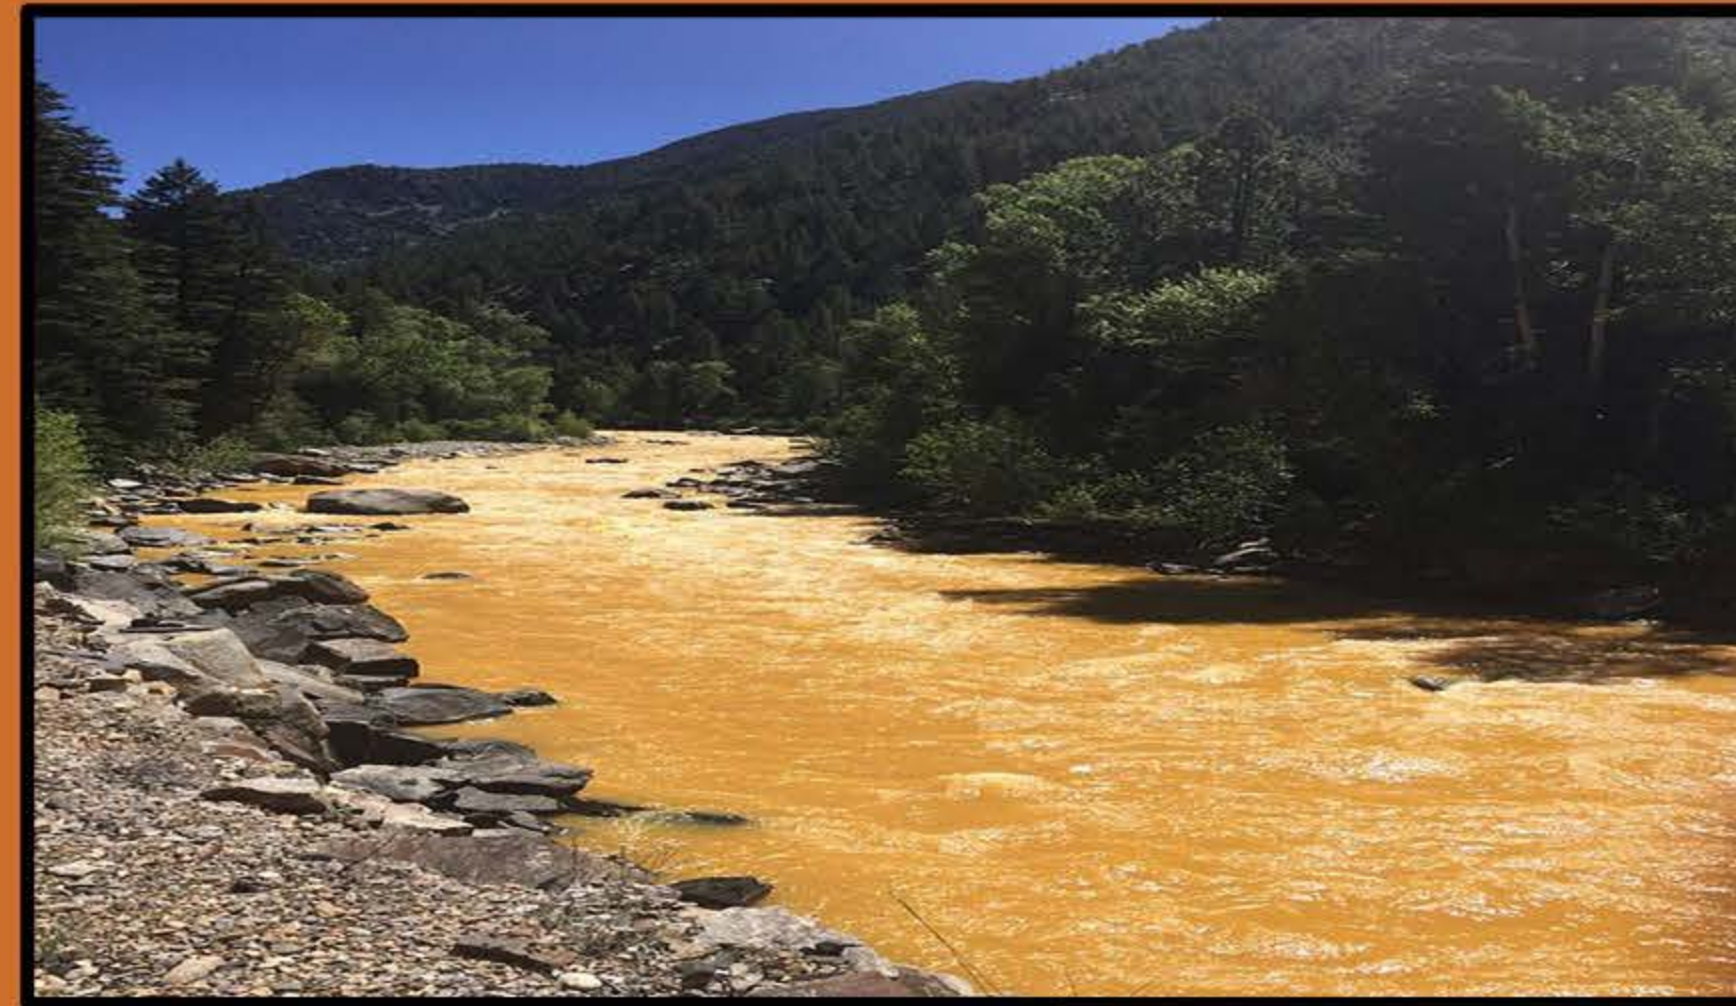
Figure 1. Animas River Spill (Commons Wikimedia, 2015)

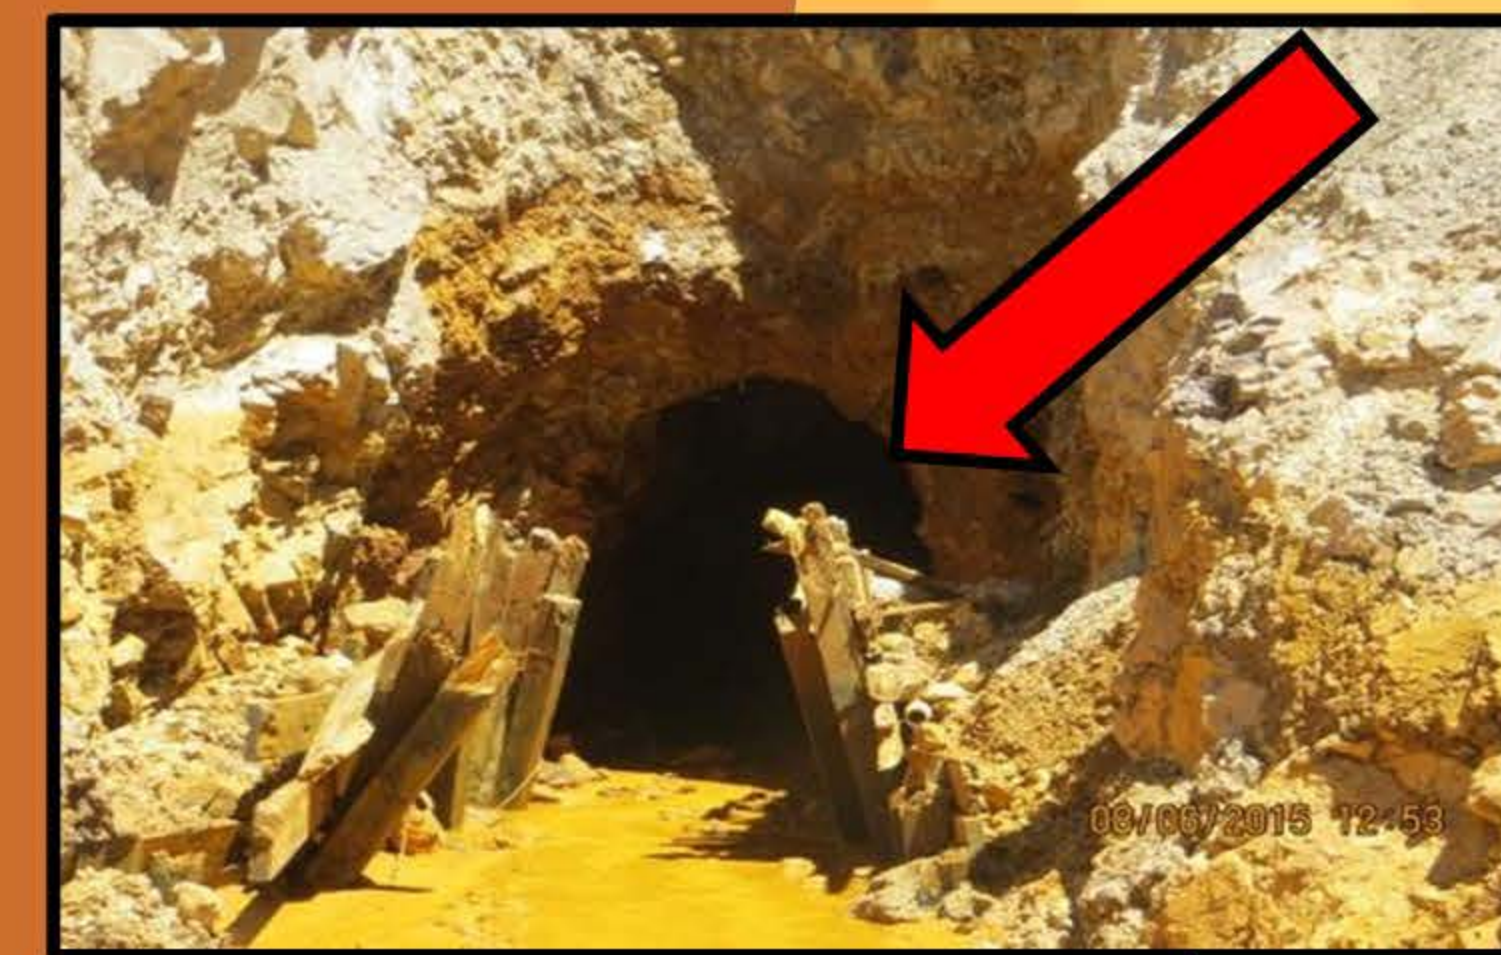
Figure 5. Plug entrance of the Gold King Mine Spill (flickr, 2015)

Wednesday, August 5th, 2015, the EPA investigated an old mining site in Silverton, Colorado, to assess ongoing water releases, treatment of mine water, and the feasibility of further mine remediation (EPA, 2022). During excavation above an old adit (Figure 5), a pressurized 3-million-gallon acid mine drainage began leaking above the mine tunnel and was released via a heavy equipment disturbance into Cement Creek. Copious amounts of heavy metals, such as lead, arsenic, mercury, and cadmium, flowed into the Animas and San Juan rivers. Once the metals were exposed to air and water, they generated a red-to-orange coloration (Figure 1.) as acids from the metals diluted into the rivers. Approximately 190 tons of solids mixed into 3,043,067 gallons of water (EPA, 2022), almost the size of 9 football fields. The waste plume was transferred into surrounding areas of recreational, agriculture, livestock, and drinking water usage.

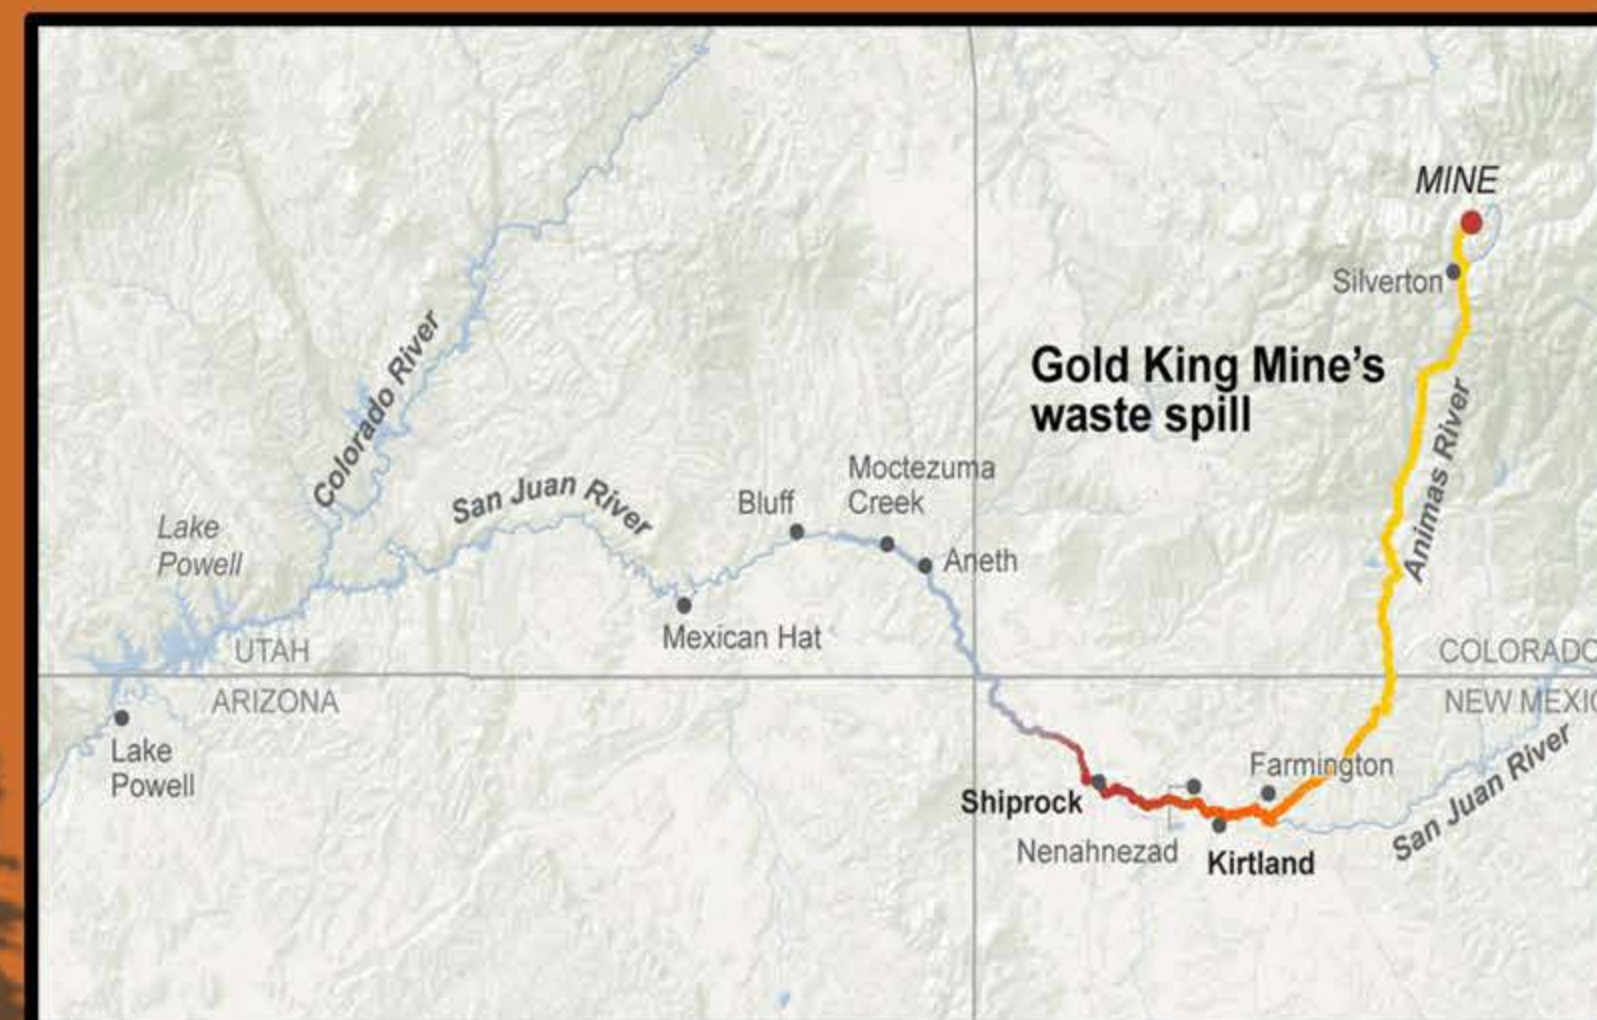
Figure 2. Map of the affected rivers of the Gold King Mines Spill, (Los Angeles Times, 2015)

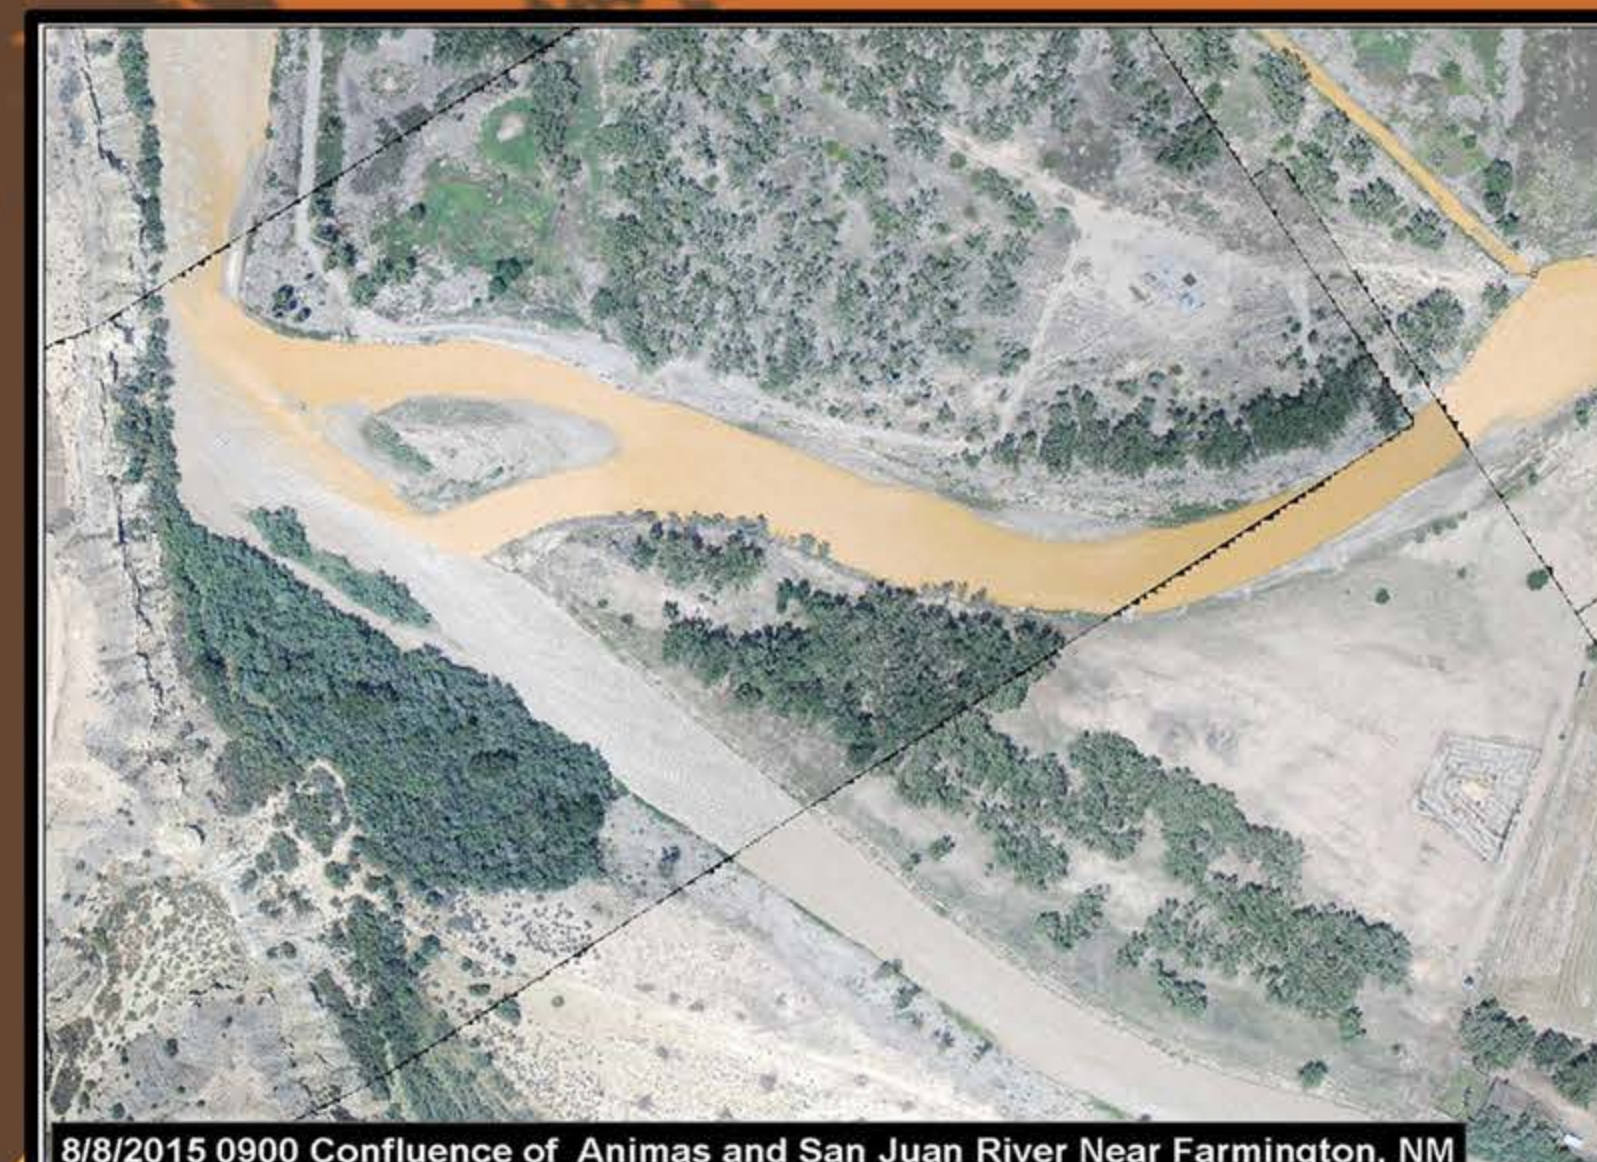
8/8/2015 0900 Confluence of Anima and San Juan River Near Farmington, NM

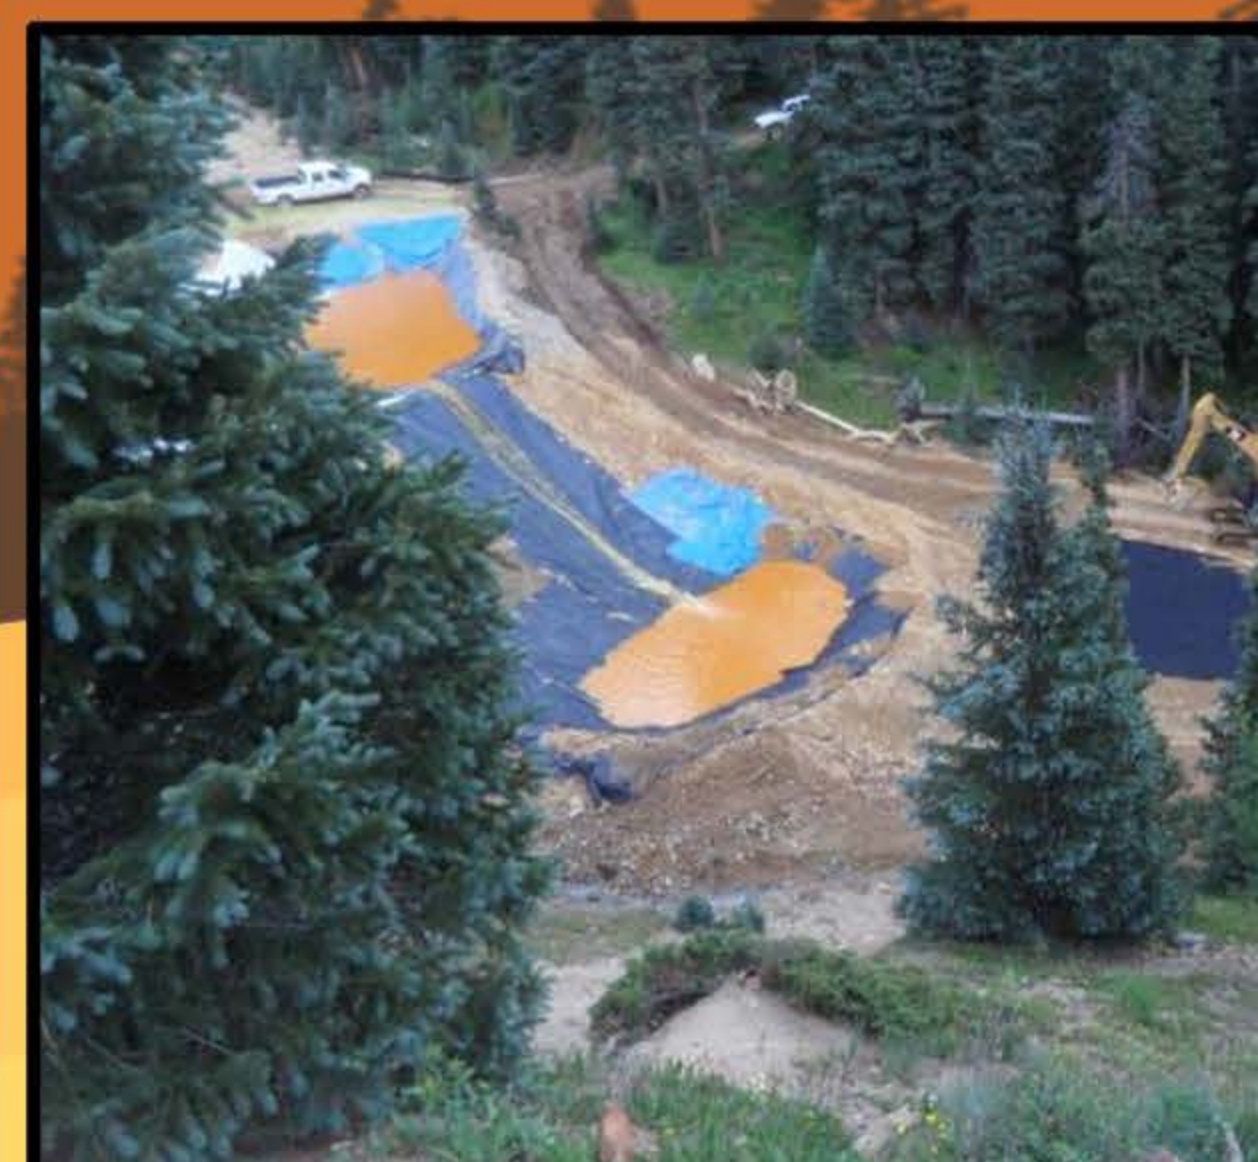
Figure 4. Settling Pools created by EPA for water treatment (flickr, 2015)

Due to the flow rate of the river and the lack of dams, the response to stop the contamination or pump out the water was not possible. It was decided to let the contamination dilute, becoming less acidic, and for solids to settle onto the riverbeds. Several surrounding organizations were called to the emergency by EPA for monitoring and treatment, along with public statements on water quality conditions. The U.S. Geological Survey (USGS), U.S. Agency for Toxic Substances and Disease Registry (ASTDR), New Mexico Environment Department, Colorado Fish and Wildlife Conservation Office, Navajo Nation and the Bureau of Indian Affairs, Southern Ute Indian Tribe Water Quality Program (EPA, 2022) were all responders. The EPA created settlement ponds (figure 3.) near the portal to continue water treatment and ongoing flow from the Gold King Mine by adding lime and sodium hydroxide, neutralizing acids, and removing solids. The treated water was then discharged into Cement Creek at a pH of 5.0-5.5.
