# ASSESSMENT OF CONDITIONS

State University of New York College of Technology at  
Canton, Client

The intent of the document is to provide guidelines for future campus improvements and developments that support SUNY Canton's academic mission and strategic plan. It will also identify, prioritize, and structure future project requests for capital funding. This report, Phase 2 of the FMP, presents the Assessment of Conditions.

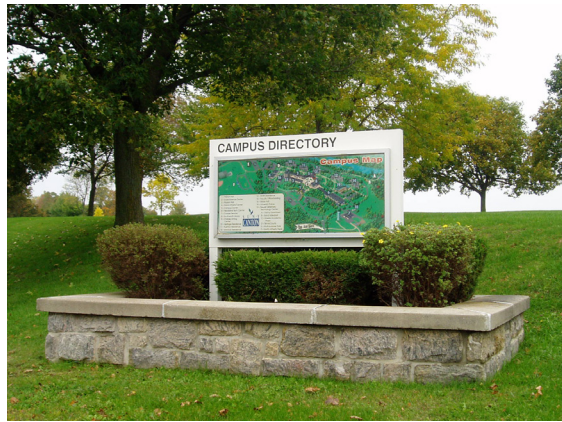
Campus Directory Sign

Campus signs should provide identification, orientation and direction on campus in a way that is easy to read and incorporates a logical priority in the presentation of information. Existing campus wayfinding signage is limited to a campus directory sign off of Cornell Drive at the entry and a directional sign at the “Y” intersection. There are also other identification signs around campus, but are in need of updating. The campus is lacking a cohesive signage plan and sign standards. The campus image and wayfinding would benefit from a cohesive campus signage plan and signage standards.

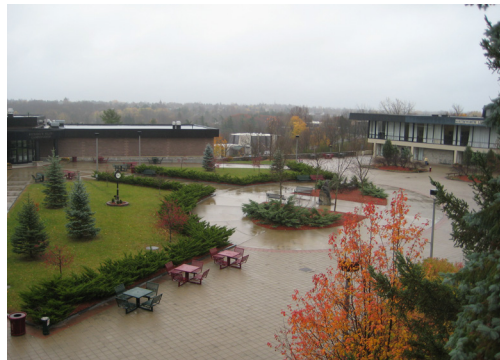
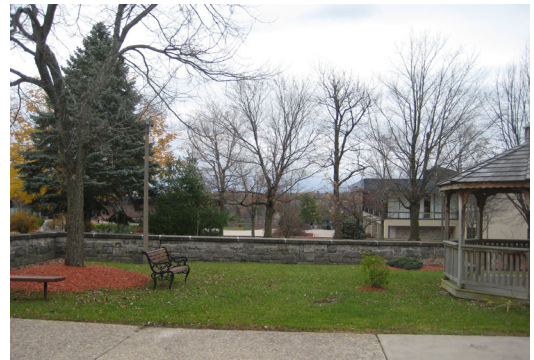
Roselle Academic Plaza and  
Gazebo at French Hall

A larger plaza space, with a gazebo, exists on the east side of French Hall. As with the other plaza spaces on campus, this plaza would benefit from additional planting areas to soften the concrete appearance. Although this space is primarily used by administrators working in French Hall, it could be transformed into an assembly area for College functions. Small gazebos are located in front of all the dorms. Unfortunately the gazebos do not appear to be well utilized.

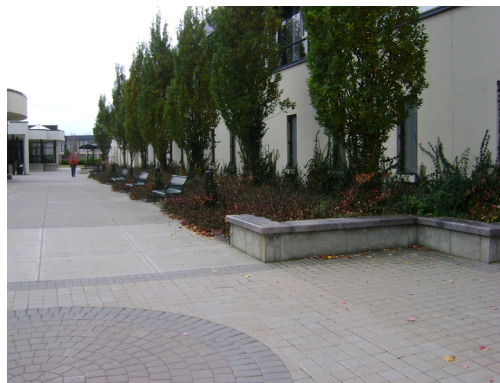
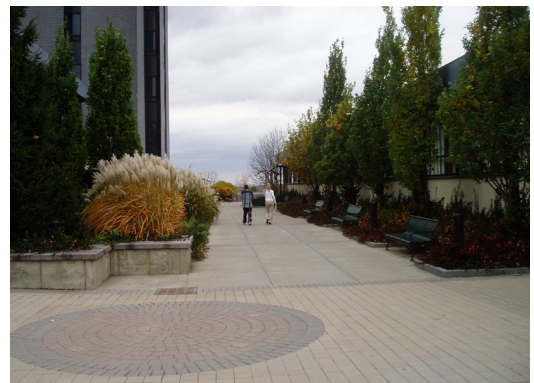
Circulation Corridor

The corridor between Payson Hall and Dana Hall is nicely landscaped with ornamental grasses, small columnar oak trees, lilies and vigorous ground cover. Other amenities include pavers, granite curbs, benches and light bollards. The existing ground cover presents maintenance issues for the College and this plant material should be reconsidered. In general this space is successful in both function and aesthetics.

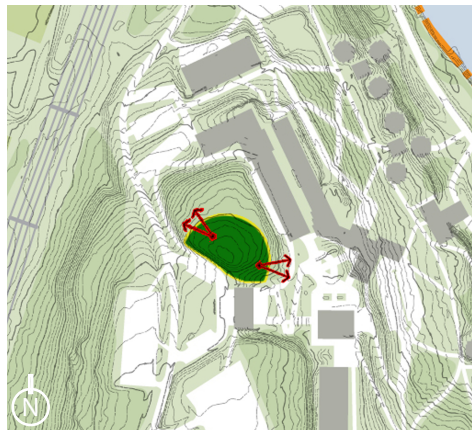
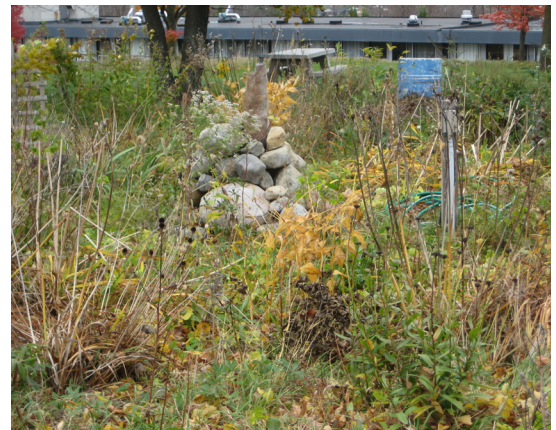
Peace Garden

A few dedicated/memorial areas exist on campus. To the north of French Hall there is the Peace Garden. This space is ideal for a gathering space and garden. It is located at the highest elevation and provides panoramic views of the campus and surroundings. This space currently contains a small garden surrounded by various tree plantings and benches. If desired, this quaint space could be enhanced to become an outdoor classroom and successful gathering space. Recently, a small planting and covered seating area near the entry of Cook Hall was dedicated to President Joseph Kennedy. This area is reportedly popular with students and staff.

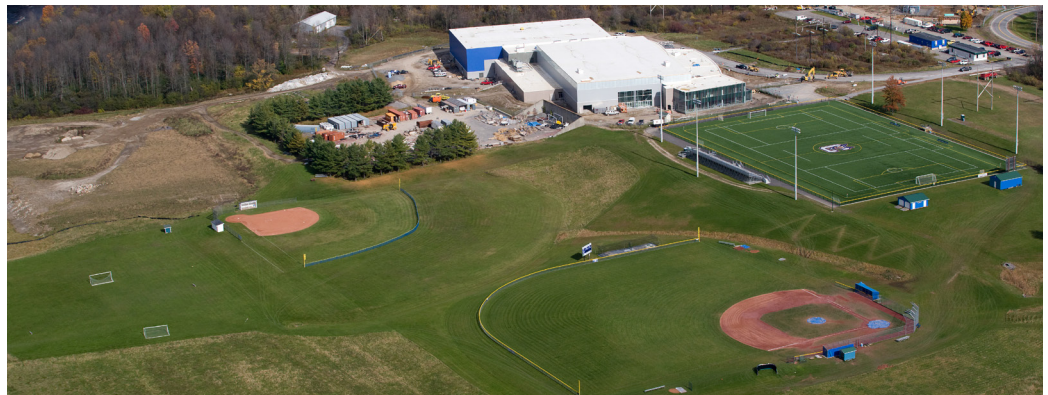
Athletic Fields

bleacher system and field lights. This effort also resulted in a new natural turf baseball field. Other existing fields consist of a softball field, soccer field and various practice fields. All of the fields, both new and old, are well maintained and are in good condition.

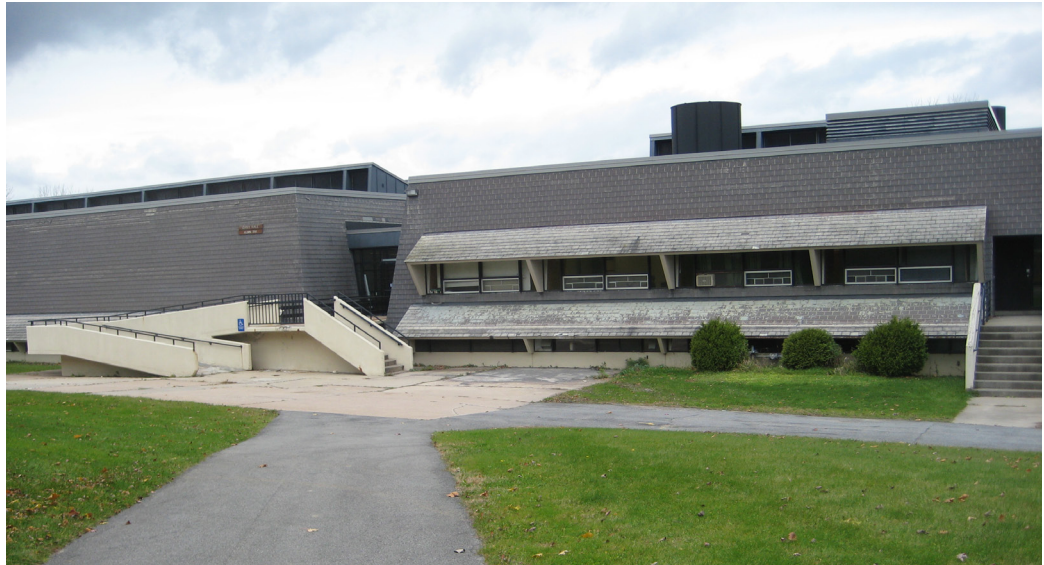
Since the BCAS assessment, Dana Hall has been vacated and is currently under construction to repair the structural wood beams of the building. As a result of the construction project, walls, ceilings, doors and frames are not in as good condition as noted in the BCAS. Additionally, the exterior doors, frames and hardware were judged to not be in as good of quality as the BCAS indicated. The gymnasium, in comparison to the remainder of the building, is in good condition. Protective measures to preserve the wood basketball court and bleachers during the rehabilitation project are in place.

- Complete roof replacement
- Window replacement - single pane windows throughout building
- Exterior shake shingles in poor condition - replacement recommended
- Replace aged doors (interior and exterior), frames and hardware
- Building not fully accessible (i.e. toilet rooms, elevators including visible signals, car dimensions, control buttons, etc., door widths, clearances, door hardware, etc.)
- Mechanical, electrical and plumbing equipment is original and requires replacement
- No fire protection system

- All equipment in Dana Hall is from the original 1967 construction.
- A 250 BHP Cleaver-Books Model CB760-250 steam boiler provides low pressure steam for the building. The boiler is served by a duplex condensate return set with 2 HP pumps. A steam to water heat exchanger with parallel 3/4 HP end suction, base mounted Taco pumps rated at 27 GPM and 25 ft. hd. provides heating water for a limited amount of perimeter fin radiation.

- The interior building cold water main consists of a 3-inch copper main. There is no water meter or backflow preventer at the service entrance into the building. All of the observed piping and valves appear to be original except where modifications have occurred over the years. The piping appeared to be in fair condition. Valves of this age are generally in poor condition. Maintenance reports the valves to be non functional.

- Pipe and equipment insulation is original and is in poor condition. Portions of the insulation are worn or completely missing in areas where it is exposed and subject to damage such as in the Boiler Room.

- Domestic hot water is provided by one (1) gas fired Patterson-Kelley #PK-231-5 water heater constructed in 1966. The heater is original to the building and is in need of replacement. The interior hot water main consists of a 2 1/2-inch copper main. All of the observed piping and valves appear to be original except where modifications have occurred over the years. The piping appeared to be in fair condition.

- The building has a conventional sanitary, waste and vent system. All observed piping is in poor condition. There is one (1) 6-inch building sanitary drain serving locker and toilet rooms. This drain exits the building below the lower level floor on the south side of the building.

- The observed plumbing fixtures and trim are in poor condition and in some cases inoperable due to age and being out of service for some time. The majority of the water closets and flush valves in the building are the older type and are not the water conserving type. Shower valves and heads are in poor condition.

- Replace the existing steam boiler plant with a hot water boiler plant, utilizing multiple high efficiency boilers, new stainless steel double wall flue and combustion air ducting, and primary/secondary hot water loop pumping. The secondary pumping system will be a two pump lead/backup system with VFD's on both pumps. A separate glycol heat exchanger and pumps will be provided to serve all air handling unit heating coils as required by SUCF design directives.

- Replace the interior water system piping. Provide water meter and backflow preventer at service entrance. Provide duplex backflow preventer in duplex arrangement at water service entrance to the building at grade level. Locate backflow device at grade level to permit the backflow emergency relief to discharge to an exterior location above grade.

- Provide all new pipe insulation for domestic water and storm water drain piping.
- Replace the domestic water heating system with energy efficient gas fired condensing type heaters and a hot water storage tank. The tank will store water at 140 deg F. A master mixing valve will temper water to 110 deg F for distribution to the remainder of the building.

- Replace the entire building sanitary drain and vent system. All the existing underground piping 4 inch and larger shall be hydro-flushed and inspected by video camera. Reuse underground piping where inspection confirms piping is acceptable.

- Replace all gas piping and shutoff valves.
- Replace all plumbing fixtures with the water conserving type fixtures. All faucets and flush valves will be the electronic type powered by batteries.

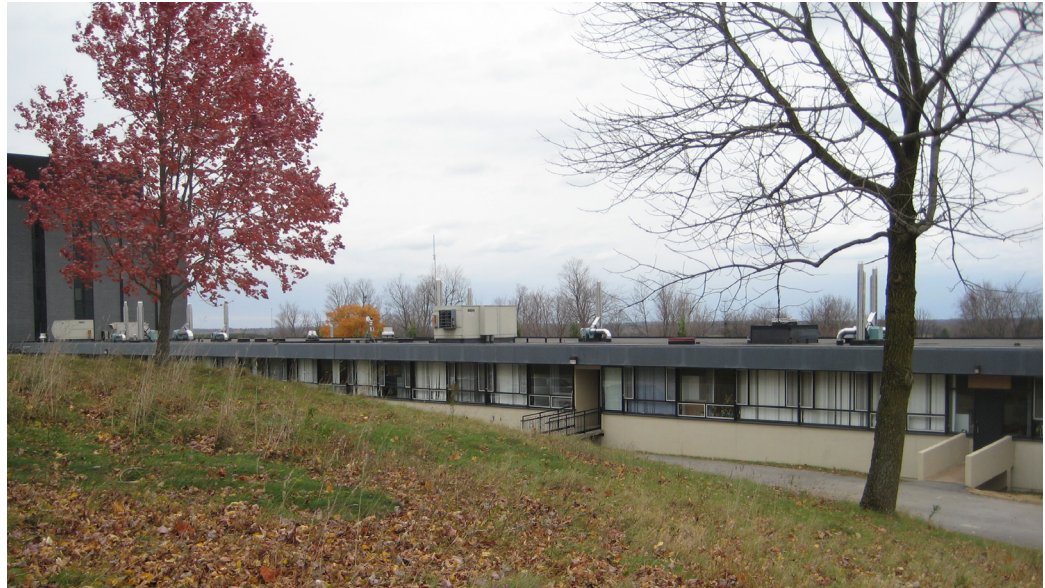
- Complete roof replacement
- Window replacement - single pane windows throughout building
- Exterior stucco panel system is cracking and requires repair
- Enhance integrated building signage on front facade
- Building not fully accessible (i.e. toilet rooms, elevators including visible signals, car dimensions, control buttons, etc., door widths, clearances, door hardware, etc.)
- Ceilings at second floor have deteriorated
- Main distribution panel and branch circuit panels are full and original to the building
- No fire protection system

- Steam is supplied to Cook Hall underground from nearby Payson Hall. The steam and condensate lines were replaced in 2000. Chilled water is supplied from the adjacent Faculty Office Building chilled water plant.

- Air handling unit V-2 is a 40 HP 19,860 cfm Nesbitt Model HD-65 horizontal draw-thru air handling unit serves the building, and is sized for ventilation air only. The unit has a variable speed drive but is run at 100% fan speed at all times. Building heating is accomplished thru the perimeter fin radiation system. The unit was installed in the original building construction. The original humidifier is disconnected. The unit has two (2) main steam reheat coils, one for the 1st floor (7,800 cfm) and one for 2nd floor (12,000 cfm). A glycol run around heat recovery system was installed in 1990 and reportedly does not perform adequately. Ventilation system upgrades were also done in 1990 consisting of installation of supply and exhaust VAV boxes in miscellaneous Lab spaces. There is no cooling on the first floor of the building. Cooling is only available on the 2nd floor of the building due to a 2nd floor duct main chilled water coil installation in 1997. As part of the same project, 14 ducted chilled water fan coil units were installed in various classrooms and labs. Additionally there were 5 zone duct chilled water coils installed.

- Pipe and equipment insulation is original and is generally in good condition. Portions of the insulation are worn in areas where it is exposed and subject to damage such as in the Mechanical Room.

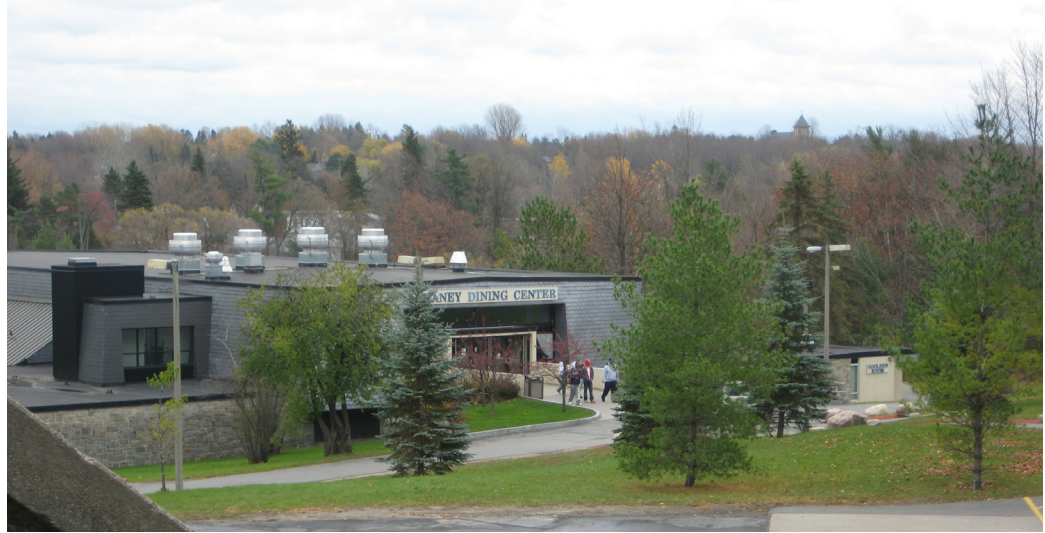
Chaney Dining Center

- Three 107 BHP Cleaver Brooks M4P-700 boilers installed in 2000, provide high pressure steam at a supply pressure of 50 psi in the summer and 60 psi in the winter. A single boiler runs during the summer at a very low load, to serve domestic hot water and kitchen cooking equipment needs. Two boilers run in the winter, with the third boiler serving as backup. The steam pressure is reduced initially from 60 psi to 15 psi, and then again further from 15 psi to 5 psi. The associated pressure reducing stations, in-floor duplex condensate return lift station, boiler feed pumps, etc. were all installed in 2000.

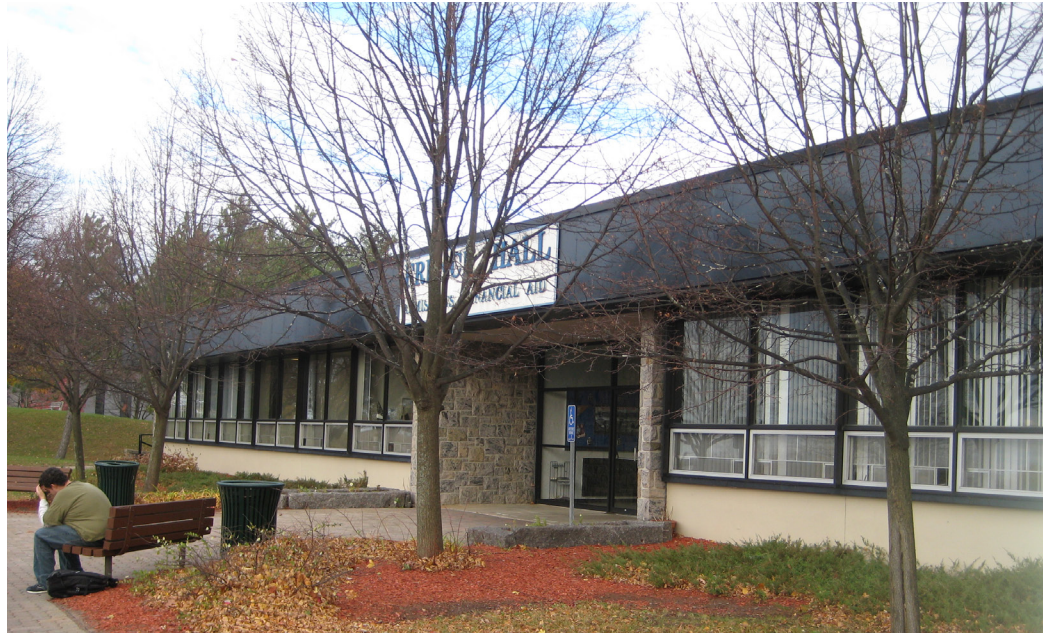
French Hall

- A 60 BHP Cleaver Brooks M4S-200 low pressure steam boiler was installed in 2006. There is currently no backup boiler. A steam to water heat exchanger provides heating water for the two pipe HW/CW fan coil unit system. Three 5 HP Bell and Gossett Series 1510 base mounted pumps at 95 gpm and 100 ft. hd. serve the two pipe fan coil system for both heating and cooling mode. One of the 3 pumps is a standby pump.

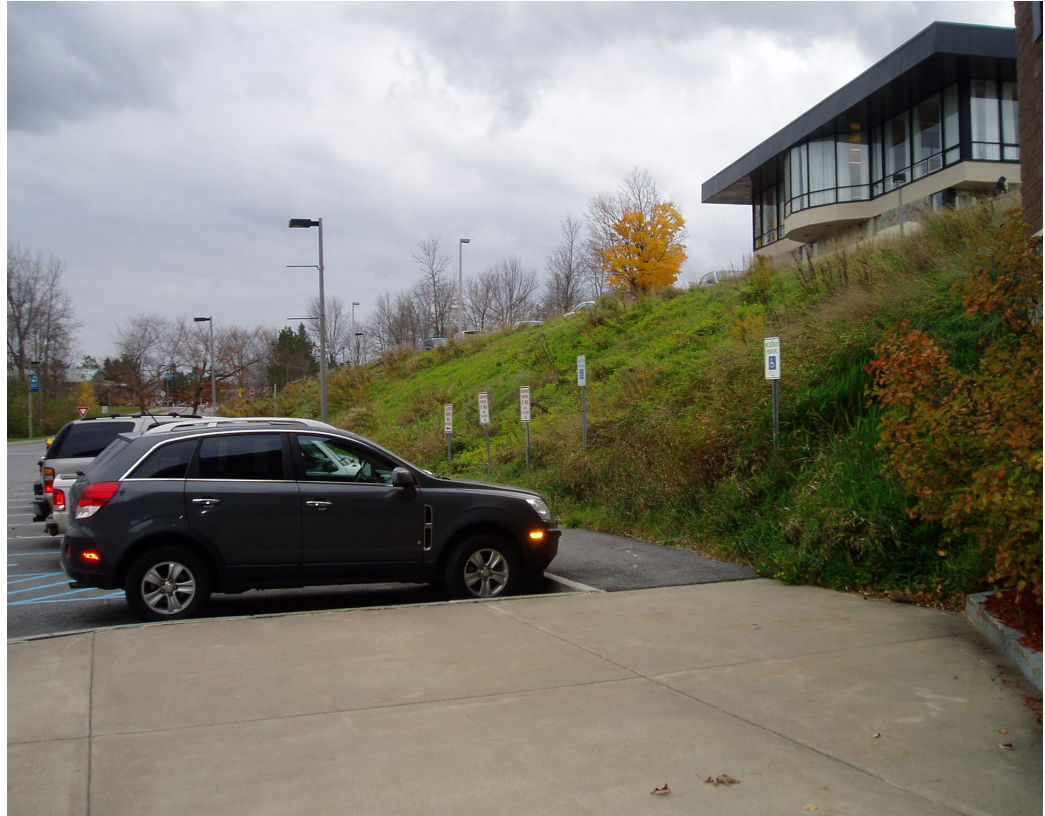
ADA Parking Space

Many of the parking lots on campus provide accessible parking, but a handful of them do not supply the required amount. Furthermore, many of the designated accessible parking spaces do not meet ADA standards. The campus is required to meet the minimum number of accessible parking spaces within the individual parking lots. Addressing these deficiencies can be part of a campus wide strategy.

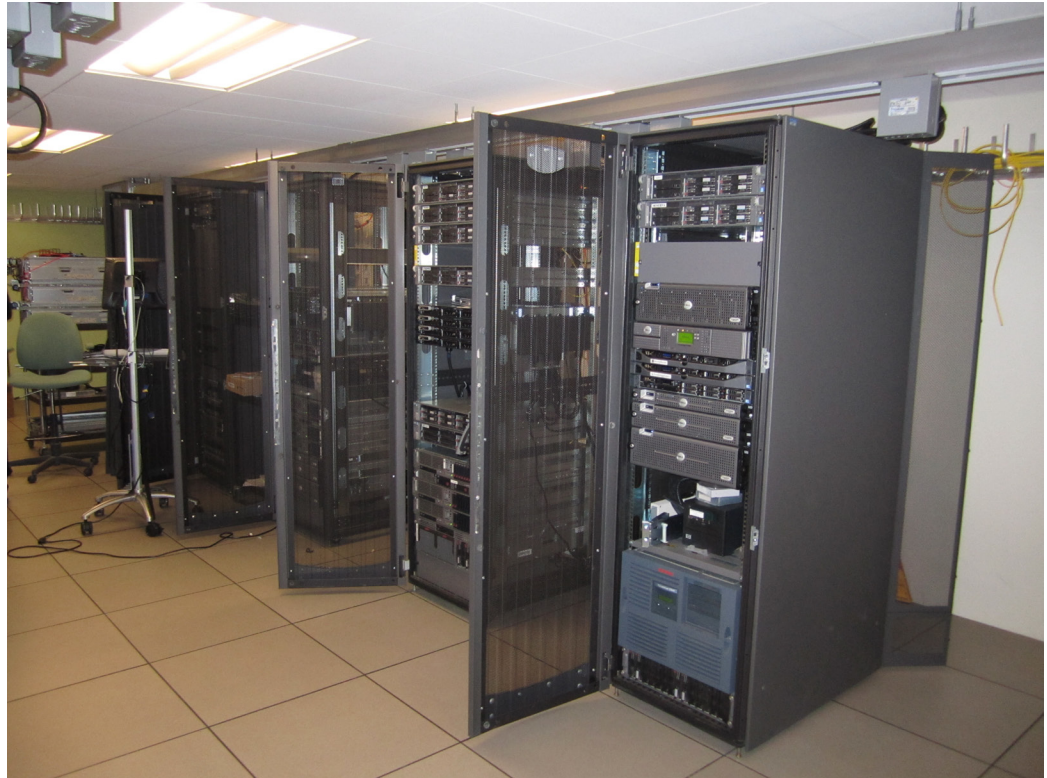
Data Center - Southworth Library

cool the room. These units are upflow style models (supply cold air through grilles mounted high) with return air grilles mounted low. The raised floor system is not used for HVAC distribution. A ducted hot-air return system, coupled with a hot/cold-aisle cabinet layout, would assist with room cooling. This may become more of an issue over time as higher power density cabinets are deployed.

Electrical receptacles are distributed via a StarLine track busway system mounted to the structure above. Adjacent sections of center-spline cable tray supports cabling connections within the room. Both systems are mounted low enough that they require any new cabinets being deployed in the room to be tilted at a low angle in order to roll past. The room is in generally good shape with available space for equipment expansion as necessary. All data backup is accomplished by disk-to-disk, tape cassette backup stored in a fireproof safe in the basement of Wicks Hall. This location stores approximately one-month of backup data.
