SUNY Canton

**Study of French Hall Sidewalks, Stairs, and Plazas,
and Campus Trees Along Cornell Drive**

SUCF Project Number: 231029001

Spring 2019

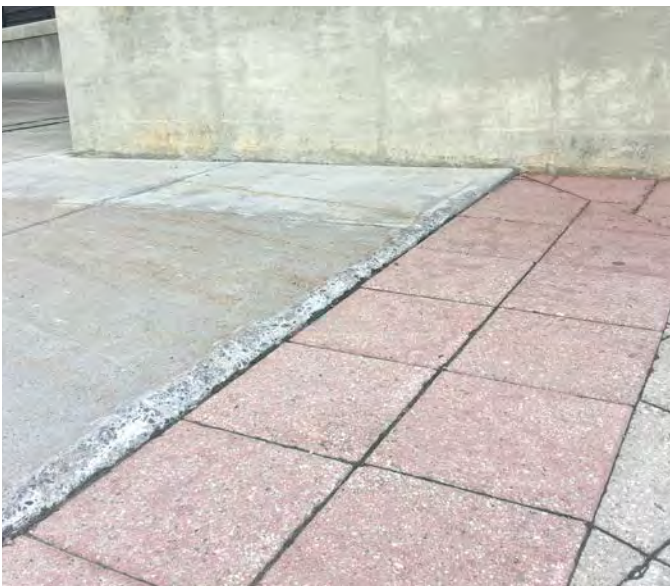
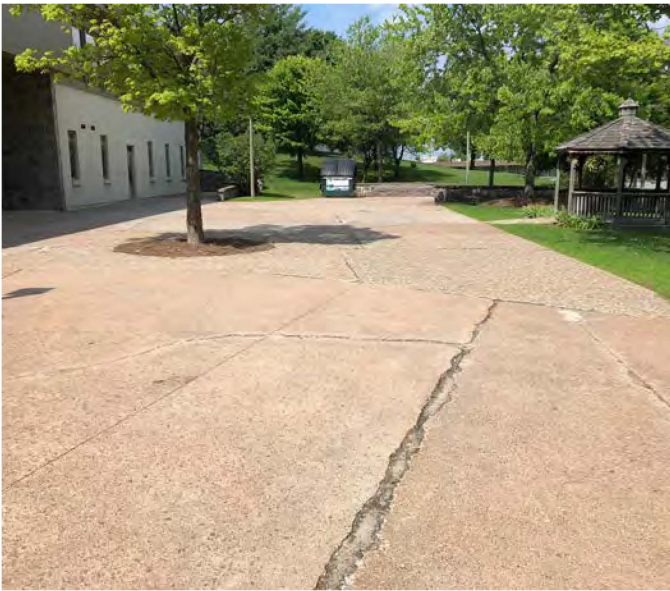
The walks within Roselle Plaza primarily consist of pavers. The pavers are in relatively good condition given that they are over 20 years old. However, some areas need repair due to cracking, oxidation marks from use of steel snow plows, differential settlement from freeze thaw, and from maintenance vehicles. In many locations where pavers abut the concrete, the pavers have settled causing a tripping hazard. The joints between the pavers are generally tight although a fair amount of weeds are growing between them.

Aesthetically, the pavers have faded a considerable amount, to the point that the color is similar to the surrounding concrete. This condition has created a monotone and dull setting. Furthermore, when broken pavers are replaced with new ones, they do not match creating an undesirable appearance.

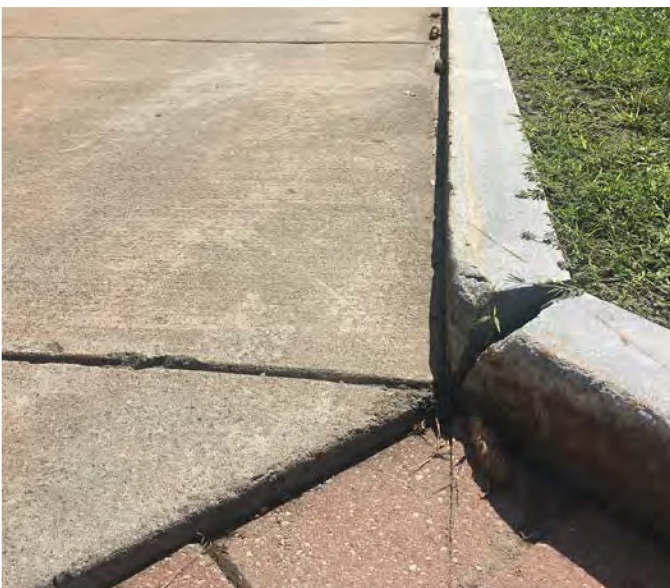
The existing curbs along walkways and plant beds are mostly in good condition. Some curbs are in fair condition, deteriorating at the corners, and have some rust / oxidation markings and chipping from the use of steel plows.

- The curbs adjacent to the plant beds are in good condition but contain some minor oxidation marks and chips in the curbing from plowing.
- The curbs along walks leading to the Miller Campus Center and the surrounding grass areas are in good to fair condition. There are heavy oxidation markings along the sides of the curbs and minor to moderate chipping from being struck by snow plowing blades. The corners of the curbs are deteriorating and in poor condition.

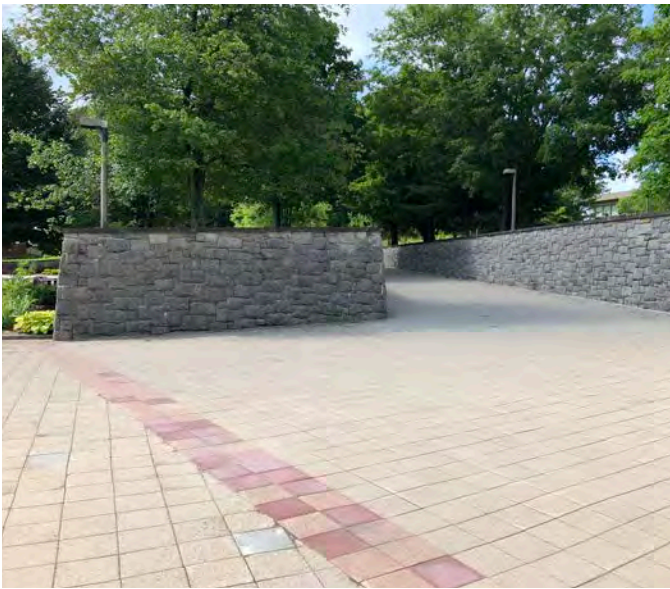
Existing retaining walls.

- The existing retaining walls are showing signs of deterioration and making repairs to the walls is costly and time consuming. In the current design the walls are the most dominate and influential feature of the landscape. They cut through grade creating pedestrian walks, however, they also create physical and visual barriers throughout and beyond the space. It was decided that due to the above concerns, that the new design should eliminate the walls to the greatest extent possible.

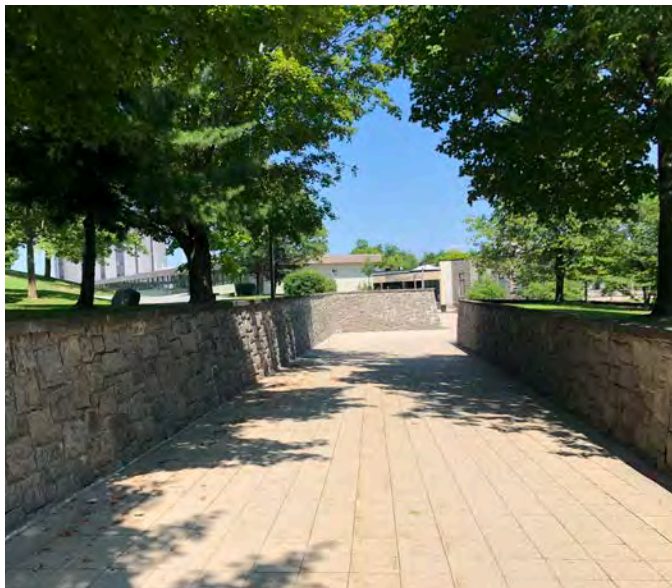
Existing pedestrian walk defined by the retaining walls.

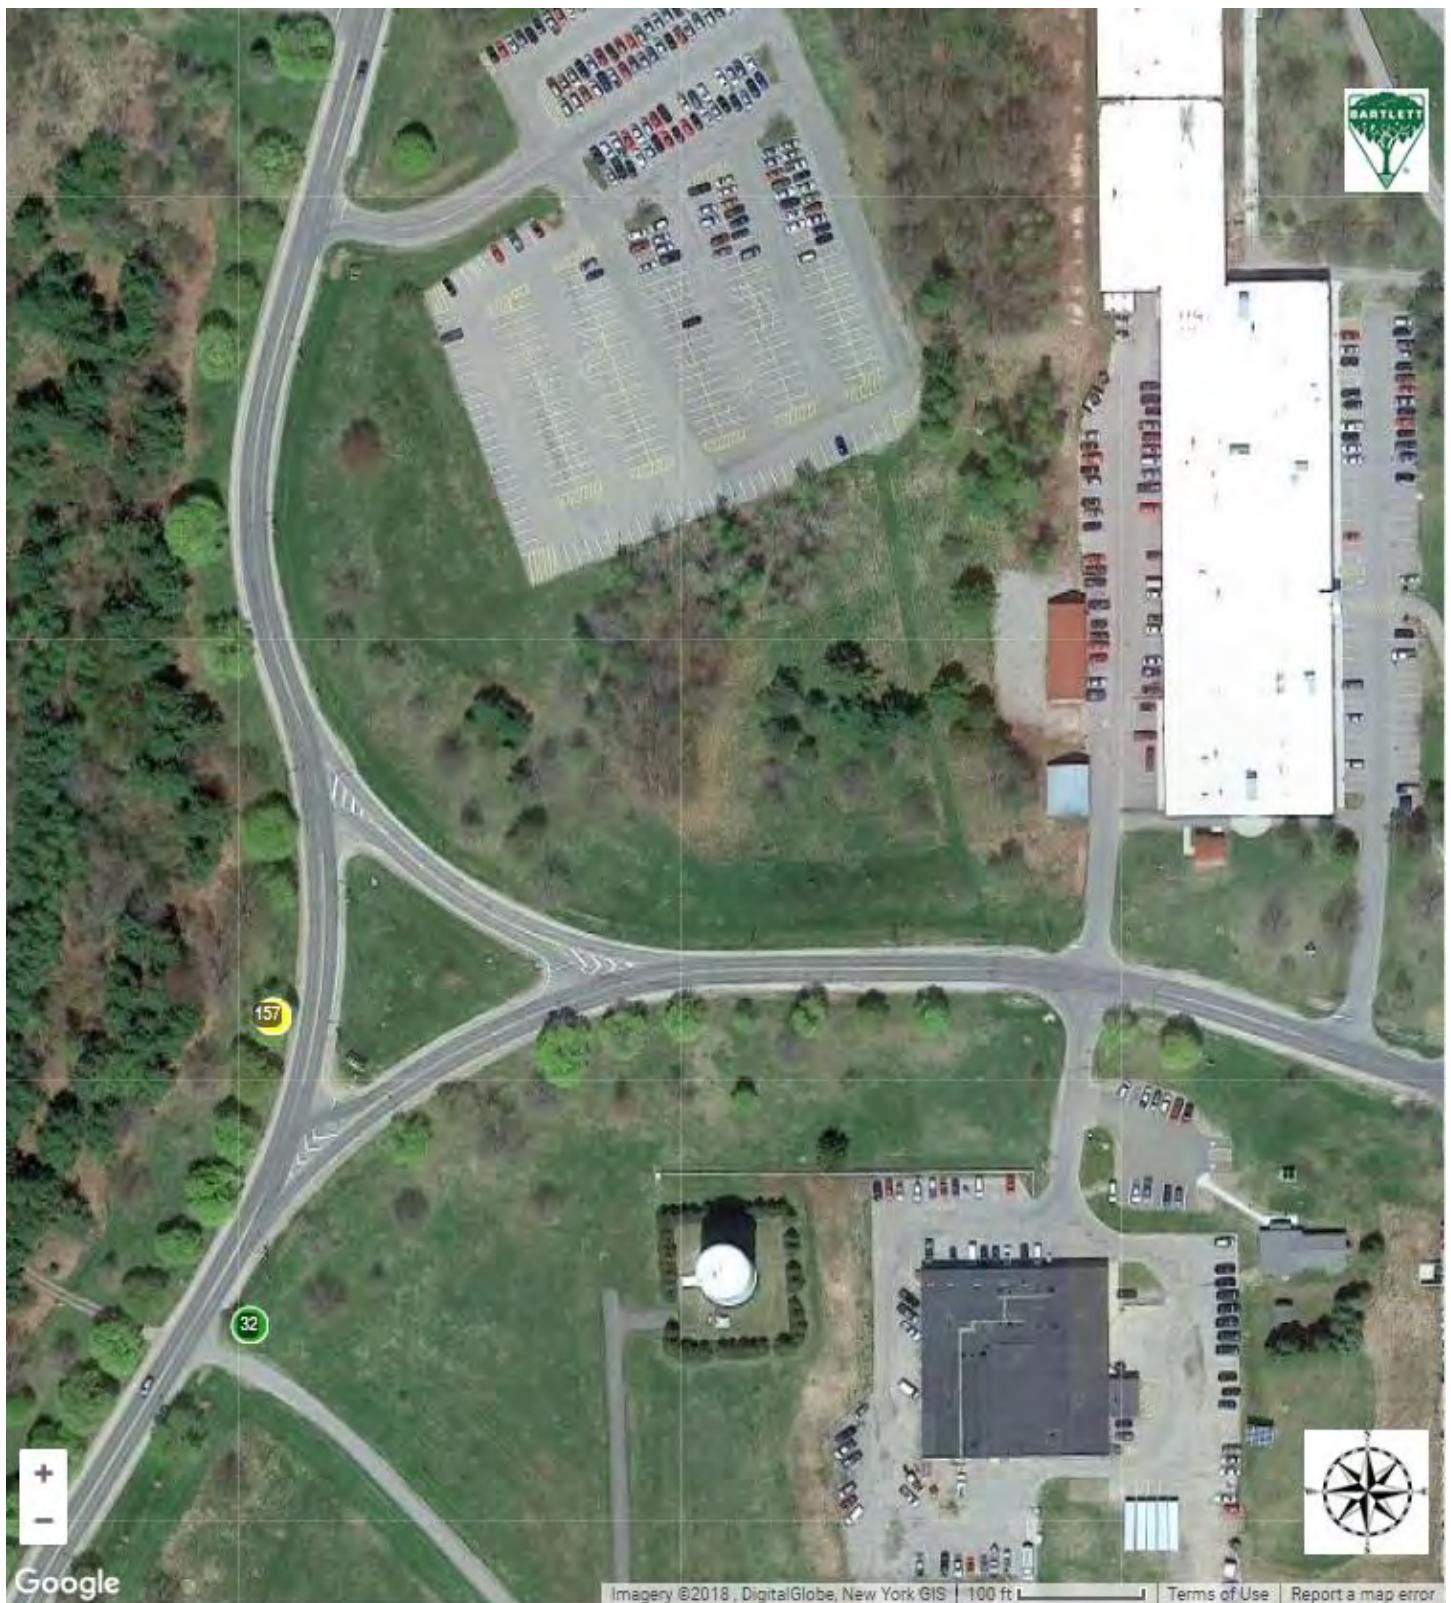
INVENTORIED TREES ASSIGNED RISK RATINGS AT THE TIME OF DATA COLLECTION

Tree ID	Common Name	DBH	Condition	Overall Risk Rating	Primary Target	Tree Care Priority	Pruning	Defect(s) or Observation(s)
157	Maple-Norway	27	Poor	Moderate	Street	1	Remove	<ul style="list-style-type: none">• Decay-Stem• Crack-branch
32	Maple-Norway	20	Poor	Low	Street	2	Remove	<ul style="list-style-type: none">• Uneven crown• Wound-stem

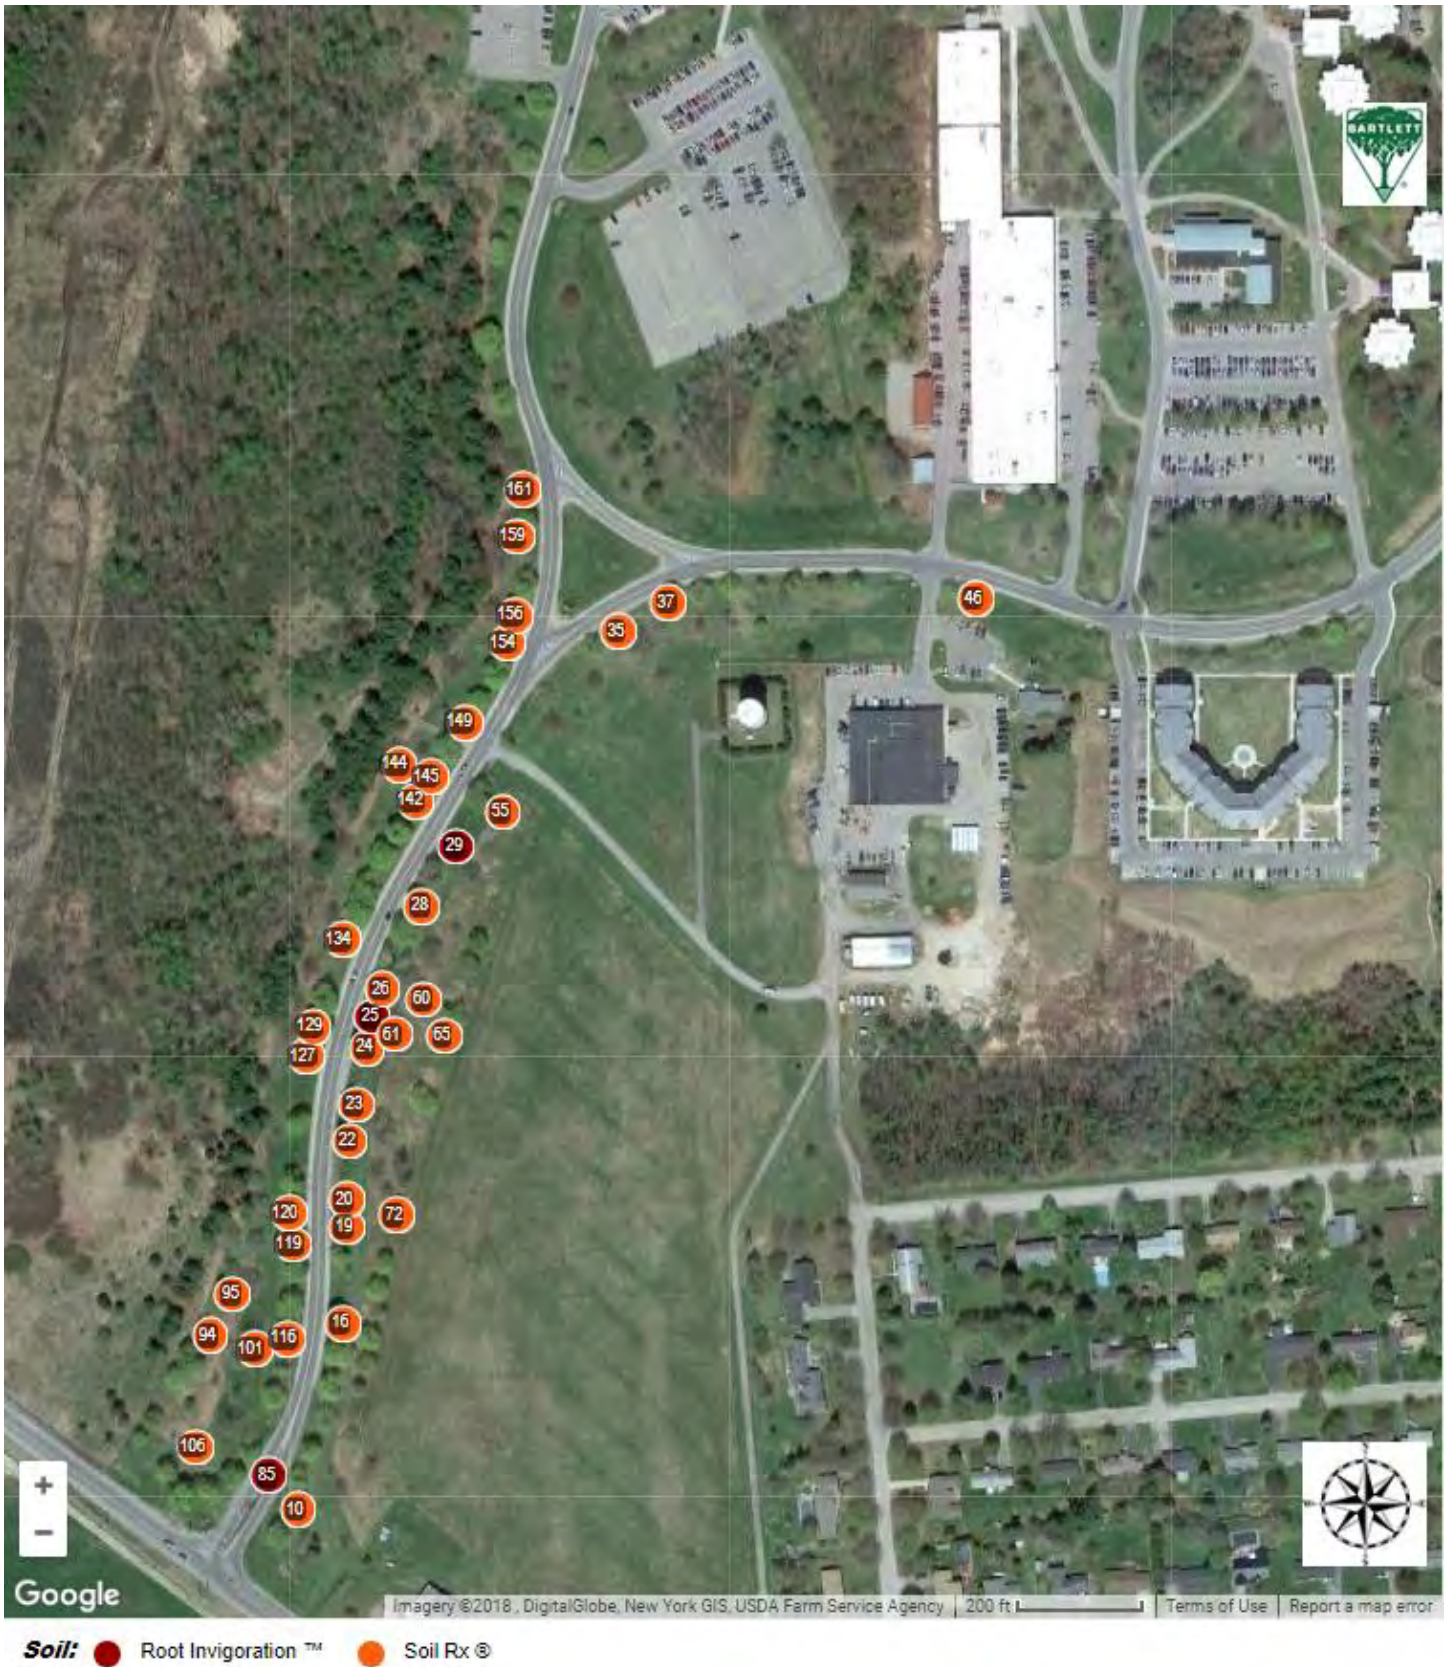
INVENTORIED TREES RECOMMENDED FOR SOIL MANAGEMENT

The following inventoried trees are recommended for soil management because of possible nutrient deficiencies, soil compaction, or inadequate soil conditions:

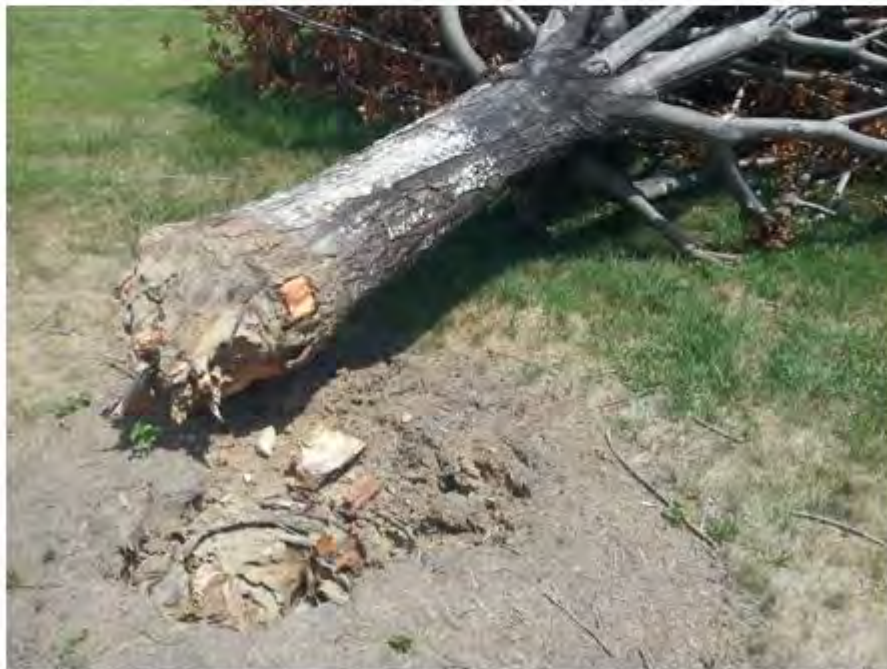
Example of tree failure from girdling roots.

The following trees are recommended for a root collar excavation:

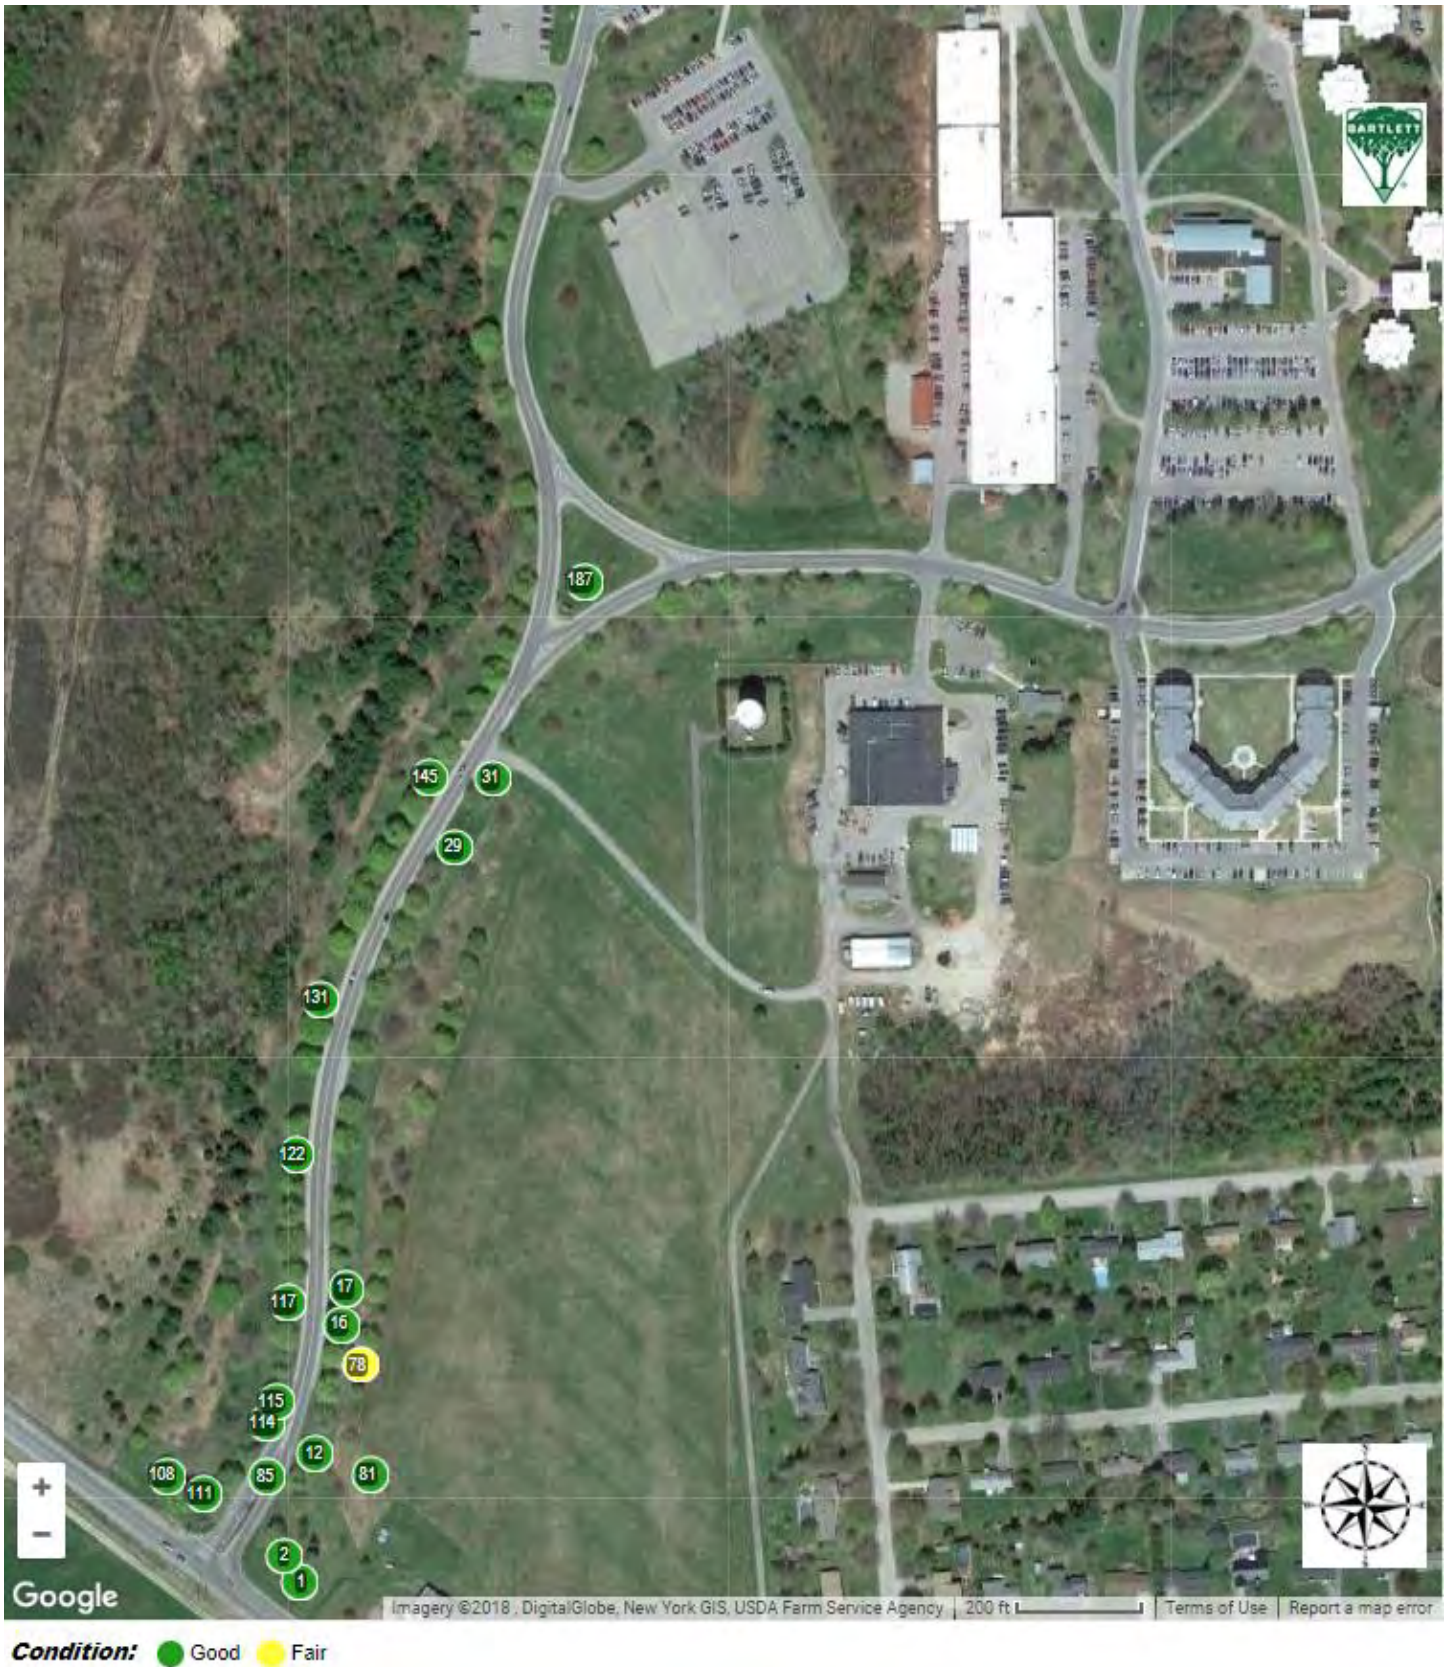
INVENTORIED TREES RECOMMENDED FOR A ROOT COLLAR EXCAVATION

Tree ID	Common Name	DBH	Girdling Roots
1	Spruce-Colorado Blue	7	...
2	Spruce-Colorado Blue	5	...
12	Maple-Norway	23	Girdling roots present
16	Maple-Norway	28	Girdling roots present
17	Maple-Norway	3	...
29	Maple-Sugar	6	...
31	Maple-Sugar	4	...
78	Maple-Norway	19	Girdling roots present
81	Maple-Red	13,10,9	Girdling roots present
85	Maple-Red	12	...
108	Maple-Norway	21	Girdling roots present
111	Maple-Norway	23	Girdling roots present
114	Maple-Sugar	4	...
115	Maple-Norway	21	Girdling roots present
117	Maple-Norway	24	Girdling roots present
122	Maple-Norway	6	...
131	Maple-Norway	24	Girdling roots present
145	Maple-Norway	27	Girdling roots present
187	Maple-Norway	2	...

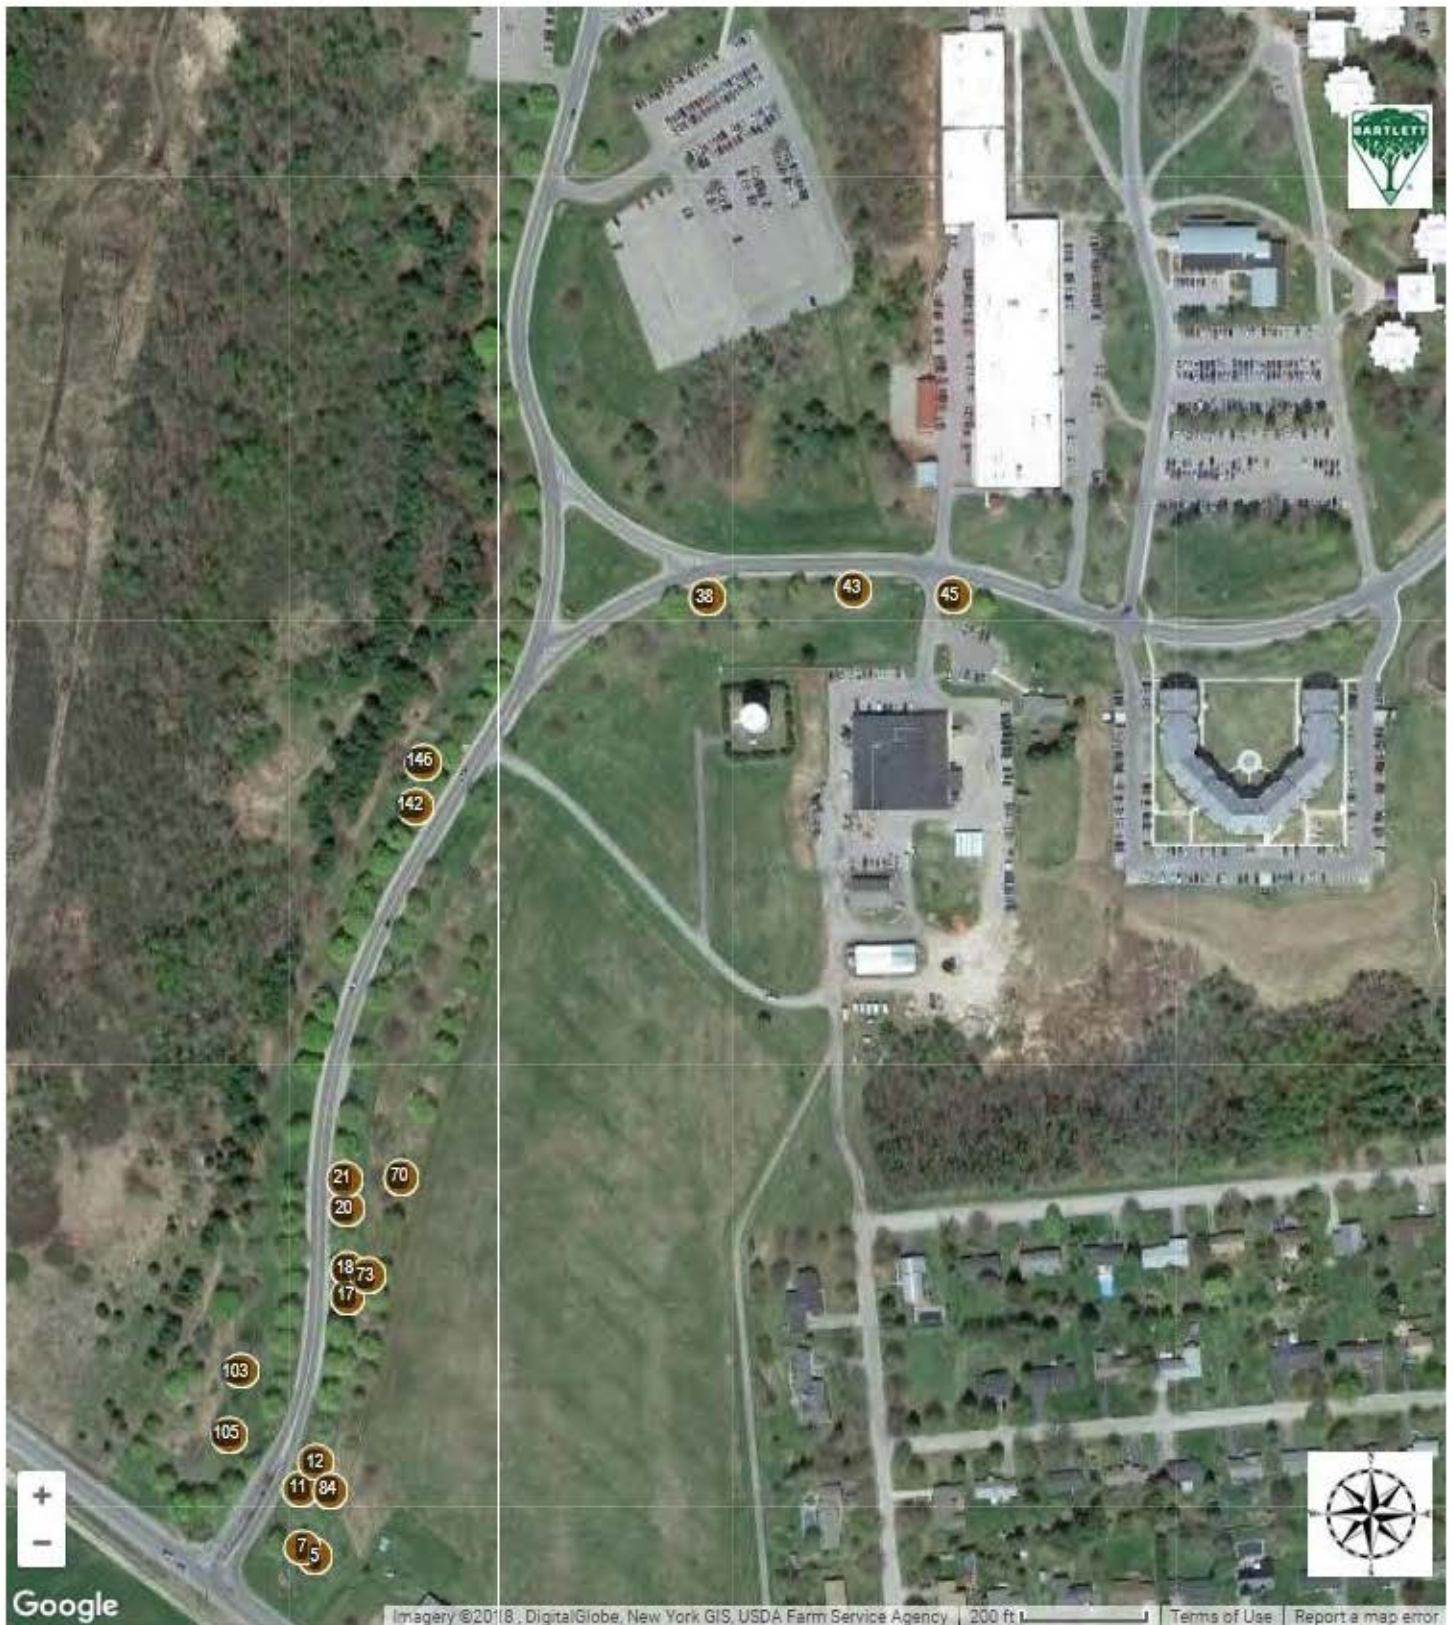
INVENTORIED TREES IDENTIFIED FOR PLANT HEALTH CARE

Tree ID	Common Name	DBH	Pest(s) or Disease(s)
5	Spruce-Colorado Blue	11	• Borers
7	Apple-Common	8,6	• Rust
11	Maple-Norway	19	• Tar spot
12	Maple-Norway	23	• Tar spot
17	Maple-Norway	3	• Tar spot
18*	Maple-Norway	33	• Tar spot
20	Maple-Norway	25	• Tar spot
21	Maple-Norway	5	• Tar spot
38*	Maple-Norway	23	• Tar spot
43	Maple-Norway	20	• Tar spot
45	Maple-Norway	17	• Tar spot
70	Ash-Green	24	• Borers
73	Ash-Green	8	• Borers
84	Ash-Green	14	• Borers
103	Oak-Bur	19	• Sapsucker
105	Ash-White	25	• Borers
142	Maple-Norway	25	• Tar spot
146	Ash-White	16	• Borers

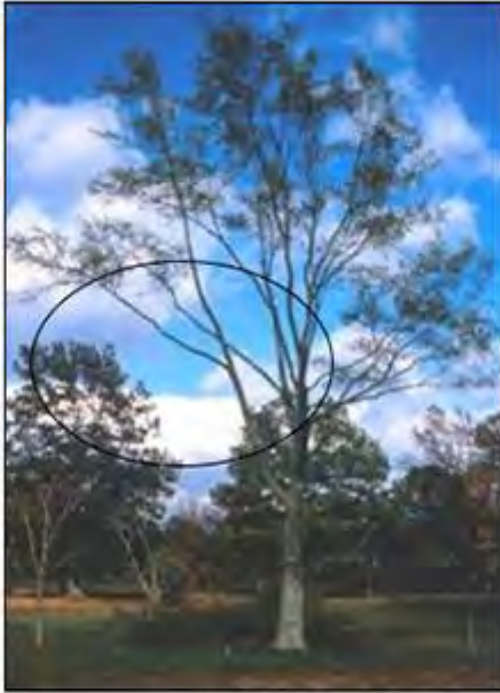
- Lion's Tailing - pruning that removes interior branches along the stem and scaffold branches. This encourages poor branch taper, poor wind load distribution, and risk of branch failure. It also deprives the tree of foliage it needs to produce **photosynthates**. See next page, top left

Example of Lion's tailing.

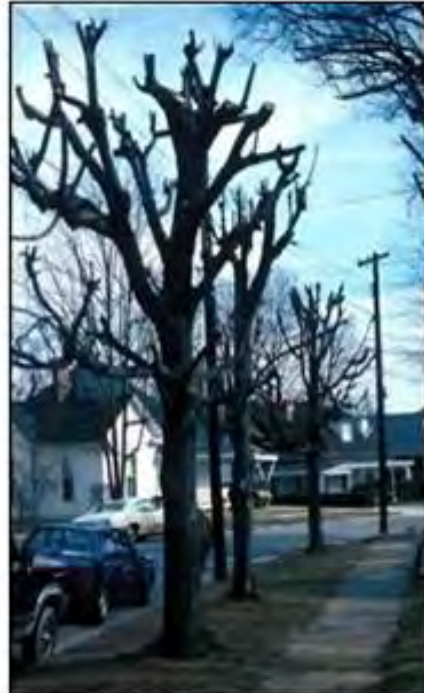
- Topping - pruning cuts that reduce a tree's size by using heading cuts that shorten branches to a predetermined size. Topping substantially reduces the functional benefits a tree is capable of providing and predisposes trees to structural defects that can contribute to failures in the future. It also reduces the value of the trees substantially and deprives the tree of adequate foliage. See next page, top right.

Examples of topping.

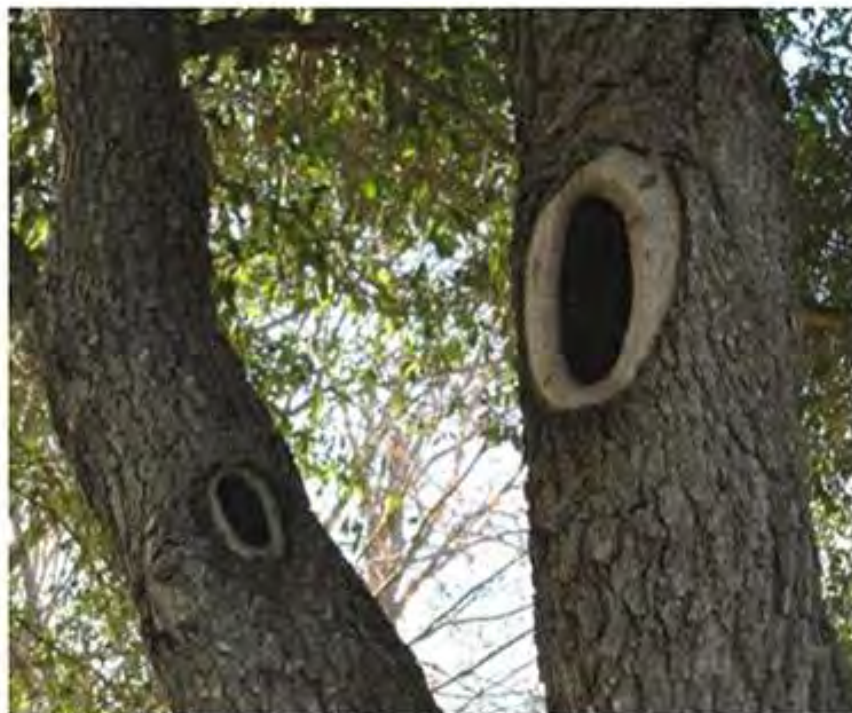
- Flush Cuts - pruning cut through the **branch collar**, flush against the trunk or parent stem, causing unnecessary injury. See next page, bottom.
- Using Climbing Spikes Inappropriately - Using climbing spikes on a healthy tree, for example, wounds healthy stem tissues and can lead to infection by fungal pathogens.

Examples of flush cuts.

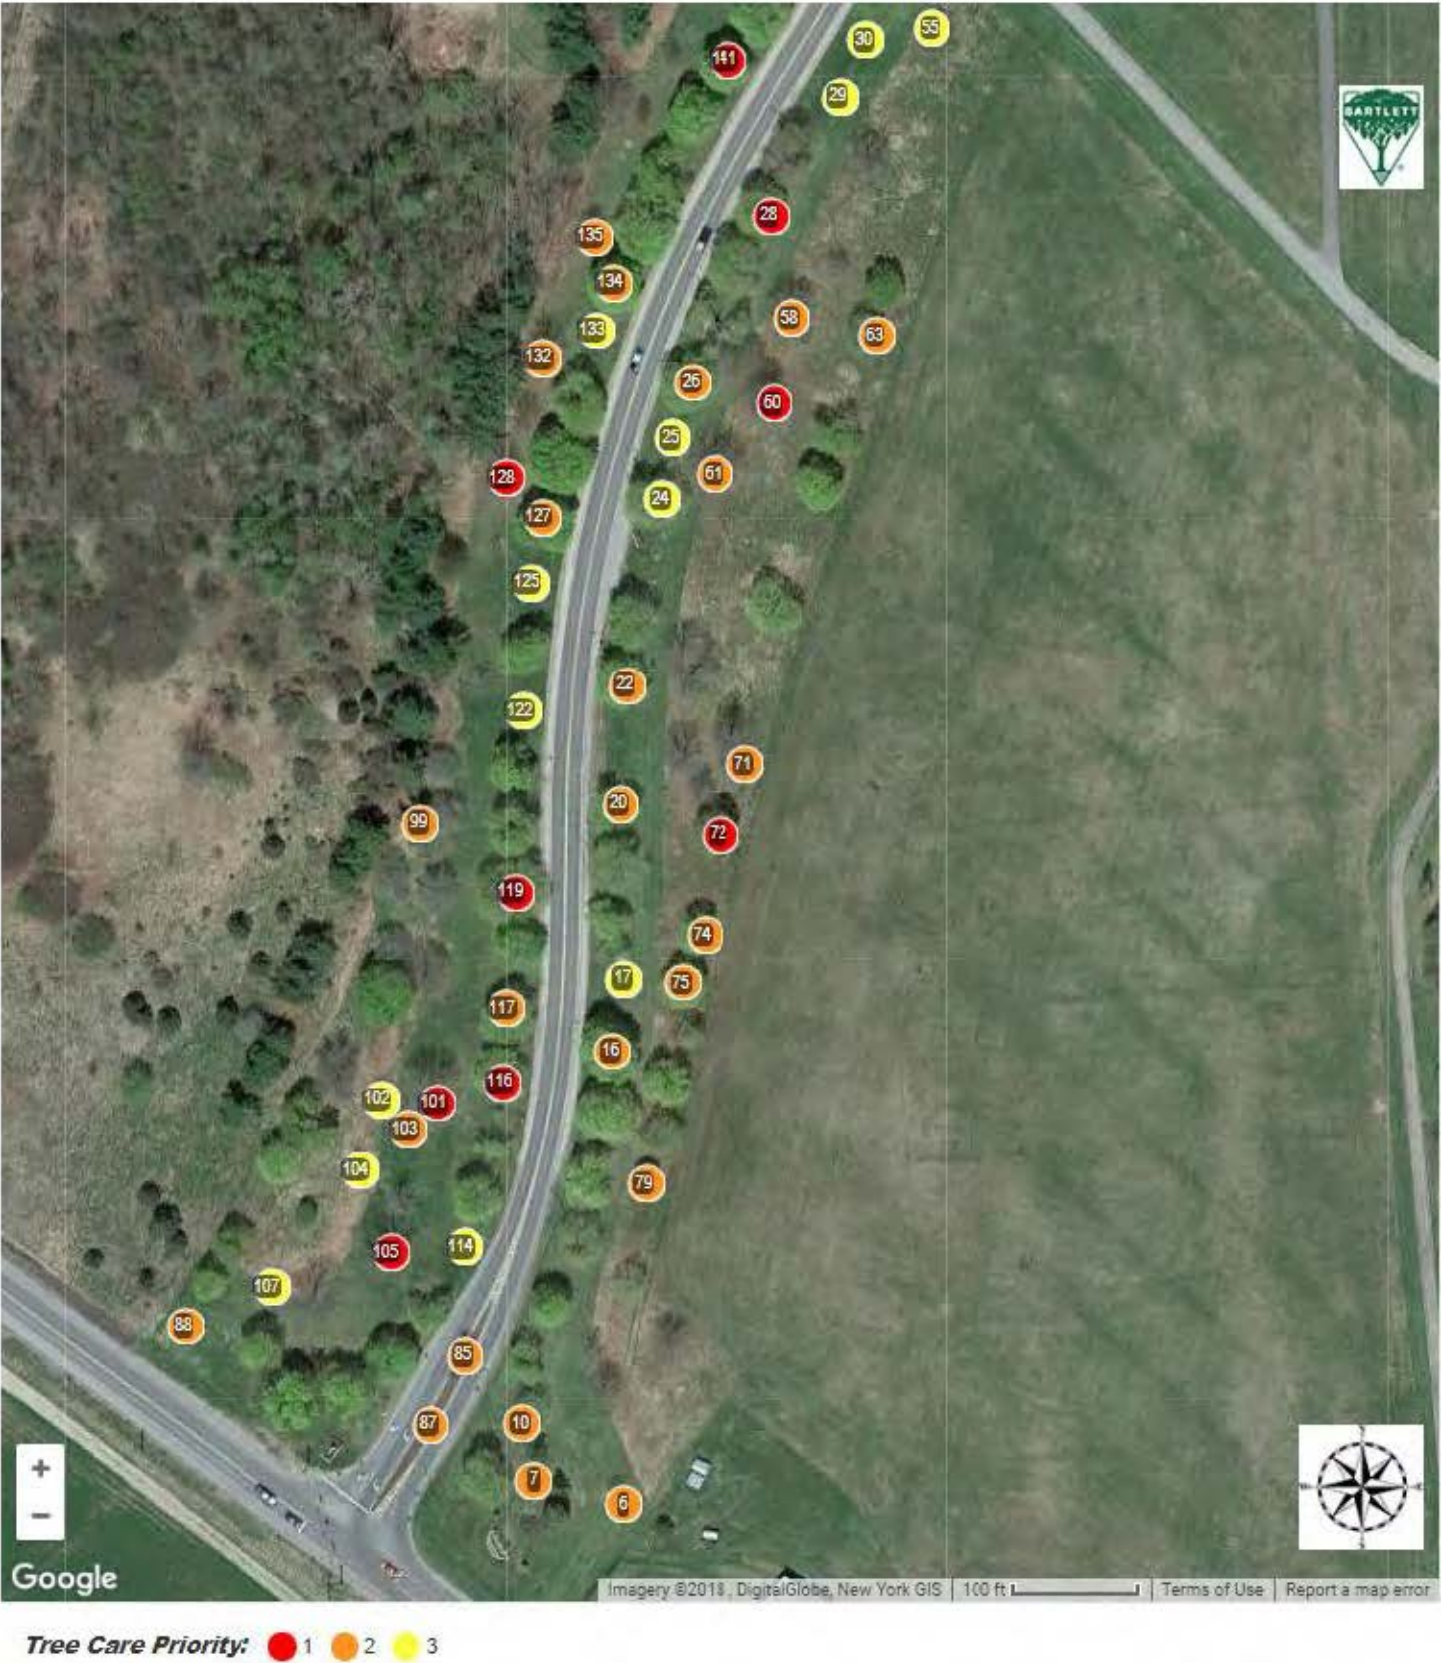
INVENTORIED TREES RECOMMENDED FOR PRUNING (SOUTH)

Tree ID	Common Name	DBH	Tree Care Priority	Pruning Recommended
28	Maple-Norway	26	1	• Clean
60	Maple-Red	27	1	• Clean • Thin
72	Maple-Norway	25	1	• Clean
101	Ash-White	34	1	• Clean
105	Ash-White	25	1	• Clean
116	Maple-Norway	27	1	• Clean
119	Maple-Norway	28	1	• Clean • Thin
128	Oak-Northern Red	24	1	• Clean
141	Maple-Norway	24	1	• Clean • Thin
6	Oak-Northern Red	15	2	• Structural
7	Apple-Common	8,6	2	• Structural
10	Maple-Norway	25	2	• Clean
16	Maple-Norway	28	2	• Clean
20	Maple-Norway	25	2	• Clean
22	Maple-Norway	22	2	• Clean
26	Maple-Norway	27	2	• Clean
34	Maple-Norway	22	2	• Clean
58	Ash-Green	24	2	• Clean
61	Honeylocust-Thornless Common	27	2	• Clean • Thin
63	Maple-Norway	24	2	• Clean
71	Maple-Red	17	2	• Thin • Structural
74	Maple-Norway	19	2	• Clean • Thin
75	Maple-Norway	21	2	• Clean • Thin
79	Maple-Norway	19	2	• Clean • Thin • Structural
85	Maple-Red	12	2	• Thin
87	Maple-Red	10	2	• Structural
88	Ash-Green	5	2	• Clean

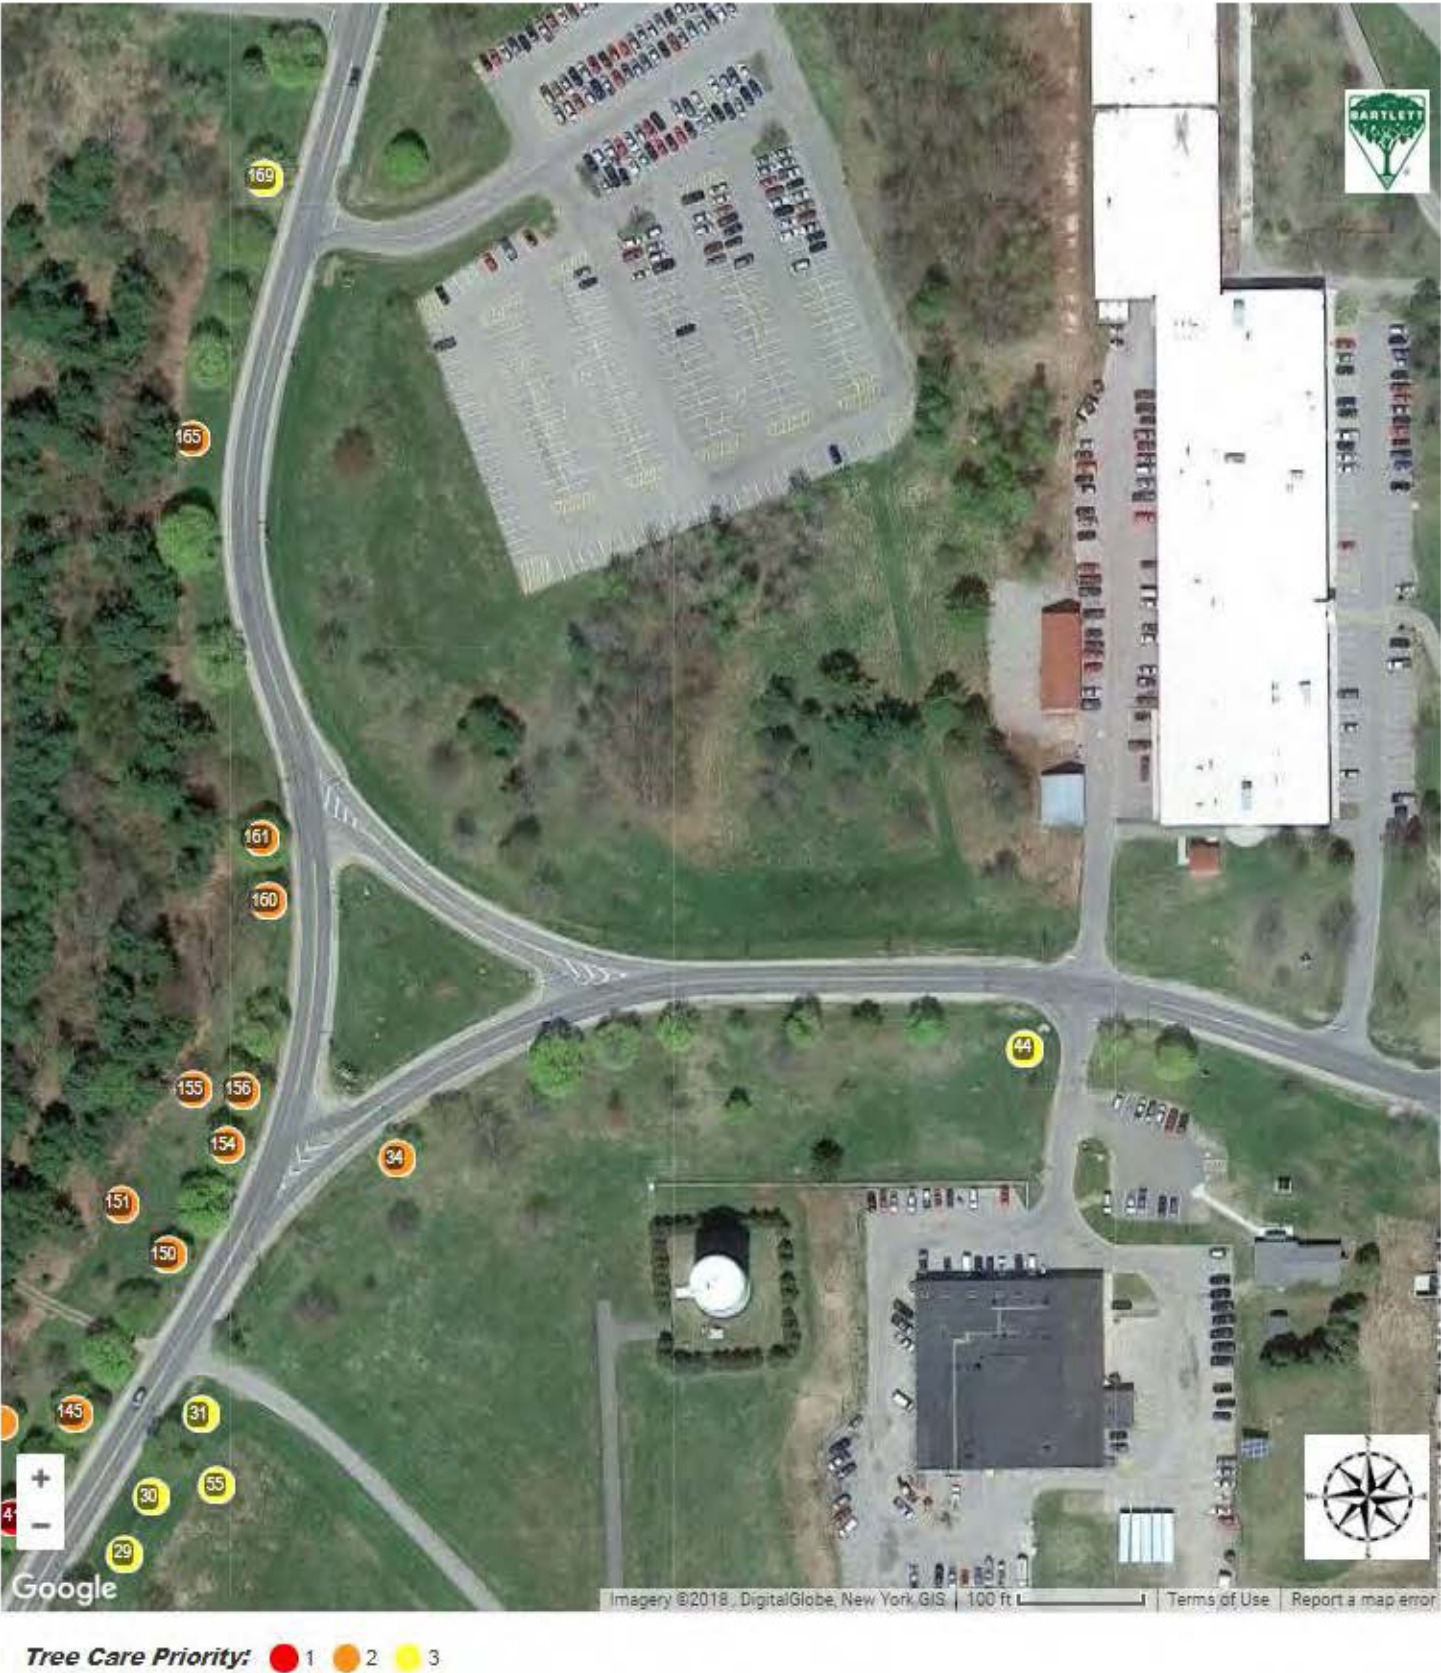
INVENTORIED TREES RECOMMENDED FOR PRUNING (CENTRAL)

Tree ID	Common Name	DBH	Tree Care Priority	Pruning Recommended
117	Maple-Norway	24	2	• Clean
127	Maple-Norway	25	2	• Clean
132	Maple-Sugar	20	2	• Clean • Thin • Structural
134	Maple-Norway	28	2	• Clean • Thin
135	Linden-American	18	2	• Thin
143	Maple-Norway	16	2	• Thin • Structural
145	Maple-Norway	27	2	• Clean • Thin
150	Maple-Norway	20	2	• Structural
151	Honeylocust-Thornless Common	18	2	• Clean
154	Maple-Norway	25	2	• Clean • Thin
155	Maple-Sugar	23	2	• Clean
156	Maple-Norway	26	2	• Clean
160	Maple-Norway	21	2	• Structural
161	Maple-Norway	25	2	• Structural
165	Oak-Northern Red	16	2	• Structural
172	Maple-Sugar	15	2	• Structural
173	Maple-Norway	22	2	• Structural
184	Maple-Norway	28	2	• Clean
17	Maple-Norway	3	3	• Structural
24	Maple-Norway	25	3	• Clean
25	Maple-Norway	4	3	• Structural
29	Maple-Sugar	6	3	• Structural
30	Maple-Sugar	5	3	• Structural
31	Maple-Sugar	4	3	• Structural
44	Maple-Sugar	6	3	• Structural

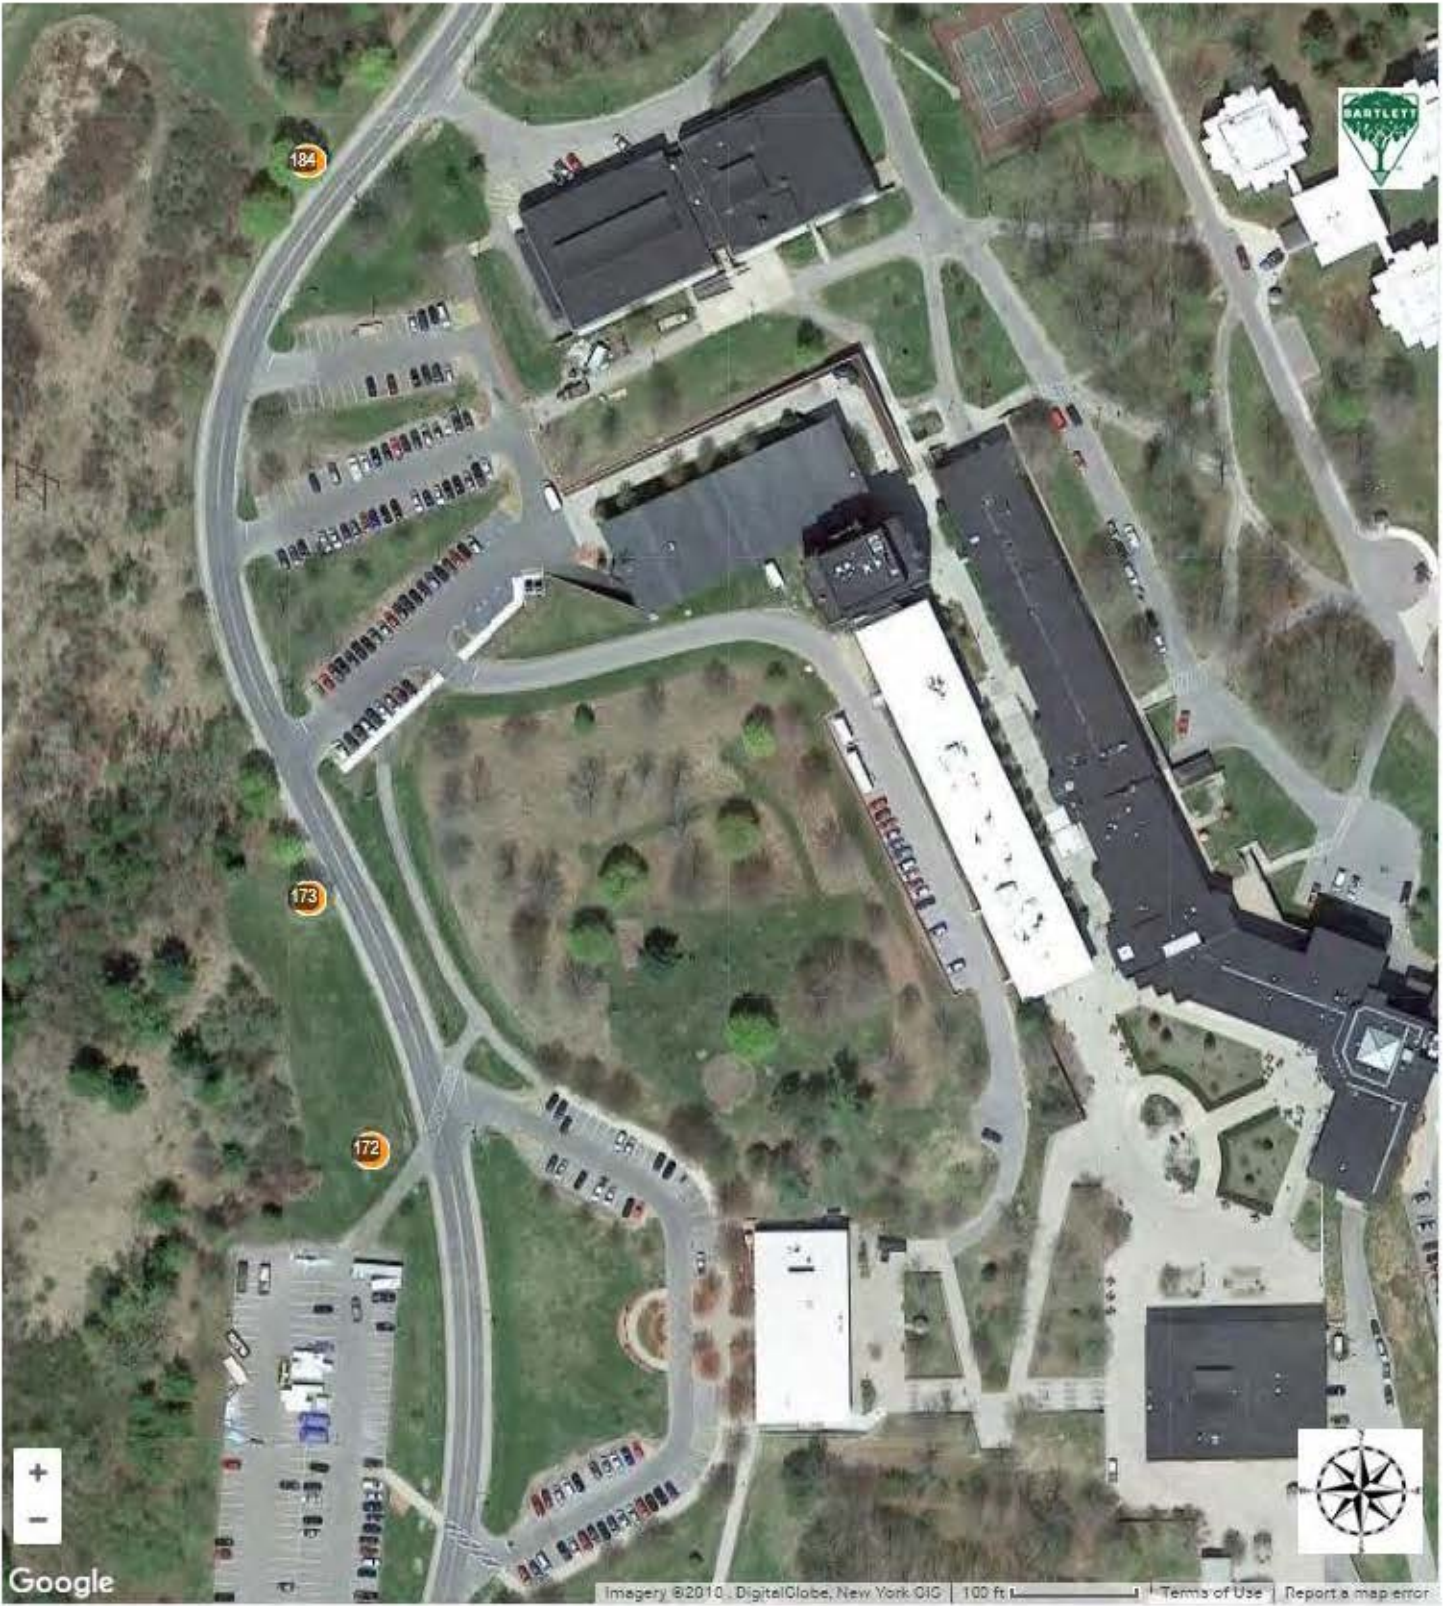
INVENTORIED TREES RECOMMENDED FOR PRUNING (NORTH)

55	Oak-Northern Red	26	3	• Thin
102	Ash-White	13	3	• Structural
104	Oak-Northern Red	13	3	• Structural
107	Ash-Green	7	3	• Structural
114	Maple-Sugar	4	3	• Structural
122	Maple-Norway	6	3	• Structural
125	Maple-Norway	3	3	• Structural
133	Maple-Sugar	5	3	• Structural
169	Maple-Norway	24	3	• Clean • Thin
