SUNY Canton

**Study of French Hall Sidewalks, Stairs, and Plazas,
and Campus Trees Along Cornell Drive**

SUCF Project Number: 231029001

Spring 2019

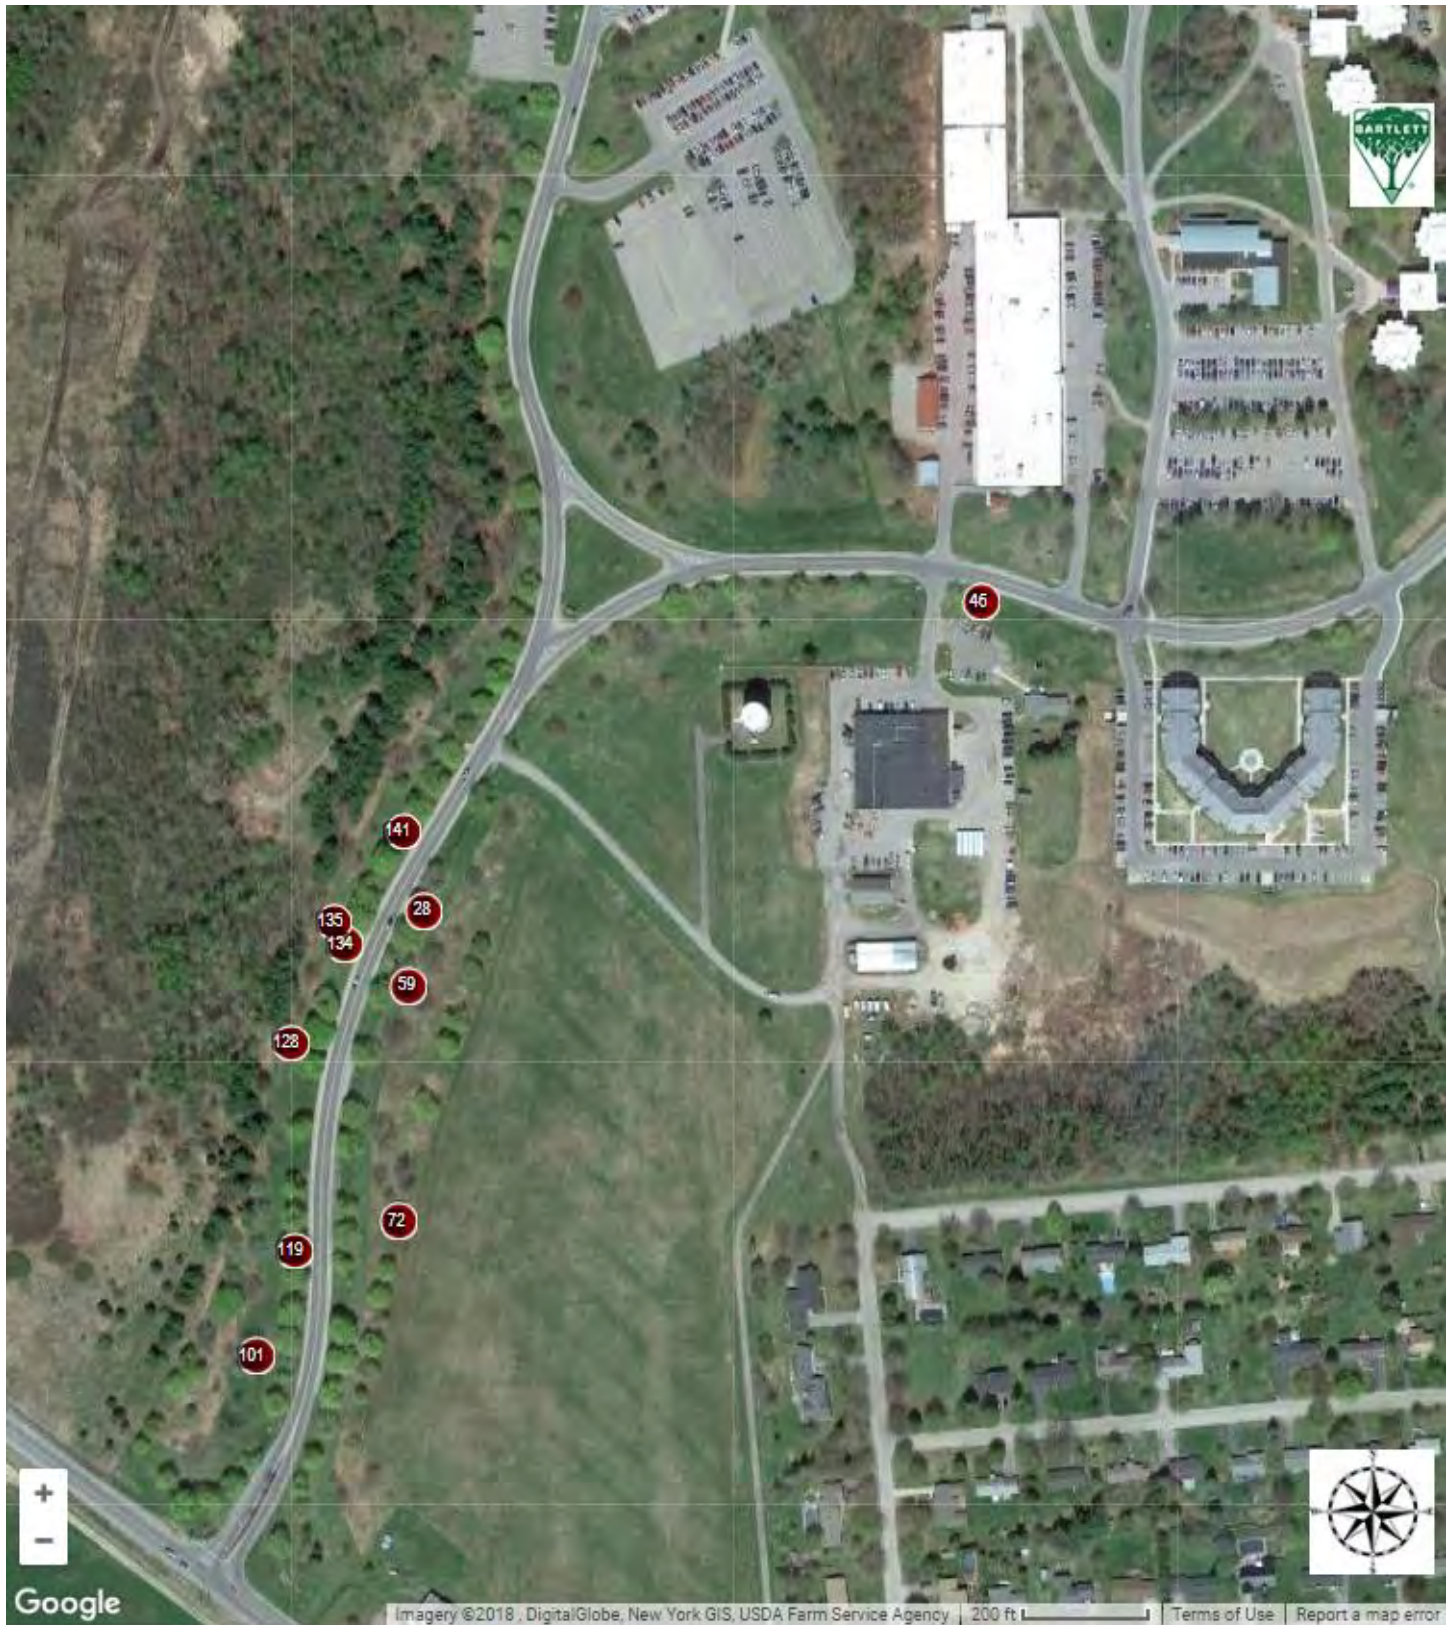
INVENTORIED TREES WITH STRUCTURAL SUPPORT SYSTEM RECOMMENDATIONS

Tree ID	Common Name	DBH	Tree Care Priority	Cable
28	Maple-Norway	26	1	New 2
46	Maple-Norway	27	1	New 1
72	Maple-Norway	25	1	New 3
101	Ash-White	34	1	New 1
119	Maple-Norway	28	1	New 3
128	Oak-Northern Red	24	1	New 2
141	Maple-Norway	24	1	New 2
59	Oak-Northern Red	21	2	New 1
134	Maple-Norway	28	2	New 2
135	Linden-American	18	2	New 2

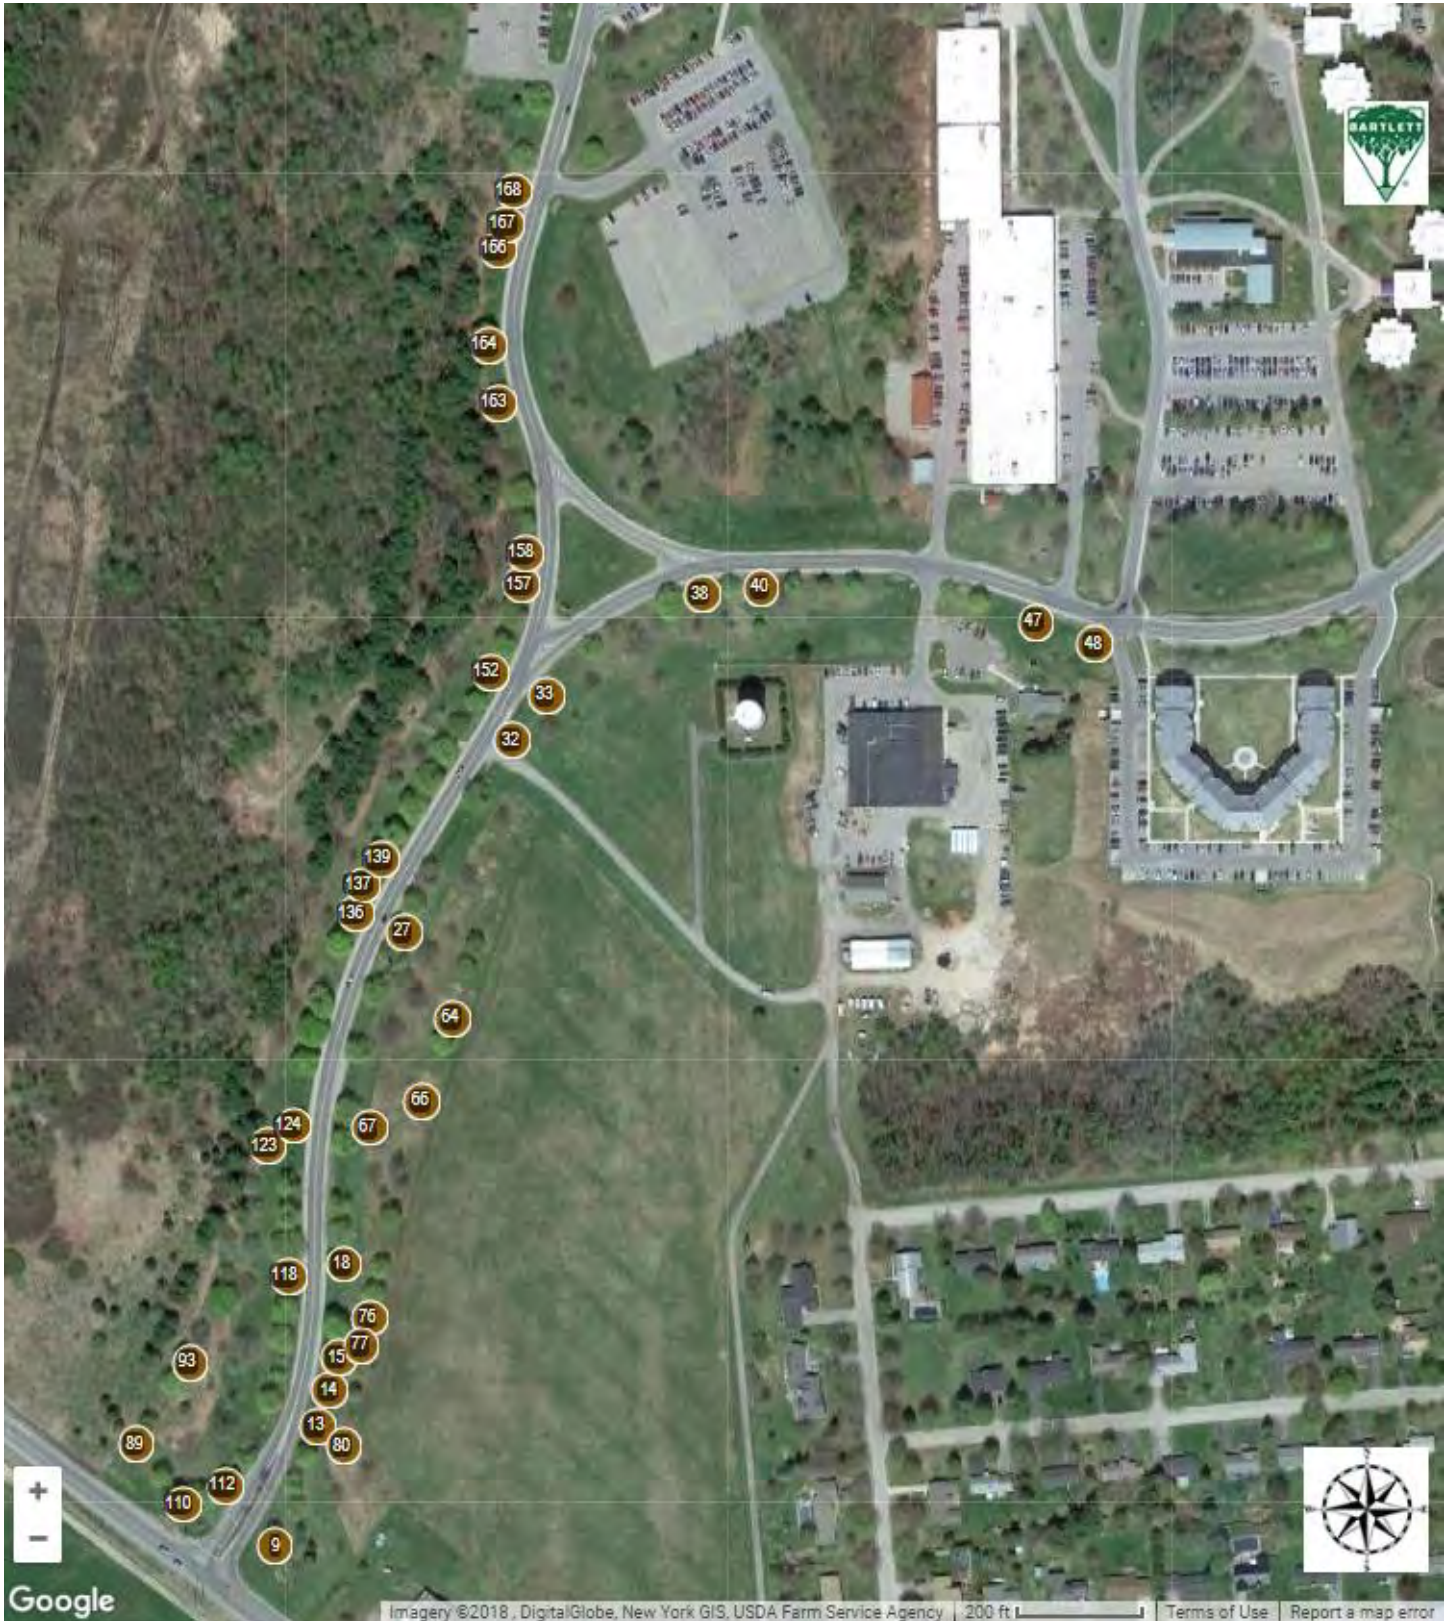
INVENTORIED TREES RECOMMENDED FOR REMOVAL

Tree ID	Common Name	DBH	Overall Risk Rating	Condition	Priority	Defect(s) or Observation(s)
157	Maple-Norway	27	Moderate	Poor	1	<ul style="list-style-type: none"> • Decay-Stem • Crack-branch
32	Maple-Norway	20	Low	Poor	2	<ul style="list-style-type: none"> • Uneven crown • Wound-stem
33	Maple-Norway	20	...	Poor	1	<ul style="list-style-type: none"> • Dieback (moderate) • Decay-Stem
47	Maple-Sugar	14	...	Poor	1	<ul style="list-style-type: none"> • Dieback (severe)
66	Maple-Norway	31	...	Poor	1	<ul style="list-style-type: none"> • Crack-stem
67	Ash-White	21	...	Poor	1	<ul style="list-style-type: none"> • Dieback (severe)
76	Maple-Norway	15	...	Poor	1	<ul style="list-style-type: none"> • Uneven crown • Dieback (moderate)
158	Maple-Sugar	17	...	Poor	1	<ul style="list-style-type: none"> • Dieback
163	Maple-Norway	26	...	Fair	1	<ul style="list-style-type: none"> • Decay-Stem • Dead branches >2
13	Maple-Norway	25	...	Fair	2	<ul style="list-style-type: none"> • Seam • Girdling roots present • Uneven crown

14	Maple-Norway	29	...	Fair	2	<ul style="list-style-type: none"> • Dieback (moderate) • Dead branches >2
18	Maple-Norway	33	...	Fair	2	<ul style="list-style-type: none"> • Decay-Stem • Uneven crown • Decay-Stem
77	Maple-Norway	24	...	Fair	2	<ul style="list-style-type: none"> • Decay-Stem
89	Maple-Norway	16	...	Poor	2	<ul style="list-style-type: none"> • Dieback (severe)
112	Maple-Norway	29	...	Fair	2	<ul style="list-style-type: none"> • Dieback • Seam • Cavity-Suspected
118	Maple-Norway	28	...	Fair	2	<ul style="list-style-type: none"> • Co-dominant leaders • Cavity-Suspected • Seam
124	Maple-Norway	27	...	Fair	2	<ul style="list-style-type: none"> • Cavity-Suspected • Dieback • Co-dominant leaders
164	Maple-Norway	37	...	Fair	2	<ul style="list-style-type: none"> • Cavity-stem • Poor branch structure
177	Maple-Norway	14	...	Poor	2	...
179	Maple-Norway	13	...	Poor	2	...
9	Maple-Norway	27	...	Fair	3	<ul style="list-style-type: none"> • Crack-stem • Decay-Stem

Tree ID	Common Name	DBH	Overall Risk Rating	Condition	Priority	Defect(s) or Observation(s)
15	Maple-Norway	31	...	Fair	3	<ul style="list-style-type: none"> • Storm damage • Cavity-Suspected • Seam
64	Maple-Norway	21	...	Fair	3	...
123	Coffeetree-Kentucky	14	...	Fair	3	<ul style="list-style-type: none"> • Wound-root flare • Dieback
152	Maple-Norway	32	...	Fair	3	<ul style="list-style-type: none"> • Wound-stem • Cavity-Suspected • Decay-Branch • Poor branch structure
166	Maple-Norway	24	...	Poor	3	<ul style="list-style-type: none"> • Cavity-stem
27	Maple-Norway	28	...	Fair	4	<ul style="list-style-type: none"> • Seam • Wound-stem
38	Maple-Norway	23	...	Fair	4	<ul style="list-style-type: none"> • Dieback (moderate) • Construction damage • Wound-root flare
93	Maple-Norway	30	...	Fair	4	<ul style="list-style-type: none"> • Storm damage • Wound-stem
110	Maple-Norway	30	...	Fair	4	<ul style="list-style-type: none"> • Rib • Dieback • Included bark

139	Maple-Norway	27	...	Fair	4	<ul style="list-style-type: none"> • Wound-branch • Uneven crown
168	Maple-Norway	24	...	Fair	4	<ul style="list-style-type: none"> • Wound-stem • Decay-Stem • Dieback
40	Maple-Norway	13	...	Fair	5	<ul style="list-style-type: none"> • Cavity-Suspected • Rib
48	Maple-Norway	20	...	Fair	5	<ul style="list-style-type: none"> • Rib
80	Maple-Norway	17	...	Fair	5	<ul style="list-style-type: none"> • Cavity-stem
136	Maple-Norway	27	...	Fair	5	<ul style="list-style-type: none"> • Storm damage • Wound-stem
137	Maple-Norway	23	...	Fair	5	<ul style="list-style-type: none"> • Wound-stem • Uneven crown
167	Maple-Norway	22	...	Fair	5	<ul style="list-style-type: none"> • Decay-Stem • Wound-stem • Cavity-Suspected

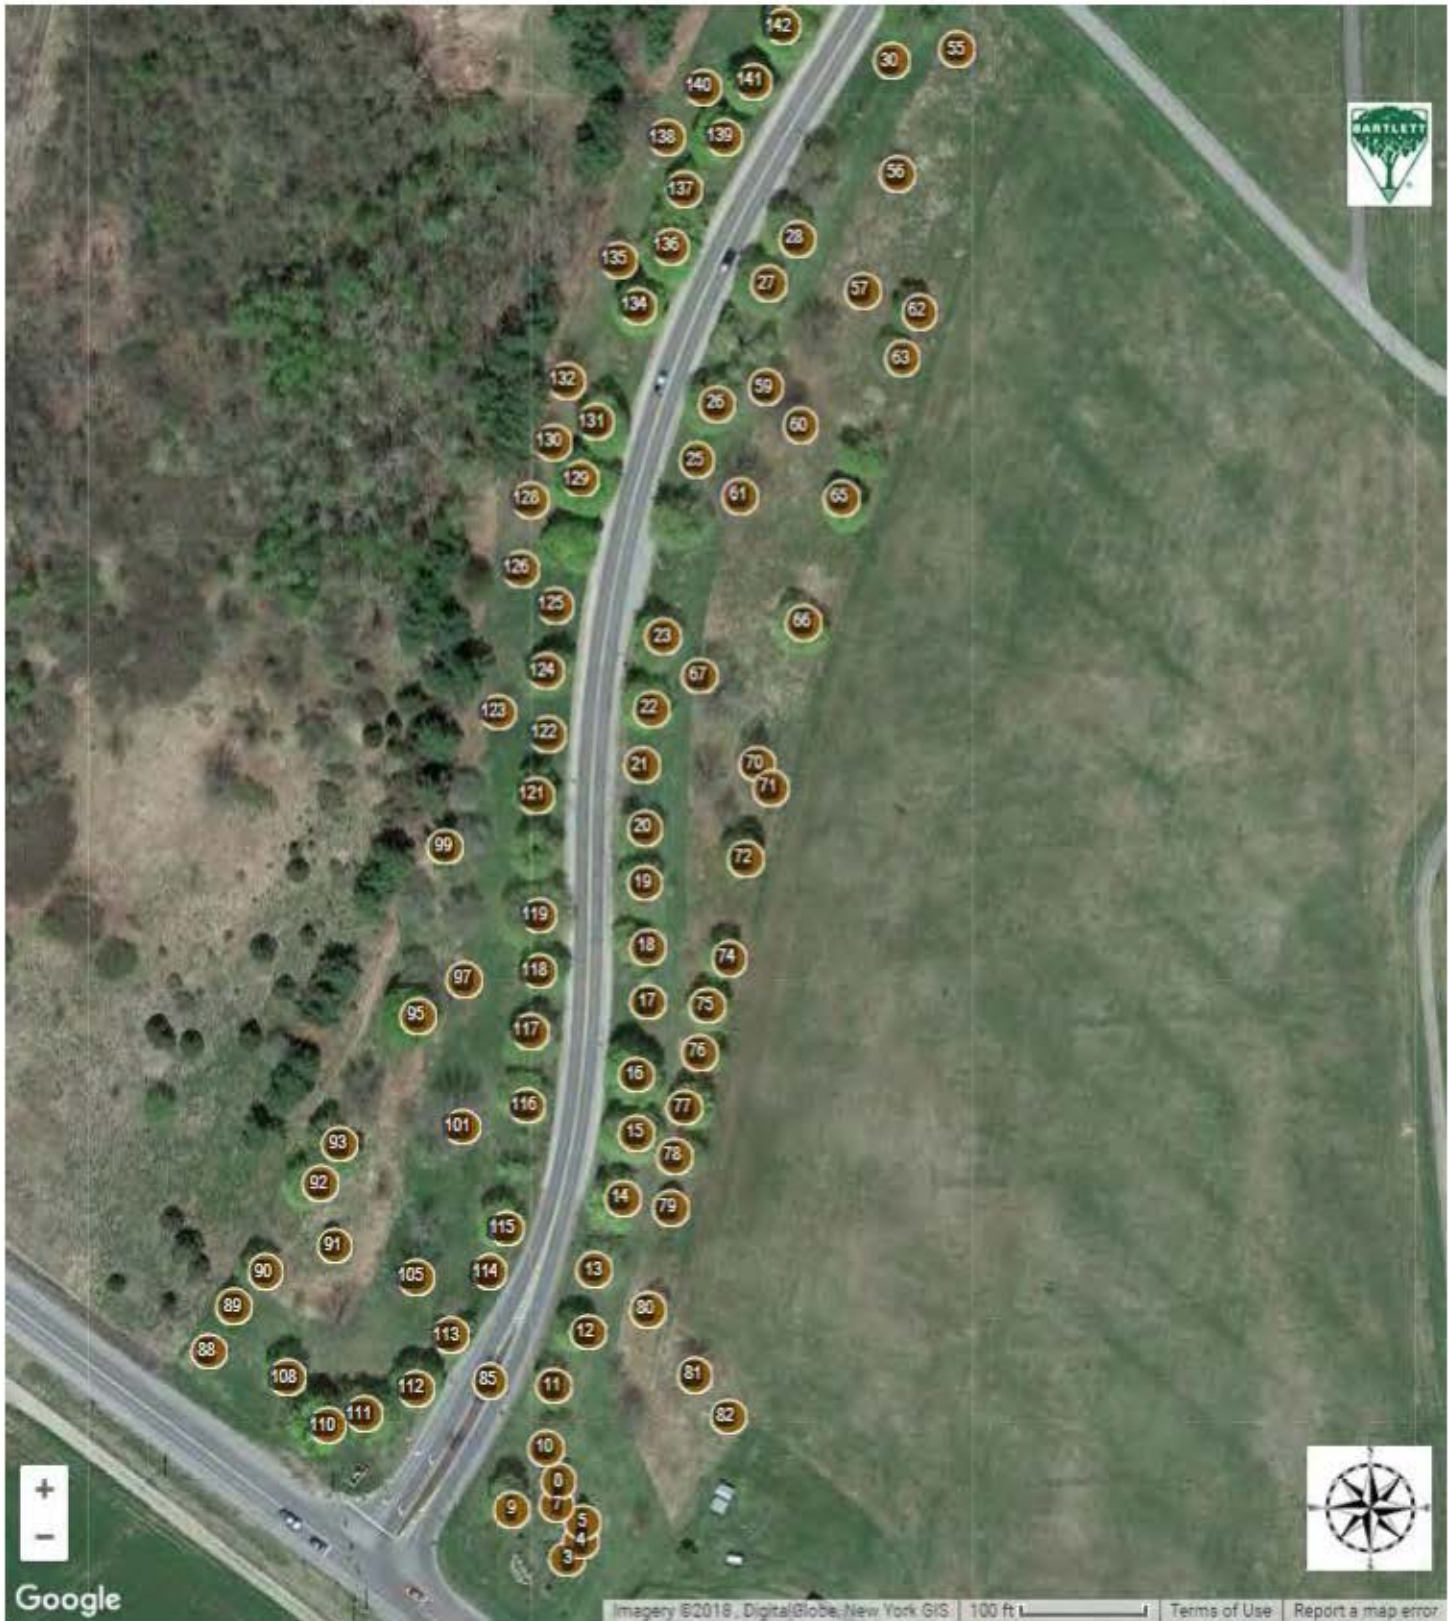
INVENTORIED TREES WITH DEFECTS, OBSERVATIONS, OR OTHER STRUCTURAL ISSUES (SOUTH)

Tree ID	Common Name	DBH	Defect(s) or Observation(s)
3	Ash-Green	15	• Wound-root flare
4	Spruce-Colorado Blue	18	• Corrected lean
5	Spruce-Colorado Blue	11	• Wound-stem • Wound-root flare
7	Apple-Common	8,6	• Wound-stem
8	Pine-Austrian	10	• Co-dominant leaders
9	Maple-Norway	27	• Crack-stem • Decay-Stem
10	Maple-Norway	25	• Seam • Wound-stem
11	Maple-Norway	19	• Decay-Stem • Storm damage
12	Maple-Norway	23	• Seam • Girdling roots present
13	Maple-Norway	25	• Seam • Girdling roots present • Uneven crown
14	Maple-Norway	29	• Dieback (moderate) • Dead branches >2
15	Maple-Norway	31	• Storm damage • Cavity-Suspected • Seam
16	Maple-Norway	28	• Cavity-stem • Storm damage • Girdling roots present
17	Maple-Norway	3	• Wound-stem
18	Maple-Norway	33	• Decay-Stem • Uneven crown • Decay-Stem
19	Maple-Norway	26	• Wound-stem
20	Maple-Norway	25	• Seam
21	Maple-Norway	5	• Wound-stem
22	Maple-Norway	22	• Seam • Dead branches >2

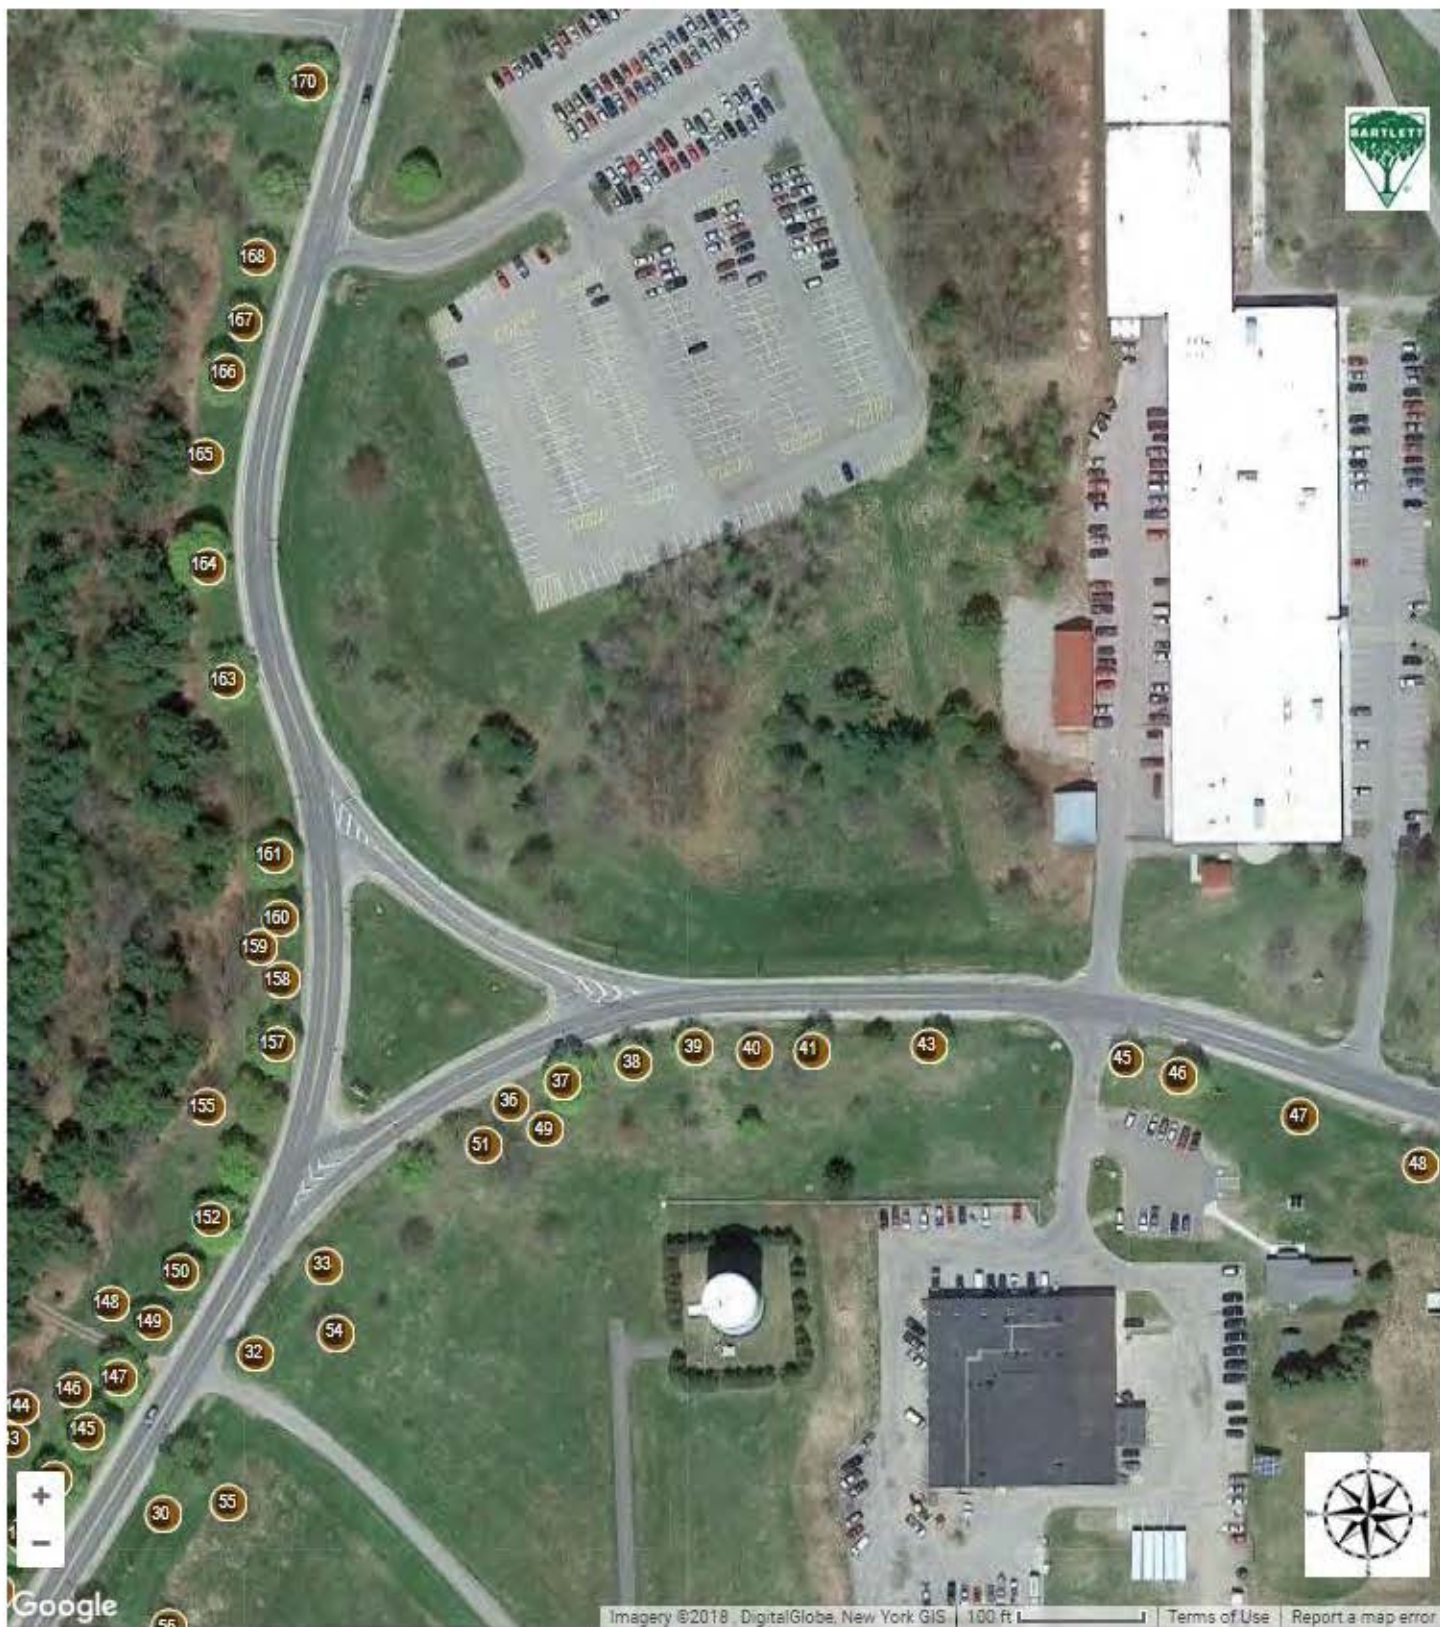
INVENTORIED TREES WITH DEFECTS, OBSERVATIONS, OR OTHER STRUCTURAL ISSUES (CENTRAL)

Tree ID	Common Name	DBH	Defect(s) or Observation(s)
32	Maple-Norway	20	<ul style="list-style-type: none"> • Uneven crown • Wound-stem
33	Maple-Norway	20	<ul style="list-style-type: none"> • Dieback (moderate) • Decay-Stem
36	Maple-Norway	2	<ul style="list-style-type: none"> • Wound-stem
37	Maple-Norway	25	<ul style="list-style-type: none"> • Rib • Construction damage
38	Maple-Norway	23	<ul style="list-style-type: none"> • Dieback (moderate) • Construction damage • Wound-root flare
39	Maple-Norway	19	<ul style="list-style-type: none"> • Seam
40	Maple-Norway	13	<ul style="list-style-type: none"> • Cavity-Suspected • Rib
41	Maple-Norway	21	<ul style="list-style-type: none"> • Included bark
43	Maple-Norway	20	<ul style="list-style-type: none"> • Wound-stem
45	Maple-Norway	17	<ul style="list-style-type: none"> • Wound-stem
46	Maple-Norway	27	<ul style="list-style-type: none"> • Co-dominant leaders
47	Maple-Sugar	14	<ul style="list-style-type: none"> • Dieback (severe)

48	Maple-Norway	20	<ul style="list-style-type: none"> • Rib
49	Ash-White	20	<ul style="list-style-type: none"> • Wound-root flare
51	Ash-White	21	<ul style="list-style-type: none"> • Decay-Root flare
54	Maple-Red	26	<ul style="list-style-type: none"> • Included bark
55	Oak-Northern Red	26	<ul style="list-style-type: none"> • Included bark
56	Ash-Green	21	<ul style="list-style-type: none"> • Co-dominant leaders
57	Ash-Green	13	<ul style="list-style-type: none"> • Wound-root flare
59	Oak-Northern Red	21	<ul style="list-style-type: none"> • Co-dominant leaders
60	Maple-Red	27	<ul style="list-style-type: none"> • Co-dominant leaders
61	Honeylocust-Thornless Common	27	<ul style="list-style-type: none"> • Dead branches >2
62	Maple-Norway	19	<ul style="list-style-type: none"> • Decay-Stem
63	Maple-Norway	24	<ul style="list-style-type: none"> • Dead branches >2
65	Maple-Norway	27	<ul style="list-style-type: none"> • Rib • Seam

66	Maple-Norway	31	<ul style="list-style-type: none"> • Crack-stem
67	Ash-White	21	<ul style="list-style-type: none"> • Dieback (severe)
70	Ash-Green	24	<ul style="list-style-type: none"> • Co-dominant leaders
71	Maple-Red	17	<ul style="list-style-type: none"> • Co-dominant leaders
72	Maple-Norway	25	<ul style="list-style-type: none"> • Included bark • Rib
74	Maple-Norway	19	<ul style="list-style-type: none"> • Co-dominant leaders
75	Maple-Norway	21	<ul style="list-style-type: none"> • Included bark • Seam
76	Maple-Norway	15	<ul style="list-style-type: none"> • Uneven crown • Dieback (moderate)
77	Maple-Norway	24	<ul style="list-style-type: none"> • Decay-Stem

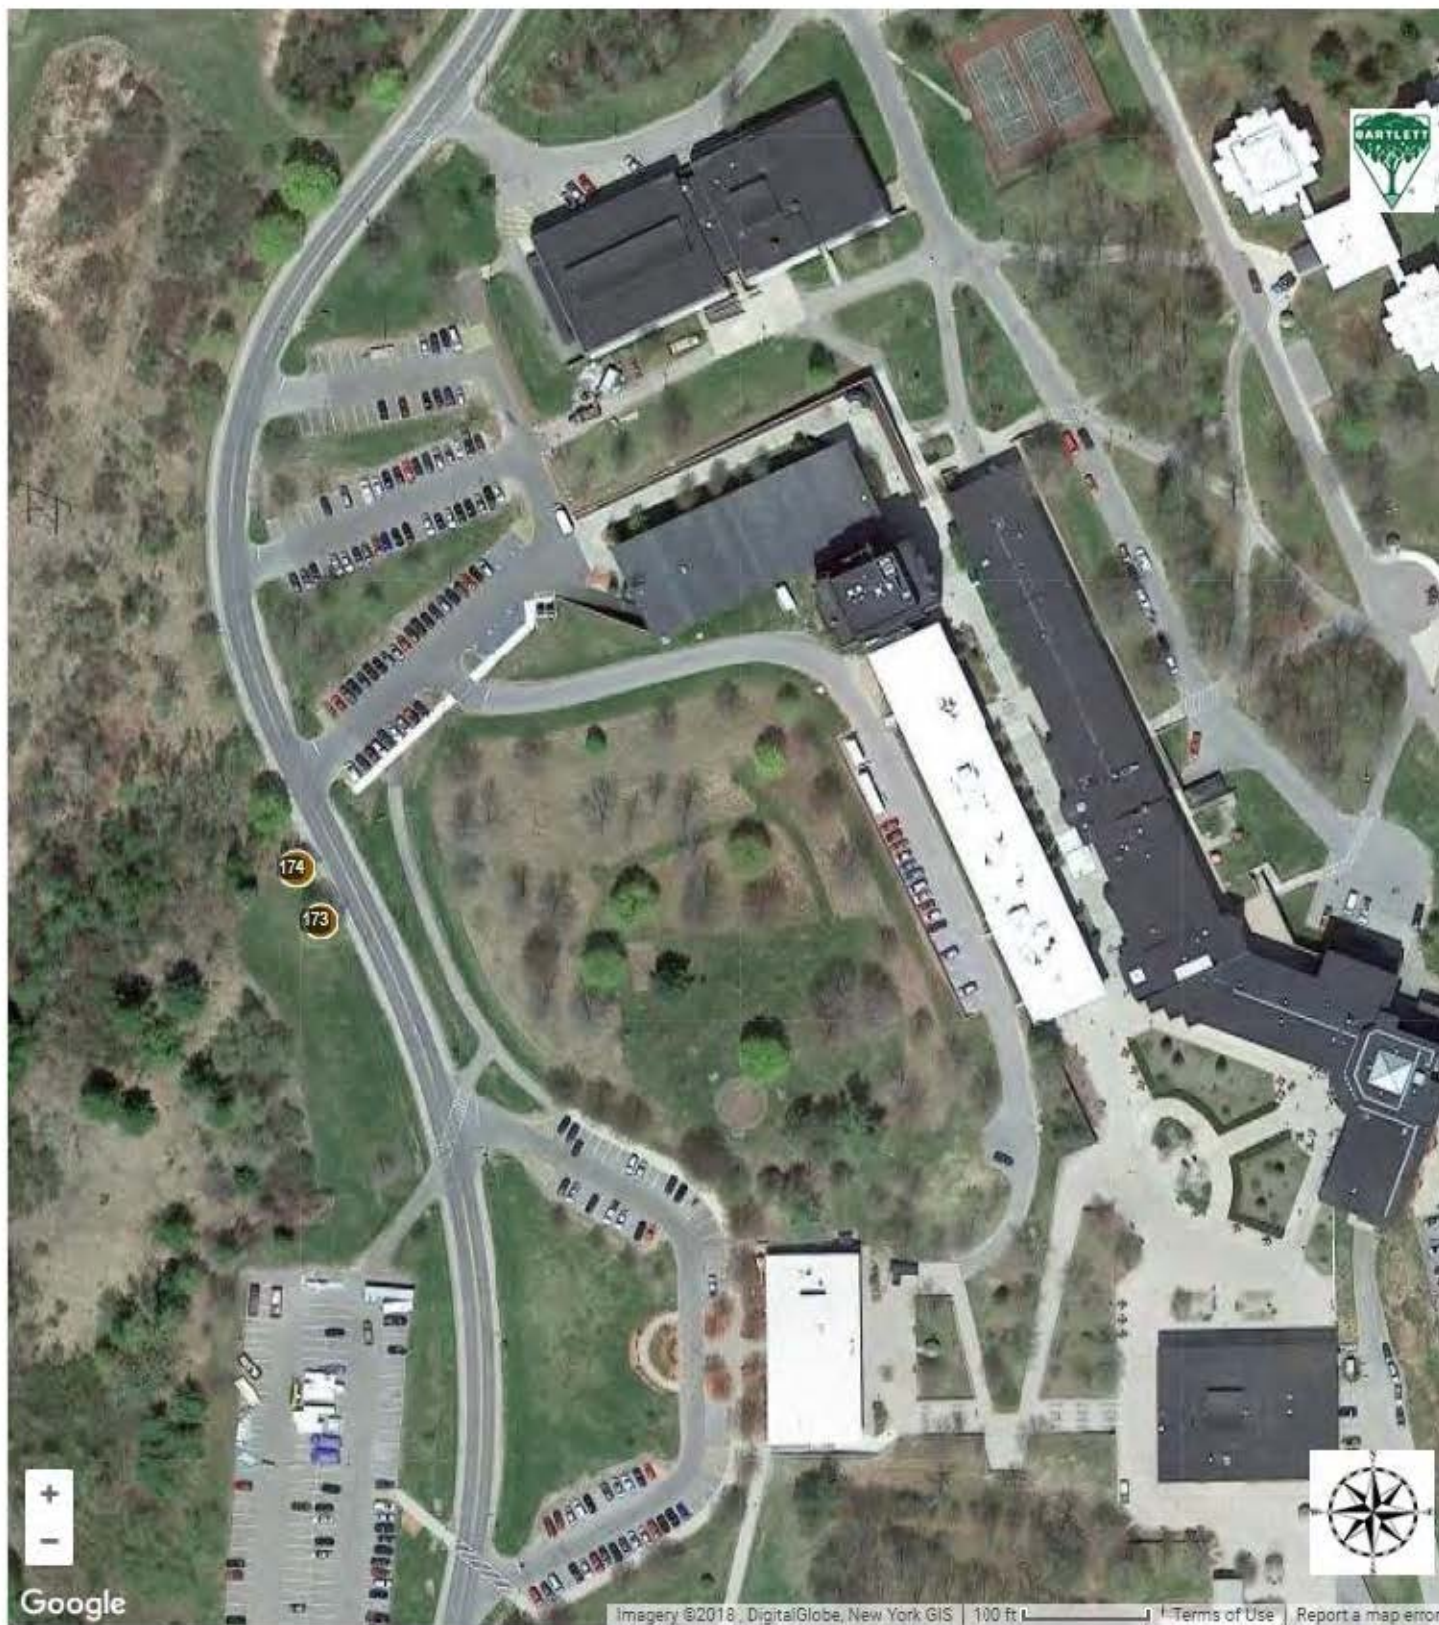
INVENTORIED TREES WITH DEFECTS, OBSERVATIONS, OR OTHER STRUCTURAL ISSUES (NORTH)

165	Oak-Northern Red	16	<ul style="list-style-type: none"> • Co-dominant leaders
166	Maple-Norway	24	<ul style="list-style-type: none"> • Cavity-stem
167	Maple-Norway	22	<ul style="list-style-type: none"> • Decay-Stem • Wound-stem • Cavity-Suspected
168	Maple-Norway	24	<ul style="list-style-type: none"> • Wound-stem • Decay-Stem • Dieback
170	Maple-Norway	27	<ul style="list-style-type: none"> • Decay-Branch • Dead branches >2
173	Maple-Norway	22	<ul style="list-style-type: none"> • Poor branch structure
174	Maple-Norway	16,9,8	<ul style="list-style-type: none"> • Poor branch structure • Decay-Stem
